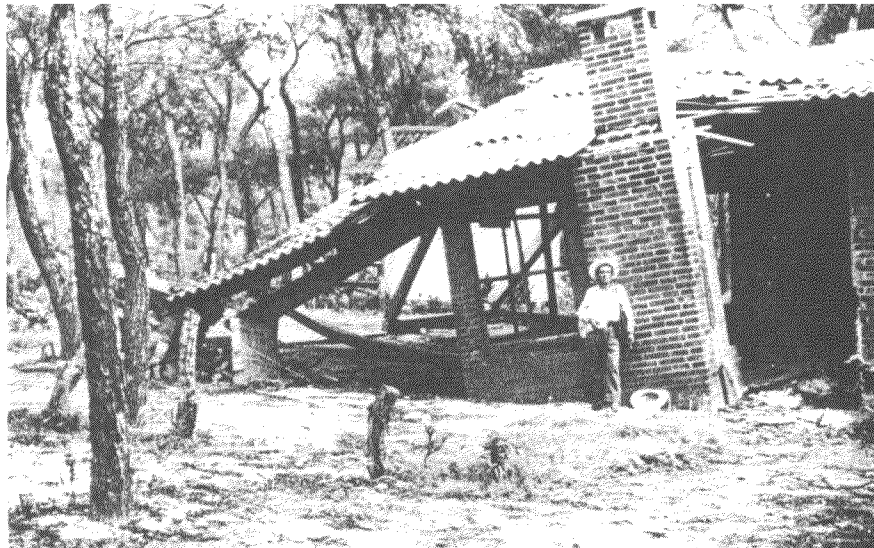
Figure 8. Collapsed southeast corner of a reinforced brick house at La Playa. The damage was caused by 1.5 m of lateral spreading. The front of the house also subsided and allowed the fireplace to rotate. There were no cracks in this structure except the one due to lateral spreading and differential settlement.

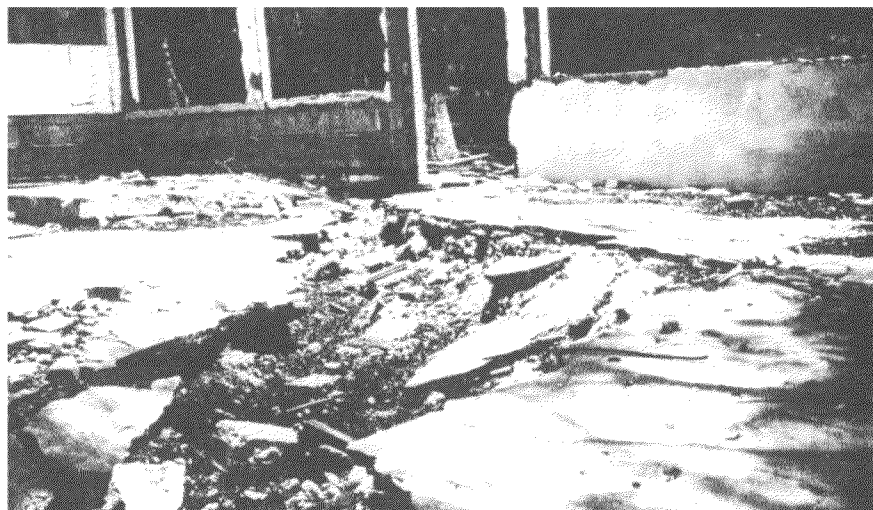
Figure 9. Floor of a concrete-block house pulled apart 1.5 m by lateral spreading. The house was located at the northwest end of the central lobe of the Villalobos River delta at La Playa.

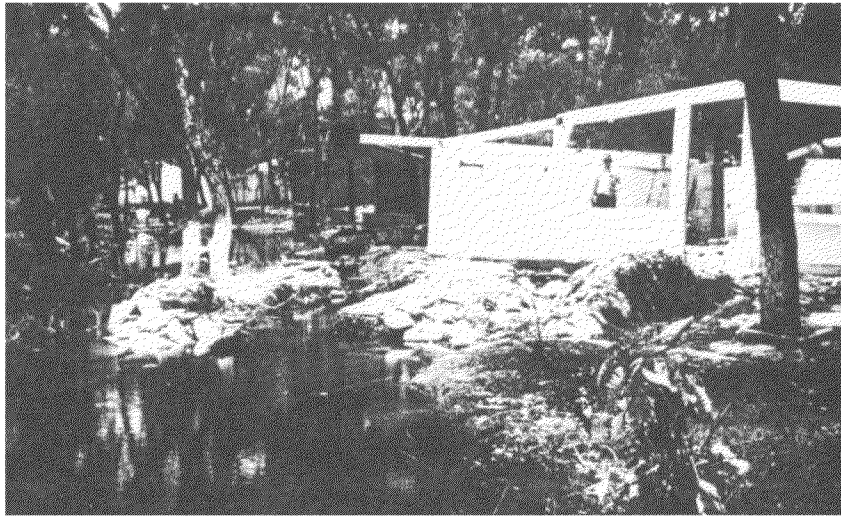
Figure 10. Back patio of the house shown in Fig. 9. Photo shows a series of ridges formed by lateral spreads (compare with Fig. 3) and trees standing in the water. The latter is a consequence of subsidence. The house shown in Fig. 11 is in the background.

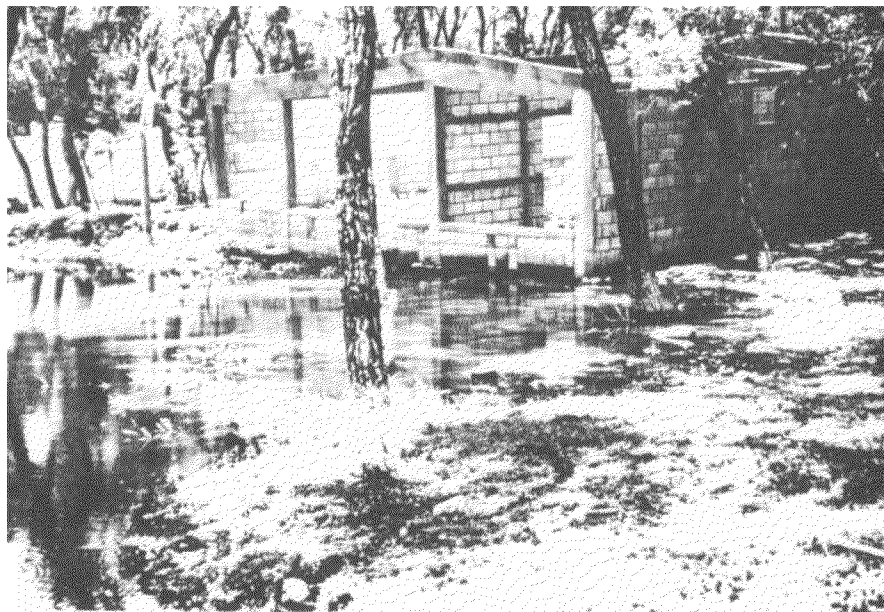
Figure 11. A large back yard slid away from behind this concrete-block house leaving the unevenly subsided foundation at lake level. The new lake bottom next to the house is composed of sand.
