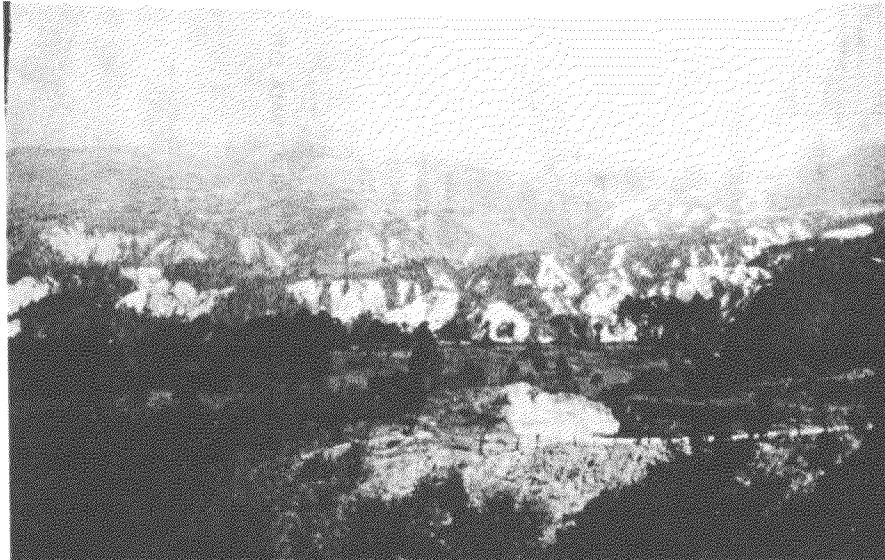
Figure 3.-- View looking SE along junction of Rios Pixcaya and Xaltaya showing high intensity of rockfall and debris slide occurrence typical in steep pumice slopes in this area.

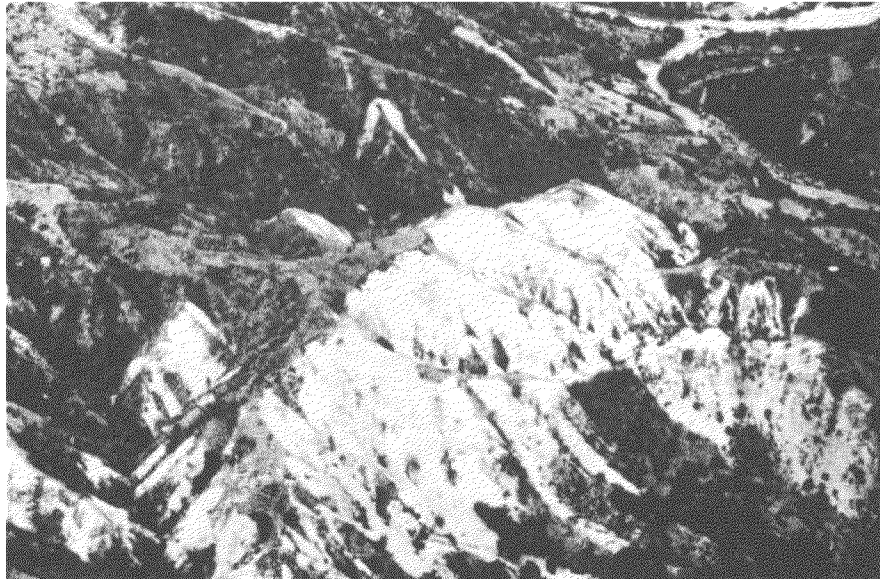
Figure 4.-- View of pumice slopes near Motagua River about 25 km north of Guatemala City which have suffered extensive failure and coalescence of debris slides. Debris slides are shallow, typically less than 1 m in thickness.

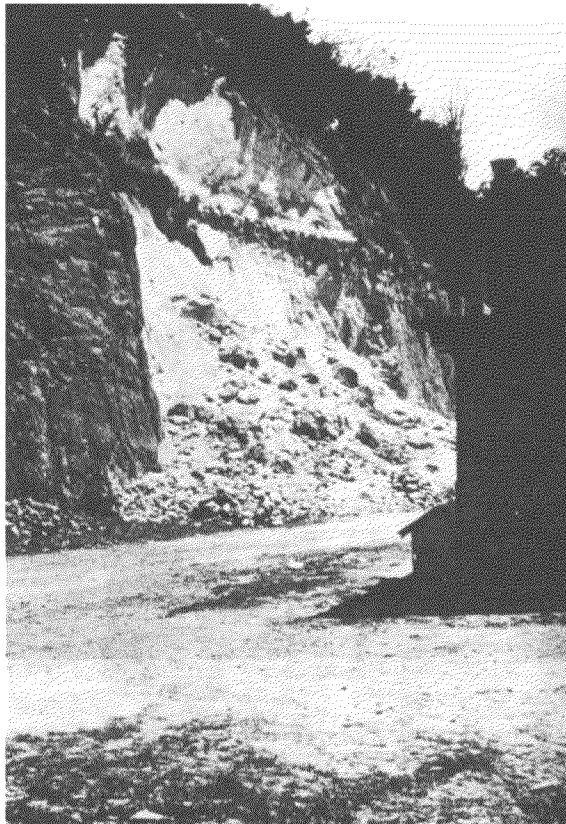
Figure 5.-- Typical seismic-induced rockfall in pumice along canyon margin near Puente Belize in Guatemala City. Failure is no more than 1-2 m in thickness (normal to canyon face) and has overall concave outward shape. Rockfall scarp is unslickensided and has no indication that shear deformation had taken place; evidence suggests that failures such as this were created by tensile spalling possibly resulting from seismic wave reflection at free faces.
