Hurri village in Bhatwari Tahsil, Uttarkashi District.

Village Ginda, Bhatwari Tahsil, Uttarkashi District

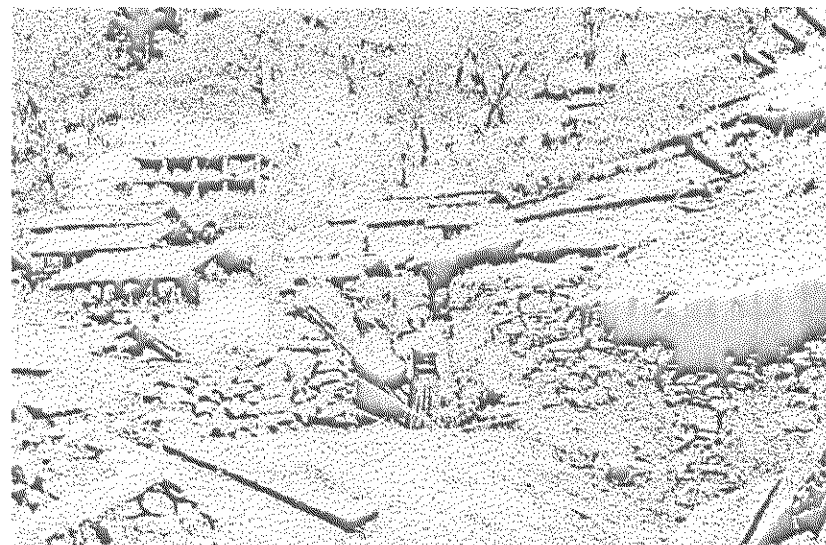
A view of Hurri village with the bulk of the houses with Slate roofs on earth and timber planking and Stone random rubble masonry in mud mortar for the walls. In the background one of the two RCC roofed building in the village can be seen. Though apparently undamaged, the walls and columns of this building are severely damaged. The slate for these roofs comes from local quarries and there is extensive use of cane "ringal" that the women is unloading from her basket. This could be used to fabricate panels and mats that could be used for insulation under an employment programme.

All the houses that collapsed had Slate roofs. The major causes of failure were: low quality of stone masonry, gable failure and subsidence of the hill-slope. A wide crack had developed in the hillside that ran alongside the building that collapsed killing three people.

The hazard risk is very high as the earthquake has created a crack of around 5-20 cm. wide, running along the hill slope. The local soil is permeable, and is likely to cause a landslide in the near future (within the next two rainy seasons) and may render a major portion of the village unsafe for habitation. Immediate measures to relocate the village are necessary.

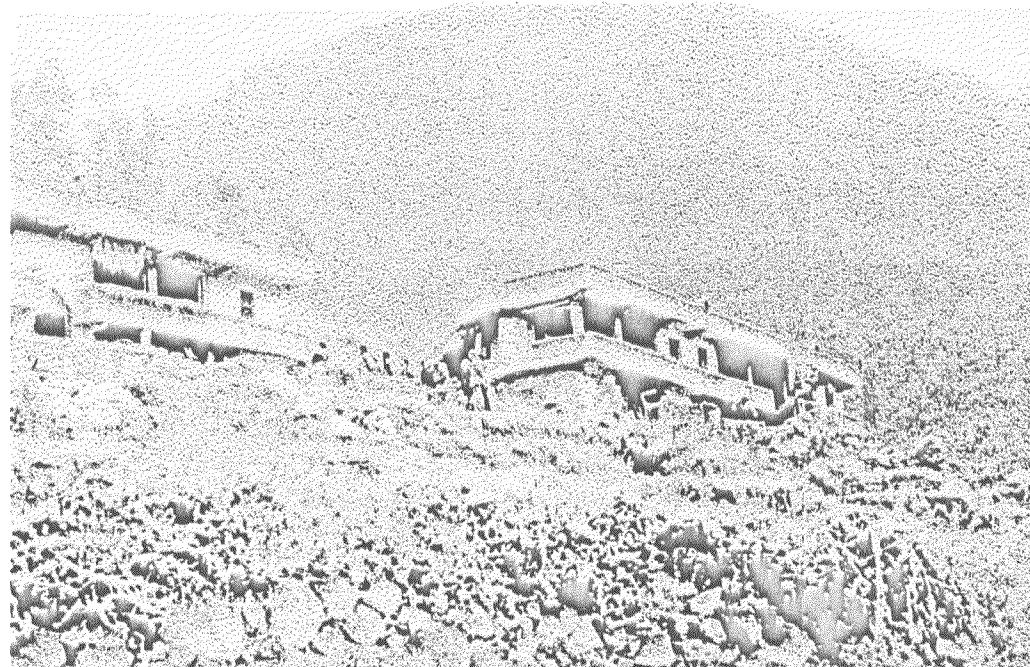
Severely damaged buildings in village Ginda, Bhatwari Tahsil, Uttarkashi District.
