FAILURE OF RCC FRAMES & SLABS

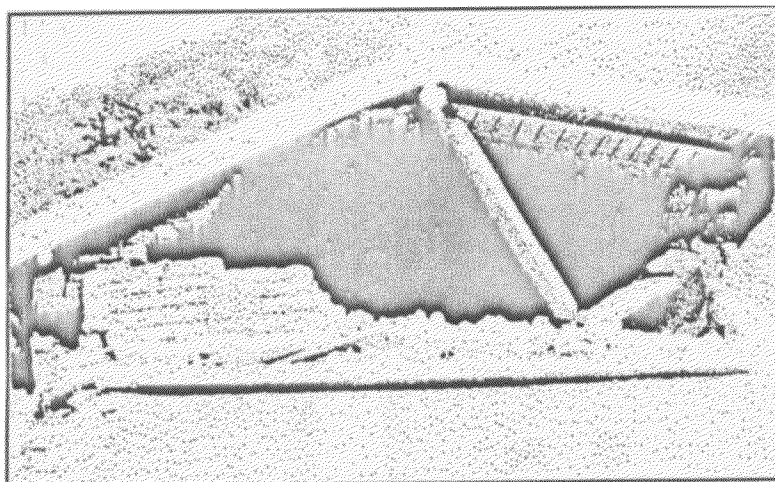
Typical collapse of corner masonry when not bonded by key-stones. The CGI sheet roof has collapsed following the outward collapse of the gable. Damage to the side wall of the upper floor can be seen due to the wall plate not being anchored properly and working free.

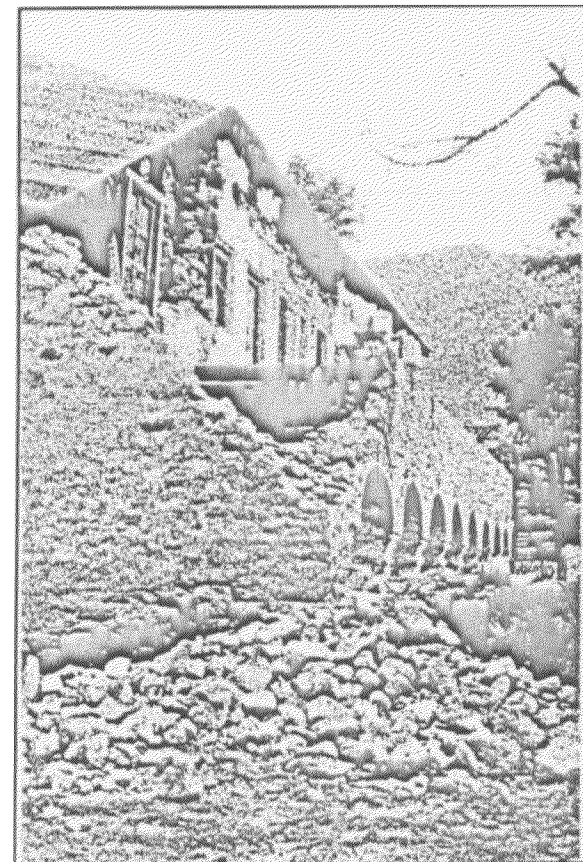
Collapse of end gable in College: Bhatwari town, Uttarkashi District

The end gable of this College building has collapsed due to a most unusual design flaw. This building has been built with a RCC column-slab frame and walls of dressed stone. The CGI sheet roof on the first floor rests on steel trusses that have prevented much damage. This gable was intended to be reinforced with a RCC tie beam in the form of a triangle. The base (i.e. the tie) was not cast. In addition, the ridge piece of the end section of the roof rested directly on the gable rather than on a truss. A classic gable failure then followed, leading to the collapse of the wall above the RCC tie beam at lintel level. The remains of the RCC tie beam at the gable can be seen suspended from the ridge.

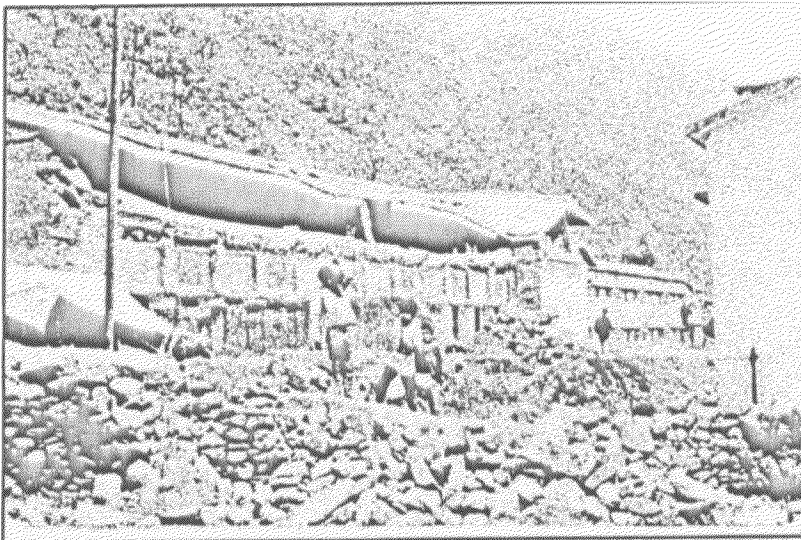
The collapse of this structure (adjoining a temple) killed a sadhu who was living in it. The failure is typical of low quality RCC construction in the region. The failure of the column-beam joints failed and hinges formed. The RCC slab then collapsed. Rescue of trapped persons from similar buildings proved very difficult because of the problems of breaking through the RCC with the redimentary equipment available on site.

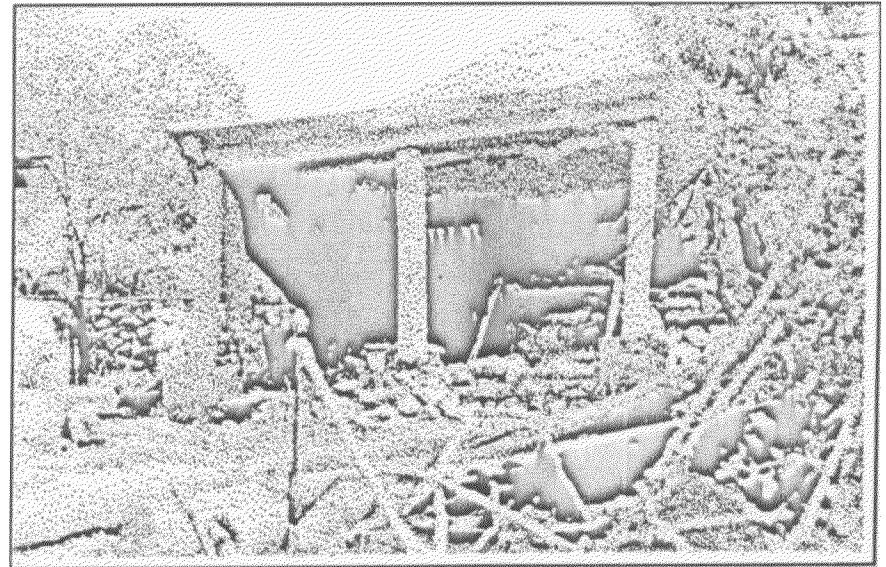
Collapse of chajja and un-supported RCC columns in college building: Bhatwari town, Uttarkashi District.

The RCC chajja and supporting columns at this college building at Bhatwari have totally collapsed along with the gable wall in the background. The rest of this structure is relatively undamaged because of the use of steel trusses for the top floor and RCC frame-slab for the intermediate floor.
