Collapsed State Bank of India building in Uttarkashi town

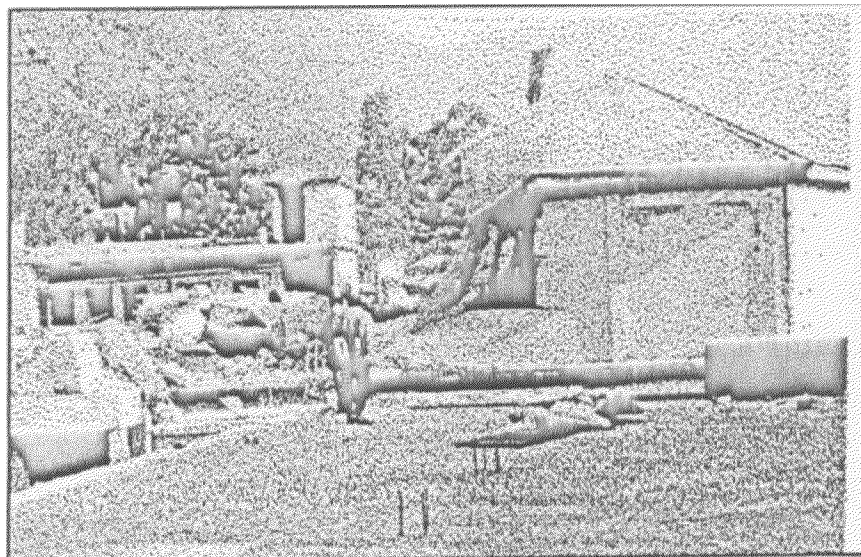
A view of the collapsed SBI building from the roof of an adjacent house. The failure of RCC columns at joints and the buckling of the side wall are visible with the resultant collapse of the roof. The tension cracks at the end wall (right) because of an asymmetric plan and local settlement can be observed.

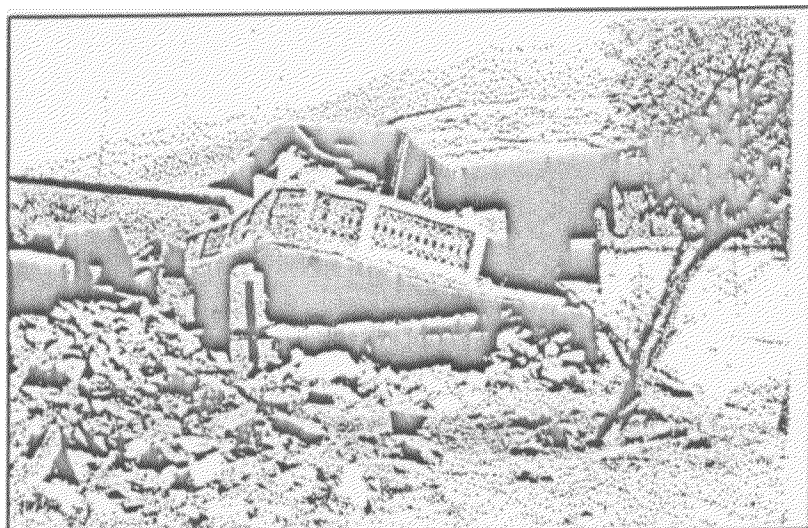
Collapse of RCC slab due to failure of stone masonry bearing wall: Village Maneri, Bhatwari Tahsil, Uttarkashi District

A two storey building in which the intermediate RCC slab has subsided due to the settlement of the supporting wall. People trapped in the building had to be rescued through the side wall. The slab is presently supported on a stone column that could collapse at any time.

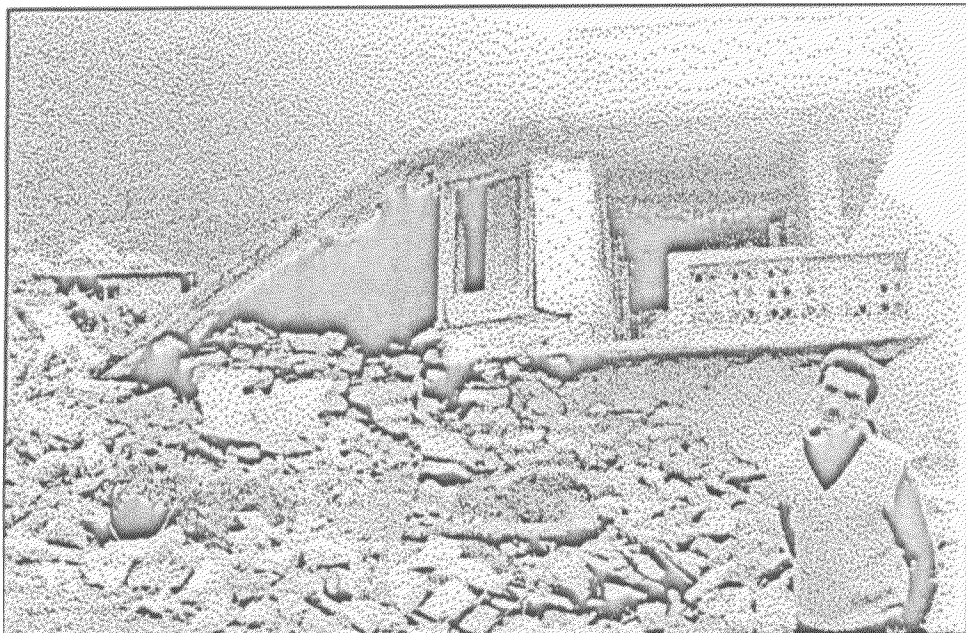
COLLAPSE OF RETAINING WALL

Collapse of RCC slab due to failure of rear wall: Village Ginda, Bhatwari Tahsil, Uttarkashi District

The buildings in this village were constructed with rear walls abutting the hillside and providing dual function as retaining walls. These were severely damaged by the lateral earthquake load and stress reversal, leading to the collapse or subsidence of roofs, trapping or killing a large number of people.
