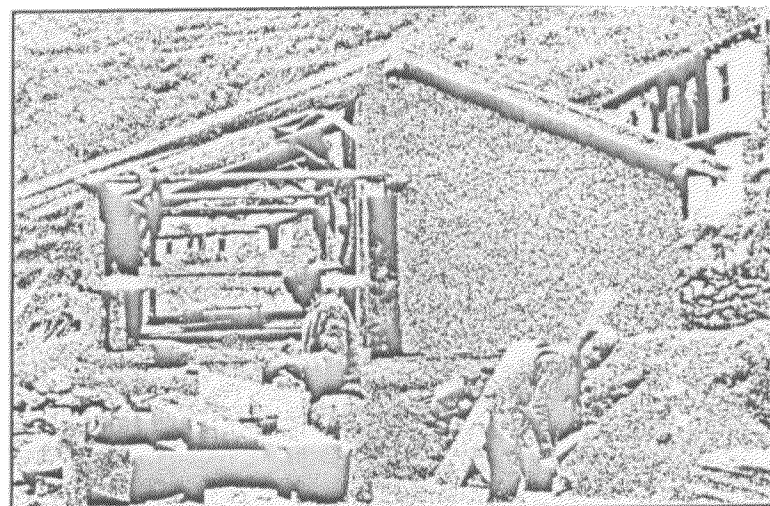
This six-roomed house is being built in chir and deodar wood (purloined at a price from the forest) on a foundation of stone in cement mortar. The timber in the house is not seasoned or treated and could be attacked by locally abundant termites in the near future. There will be no smoke from cooking in the building which could have ensure the preservation of the timber. The two carpenters in the foreground are from the village and have given up working on their own houses to earn money that will see them through the winter.

Reconstruction of building in timber in Village Ragsya, Pratapnagar Tahsil, Tehri Garhwal District

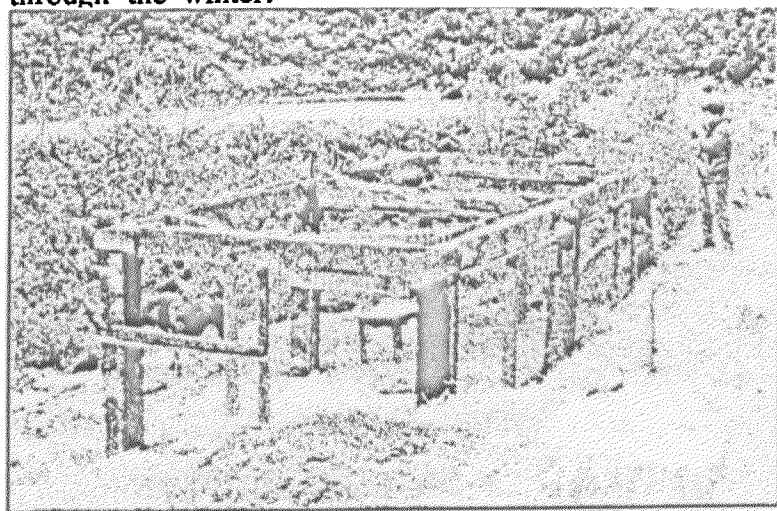
Reconstruction using an RCC frame tied at plinth and lintel level, beyond Ganeshpur, Bhatwari Tahsil, Uttarkashi District

This building alongside the road demonstrated the diffusion of the RCC framing principles for masonry construction, with horizontal bands at lintel and sill level and vertical columns at corners act as a frame. This has been built after the earthquake. Unfortunately, some of the local problems of RCC construction in the area have been repeated here including low quality aggregate and inadequate lap length for reinforcement bars.

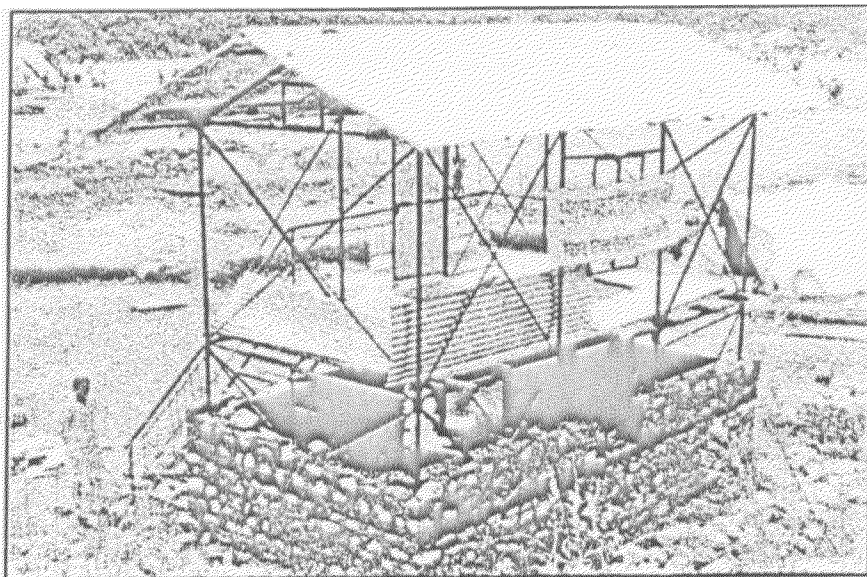
Model house using tubular mild steel frame with CGI sheet roof: Village Maneri, Bhatwari Tahsil, Uttarkashi District

A model house constructed by the VHP at Maneri with a tubular mild steel welded frame with bolted angle struts, steel trussed roof structure, timber intermediate floor and roof planking with CGI sheet roof cladding. The walls of the ground floor are in Stone random rubble in cement mortar with steel framed windows and GI sheet door. The staircase to the first floor is constructed in steel with timber planking. The first floor walling is intended to be completed in timber planking or with cane "ringal" panels. The total unit cost is Rs. 57,000 with a covered area on both floors about of 90 sq.m. This design has a number of attractive attributes including: ease of erection; insulation with timber planking, lightweight first floor structure and broad harmony with current built form and lifestyles.

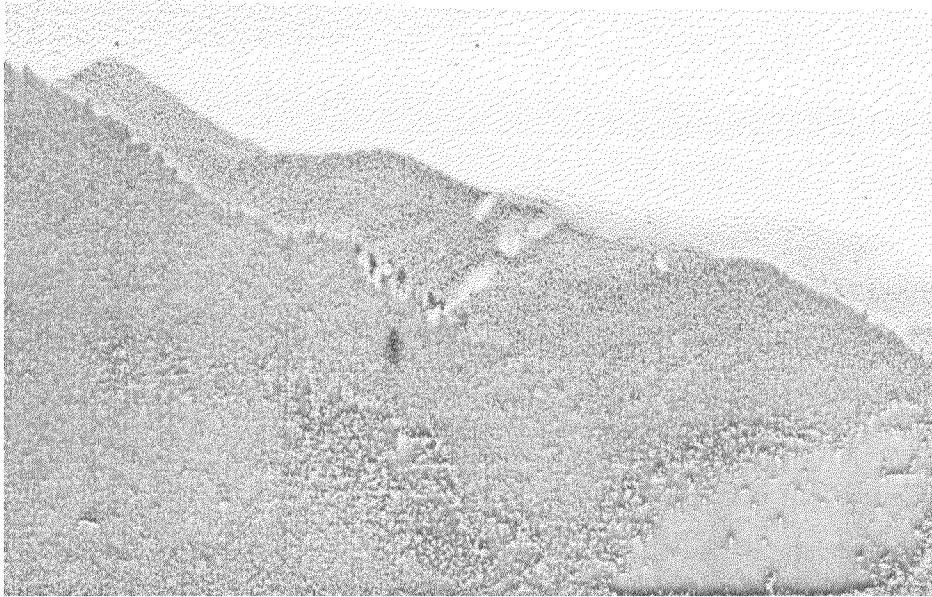
A deliberate forest fire set by villagers

Local people in almost all surveyed villages were extremely incensed that the Forest Department was not permitting them to take timber from adjoining forests before the snow, in order to build emergency shelters for reconstruction. In some places after they had been apprehended taking timber from the forest they retaliated by setting fire to the forest. This is a complex problem to solve (especially given environmental considerations for regenerating), human survival however will have to take short-term precedence - the local community will have to take responsibility of the timber that will be cut. It is useful to expedite-now, the recommendation to release the timber-grant for the next five years. This will enable villagers to start rebuilding since timber is one of the crucial building materials in this region.
