ANEXO 1

#### 4.6.5 Estructura de la Edificación.

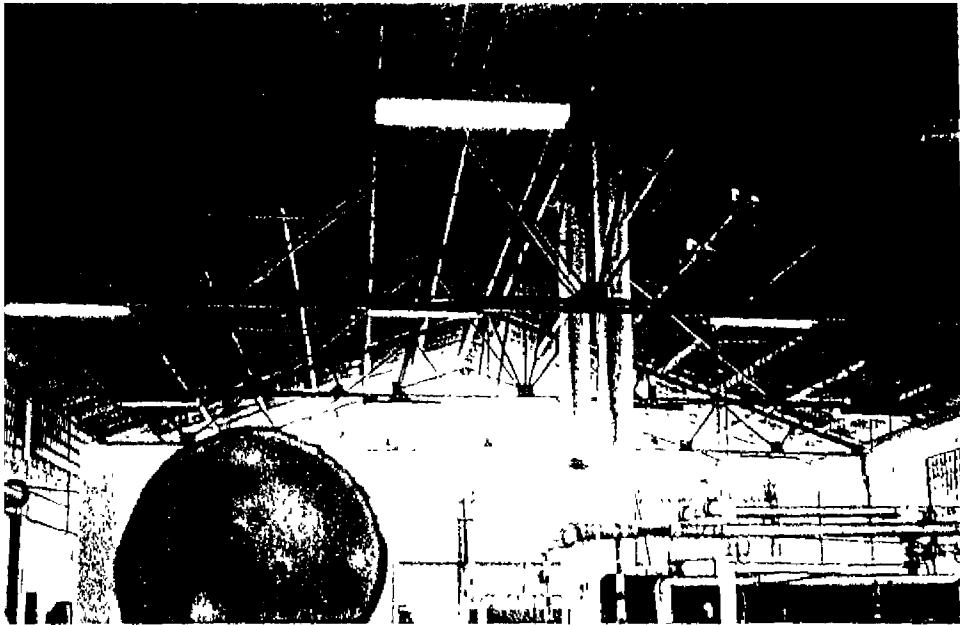
- \* Cubierta del Cuerpo E (Sala de Máquinas): esta cubierta constituida por láminas de asbesto-cemento, soportadas por cerchas metálicas, requiere reparación por haber caído sobre ella parte de un árbol adyacente (FOTOS 4.9 y 4.10).

FOTO 4.9 CUBIERTA DE LA SALA DE MAQUINAS

- ii) evitar el acceso de aguas de lluvia de las acequias y o zanjales laterales a la edificación.
- iii) reparar el techo de la sala de máquinas.

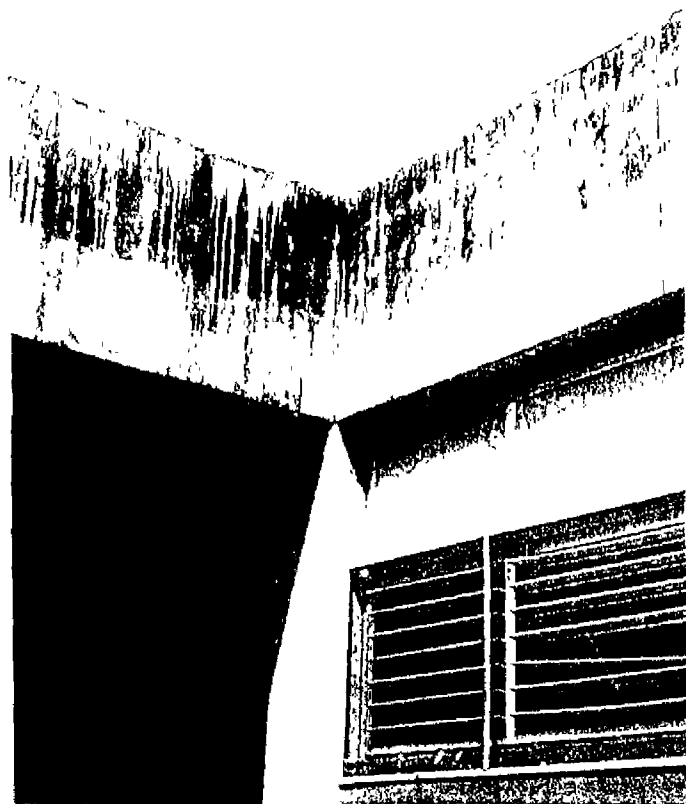
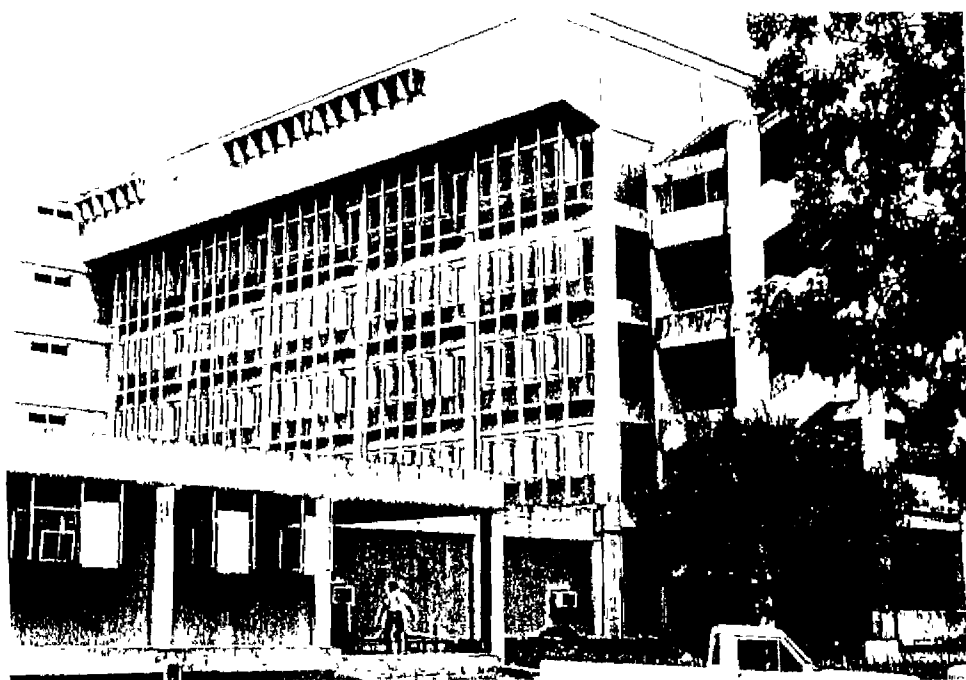
FOTOS 4.11 y 4.12 BUENA  
CALIDAD DE EJECUCION DE  
LA ESTRUCTURA Y DE SUS  
UNIONES

- \* No se conocen detalles del proyecto estructural.
- \* Planos disponibles en MINDUR
- \* Calidad de ejecución de la estructura: por encima de la media de edificaciones similares.
- \* Se observaron agrietamientos en algunas vigas del entrepiso PB-Nivel 1, no interpretadas. Estas grietas afectan toda la sección de las vigas y ameritan atención adicional.
- \* Asentamientos: véase la Sección 4.6.4.
- \* Elementos de unión: todas las uniones observadas se encontraron en buenas condiciones (FOTOS 4.11 y 4.12).
- \* No se identificaron deflexiones excesivas.

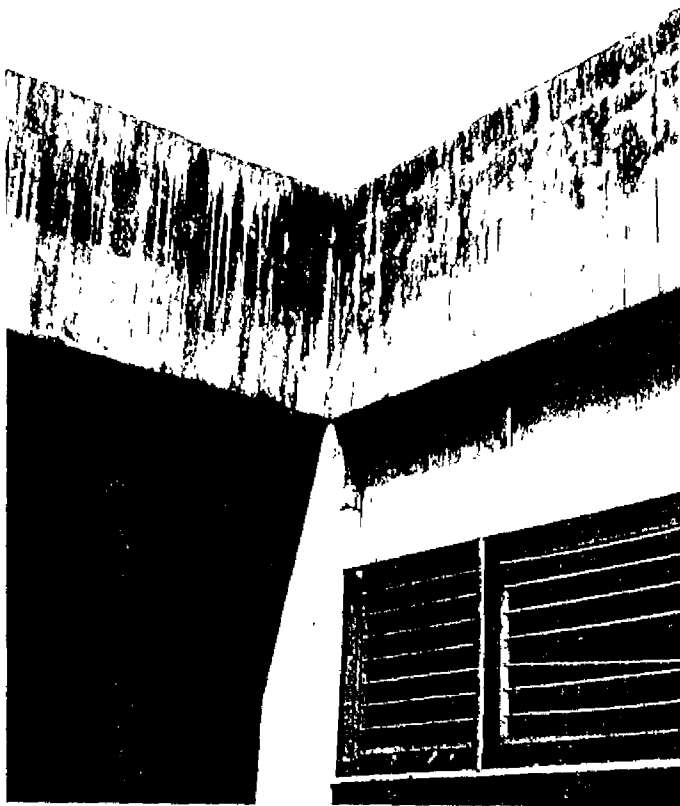
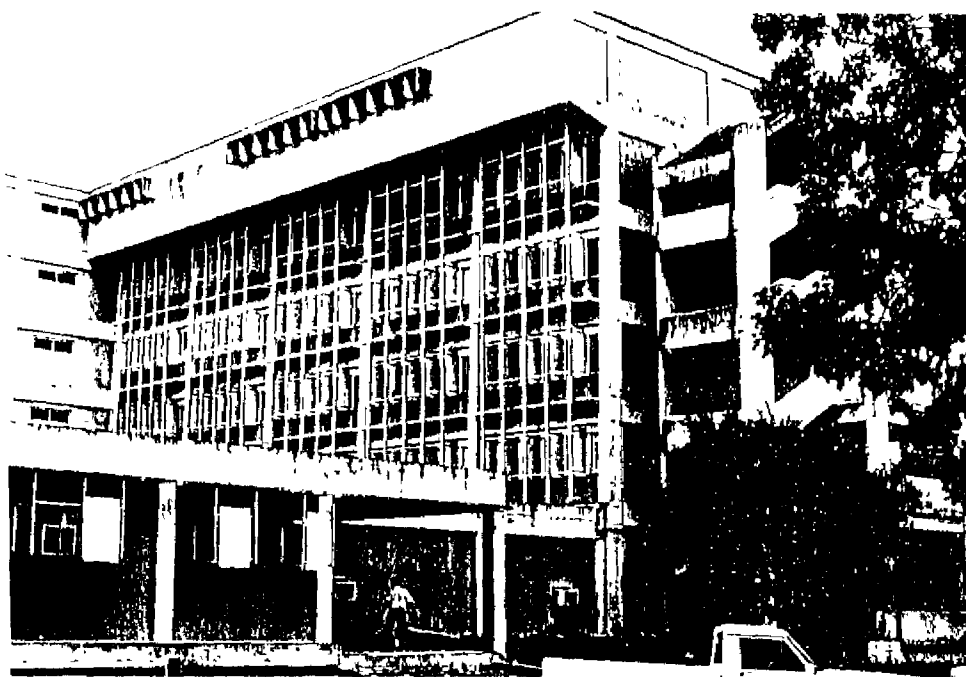
FOTOS 4.11 y 4.12 BUENA  
CALIDAD DE EJECUCION DE  
LA ESTRUCTURA Y DE SUS  
UNIONES

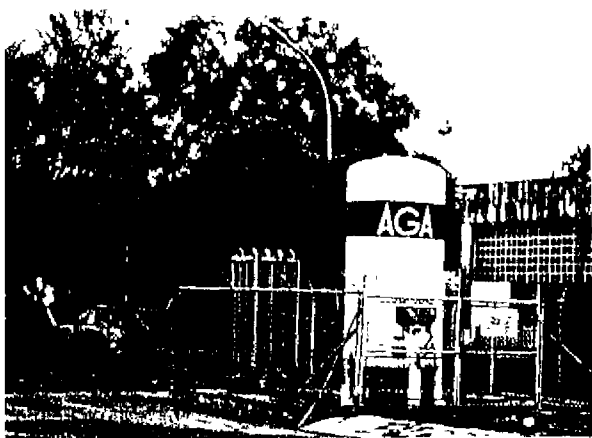
- \* Almacenamiento y distribución de oxígeno: si bien los tanques están debidamente situados al aire libre, no poseen los anclajes necesarios. Hay riesgo de volcamiento en caso de sismo (FOTOS 4.13, 4.14, 4.15). Igual comentario para el tanque de almacenamiento de gas.

FOTO 4.13 TANQUES DE  
ALMACENAMIENTO Y SUMI-  
NISTRO DE OXIGENO

- \* Fijar a sus bases los equipos no anclados, tal como se indicó en la Sección 4.7.2 d.
- \* Sustitución progresiva del sistema actual de ventanas por otro nuevo menos vulnerable a su manejo.
- \* Verificar que los estantes de productos médicos y los de equipamientos, sean estables; caso contrario fijarlos a las paredes.
- \* Programar la adquisición de los extractores de aire caliente de la sala de S/E encapsulada.

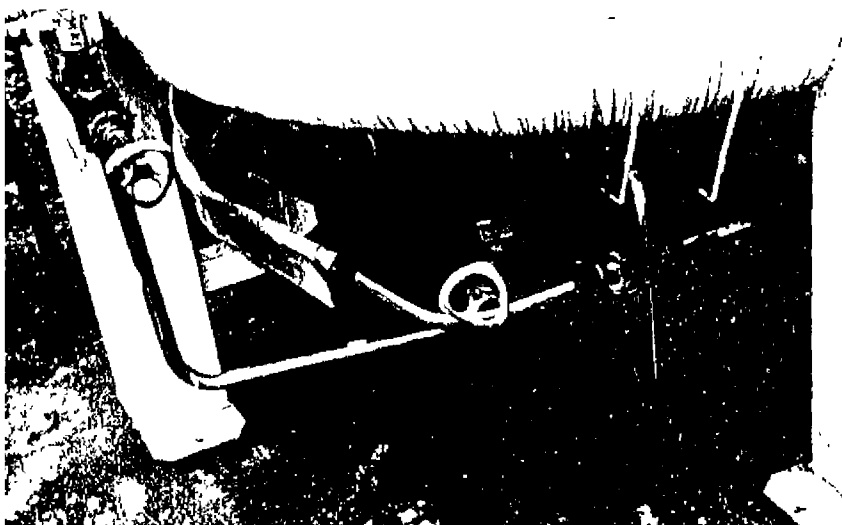
FOTO 4.15  
TANQUE NO  
ANCLADO

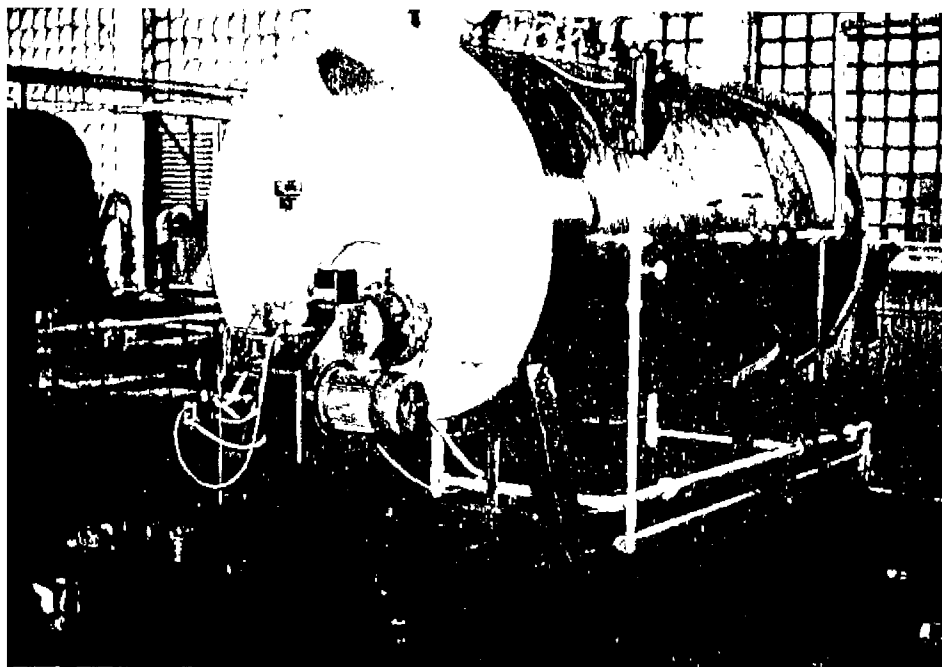
- \* Aire acondicionado central: enfriadores Westinghouse.
- \* Aire comprimido medicinal (seco): PB del Cuerpo D.
- \* Caldera de agua caliente: requiere el anclaje a la fundación (FOTOS 4.16 y 4.17).

FOTO 4.16 SALA DE MAQUINAS. CALDERA NO ANCLADA

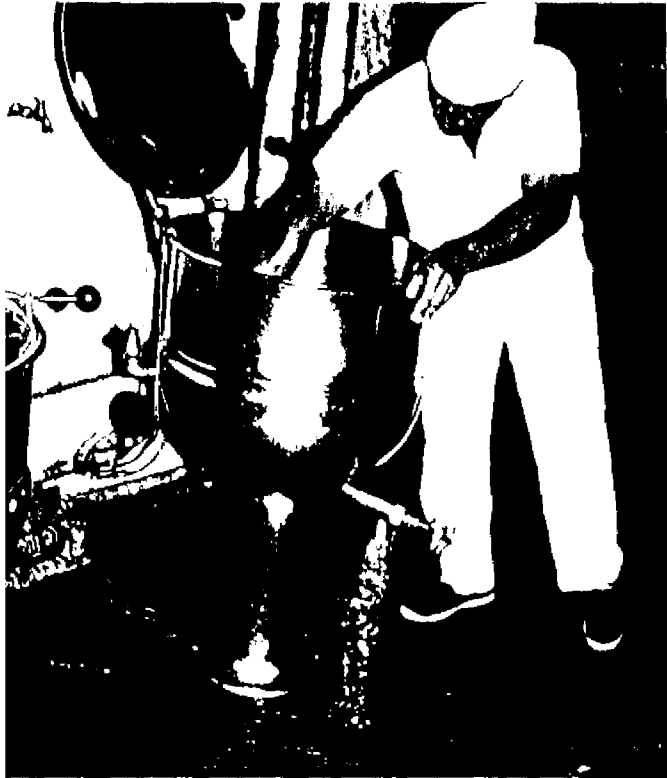
- \* Cuatro ascensores: PB a Nivel 5. Techo accesible.
- \* Cocina: instalaciones amplias; bajo riesgo de incendio. Las tuberías de aguas servidas drenan directamente al sótano inundado (FOTOS 4.18, 4.19).

FOTOS 4.18 y 4.19 AGUAS  
SERVIDAS DE LA COCINA QUE  
DRENAN HACIA EL SOTANO.  
LAS CANILLAS PERMANECEN  
ABIERTAS VARIAS HORAS AL  
DIA

- \* Reconstruir el sistema de aguas servidas de la cocina.
- \* Elevar la cota de los patios interiores a fin de que los sistemas de recolección de aguas de lluvia operen en la forma prevista. Para ello se recomienda:

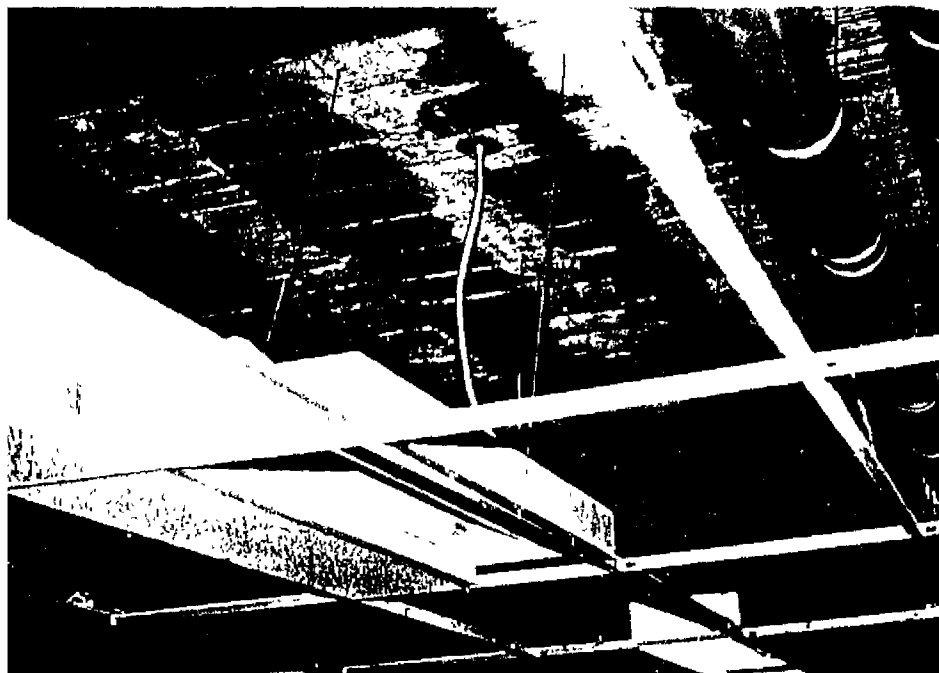
- \* La estabilidad de componentes no-estructurales tipo mobiliario no fué evaluada de modo sistemático.
- \* Los falsos techos son de configuración típica según se aprecia en la FOTO 4.20.

FOTO 4.20    SISTEMA DE SUJECION DEL FALSO TECHO  
                  (PLAFONES Y LAMPARAS)

- b) Falsos techos, lámparas para iluminación de pasillos y oficinas, están colgados por medio del tradicional sistema de alambres; bajo la acción de sismos intensos es previsible el desprendimiento parcial aun cuando no representa una elevada amenaza a la vida de los ocupantes.

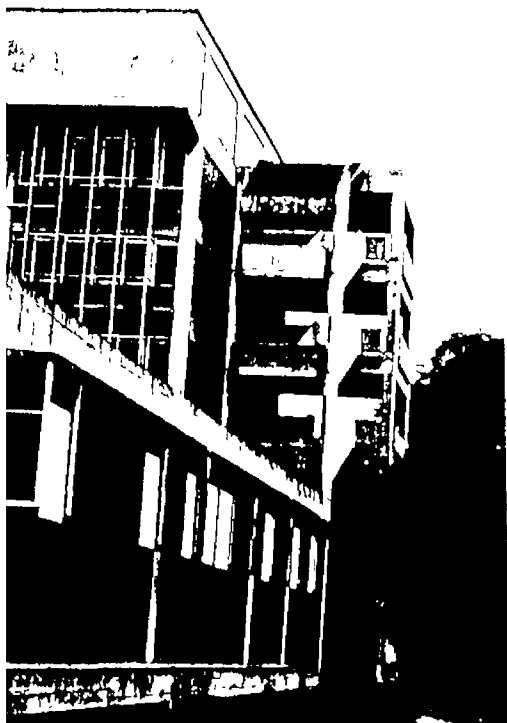
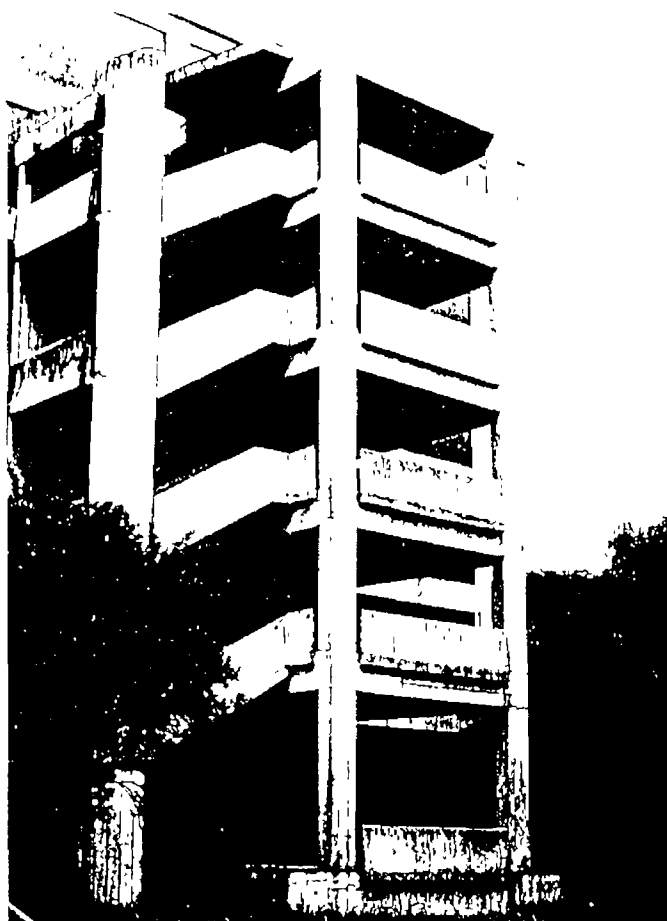
- \* Las escaleras de emergencia están convenientemente dispuestas en los extremos este y oeste del Cuerpo A (Sótano + PB + 5 Niveles). El personal y pacientes del 5° nivel, no tienen acceso a las escaleras de escape; su ruta prevista es por la azotea, vía helicóptero (FOTOS 4.21 y 4.22).
- \* No están indicadas las rutas de escape.
- \* Las escaleras de circulación interna, adyacentes al sistema de ascensores, solo ofrecen facilidades de evacuación en horas diurnas. A partir de las 4:30 PM y hasta las 7:30 AM aproximadamente, se mantienen cerradas; la llave se encuentra en poder del Señor Vigilante.
- \* Las puertas de salida son suficientemente anchas; adicionalmente, hay amplios espacios para la libre circulación.
- \* No se identificaron agravantes potenciales en las áreas de escape.

FOTOS 4.21 y 4.22 CUERPOS  
DE ESCALERAS DE EMERGENCIA

- \* Las escaleras de circulación interna deben ser de libre circulación todo el día.
- \* Elaborar un plan sencillo para atender Emergencias y/o Contingencias, así como un esquema de simulacros. Este podría prepararse conjuntamente con Defensa Civil y Bomberos.

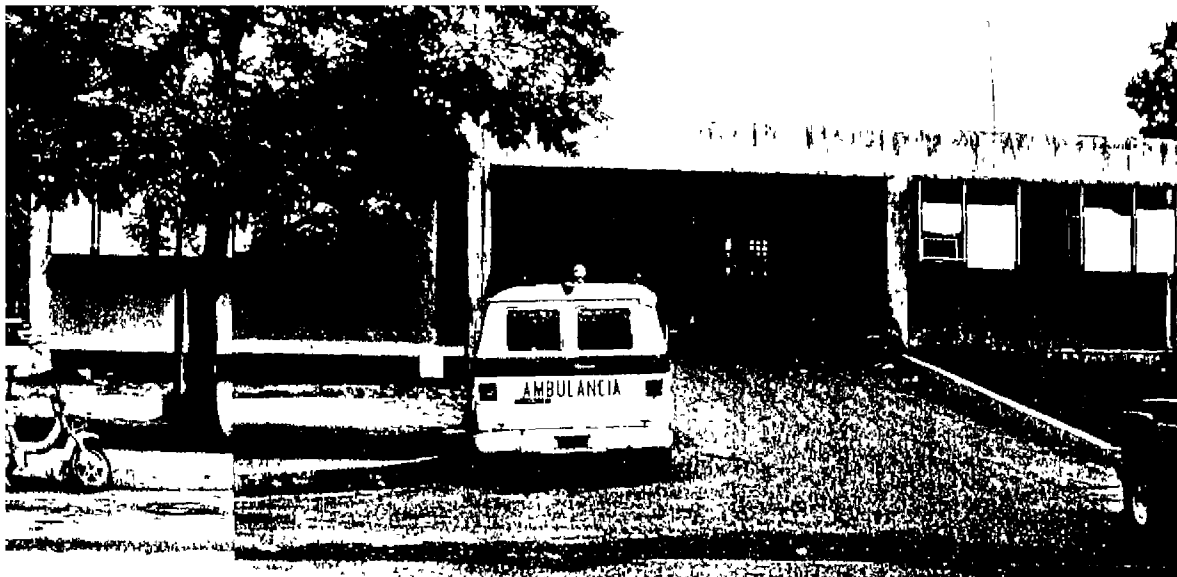
- A) La configuración en planta y alzada está asociada a una vulnerabilidad reducida. El pasillo de entrada principal pudiera presentar problemas de torsión en planta en caso de sismos intensos y, eventualmente, perder su estabilidad. Los antepechos en las fachadas norte y sur

FOTO 4.23 ENTRADA DE EMERGENCIAS (CUERPO C)

- \* En base a la información geotécnica, proceden a un análisis conservador sobre el posible problema generado en las columnas por la presencia de antepechos.
- \* Evaluar si en el pasillo de entrada se generan torsiones que puedan amenazar su estabilidad.
