CHAPTER 6 SLOPE STABILITY (LANDSLIDES)

6.1 INTRODUCTION

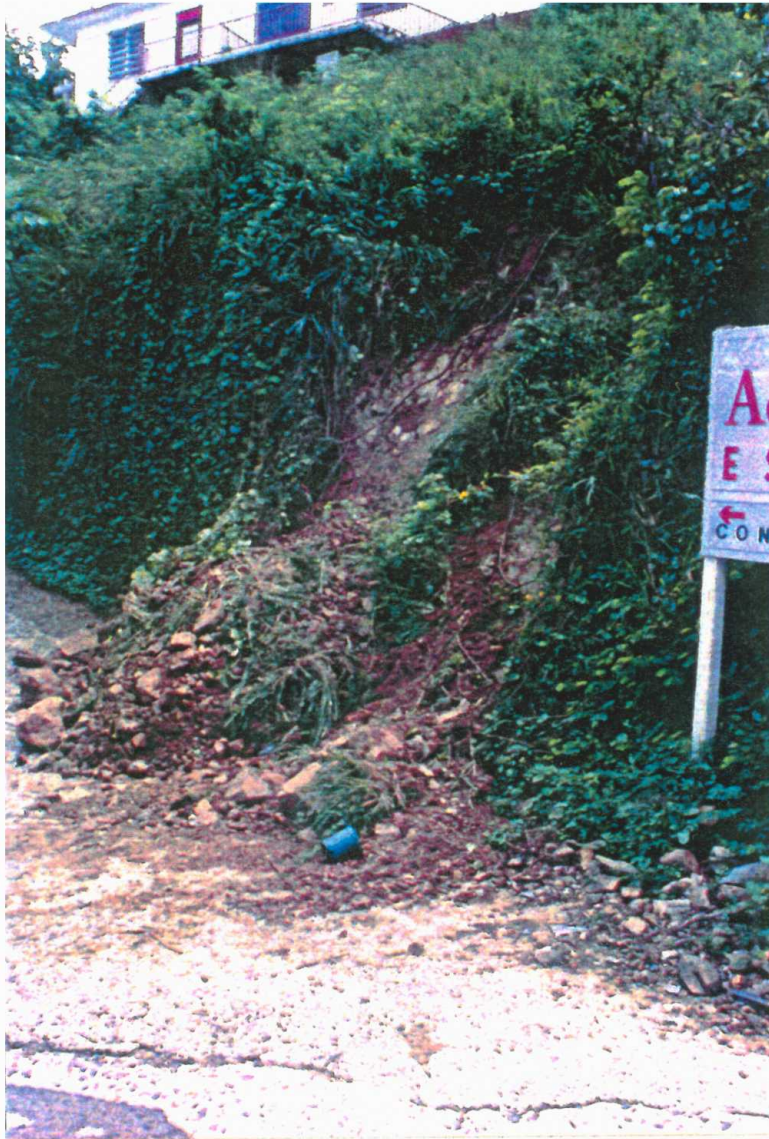
Hillslopes in the BVI are covered by a very thin soil layer usually not greater than 3 feet thick and as a result deep seated rotational landslides do not occur. Landslides within the soil layer are restricted to very small soil slippages which occur when the soil layer slides over the underlying bedrock after intense rainfall, **Plate 6.1**. These small landslides occur mainly along road cuts and are sometimes large enough to block the flow of traffic. Therefore although they are not big enough to cause any serious structural damage they can bring down utility poles, and generally disrupt activities. These landslides are easily cleared by small earthmoving equipment in a couple of hours.

PLATE 6.1: Small landslide along road cut

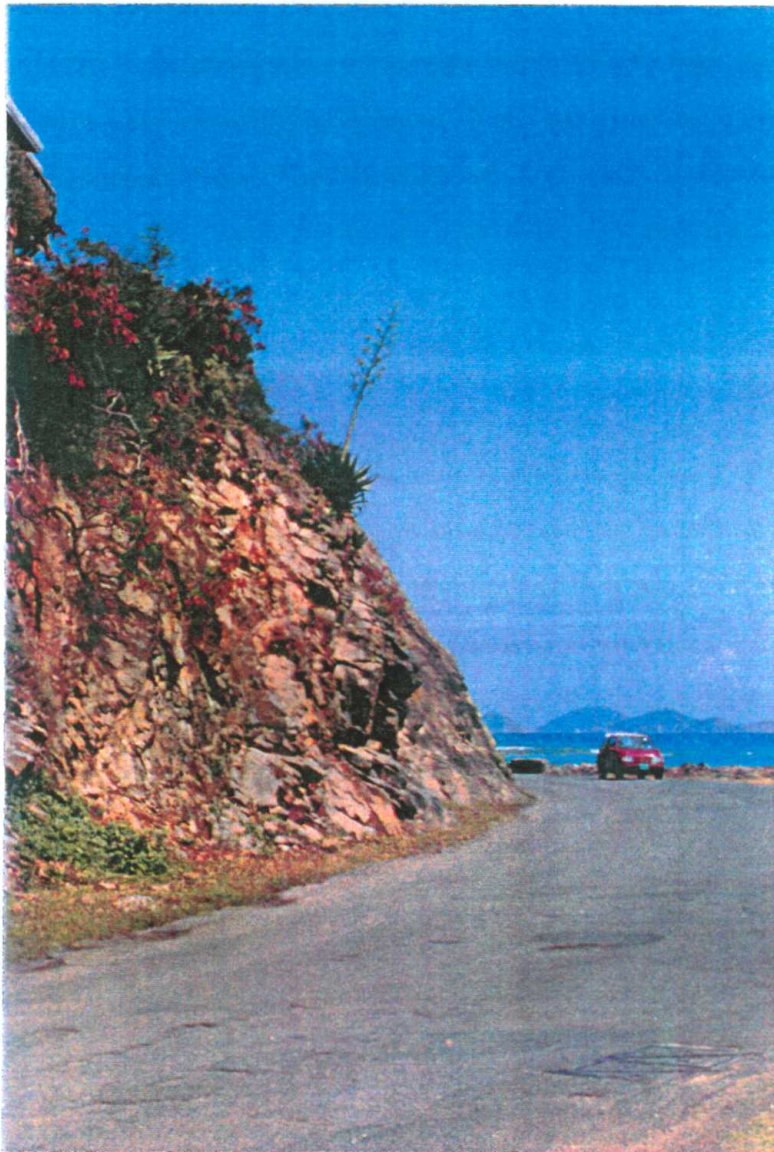
The more common form of landslides occurring in the BVI are rock falls and rock slides which involves movement of the bedrock itself. These landslides take place along steep cuts made into the hillside usually for building foundations or road construction. In these situations lateral support is removed from the rock mass and movement occurs along discontinuities within the rock mass such as fractures and bedding planes. Under the most favorable conditions the bedding planes of the rock mass slopes into the cut in the hillside such that one layer of rock can slide downwards over the underlying layers. This situation is seen along the main road to West End along the south coast of Tortola, **Plate 6.2**.

Rainfall triggers the landslides which occur in the BVI although spontaneous rock falls take place along some road cuts primarily those sections which are inherently unstable, which are described above. The absence of a thick soil layer discourages the percolation of rainfall which instead flows over the slopes as runoff. The effect of this is to prevent the build up of high pore water pressures within the slope materials and therefore the internal cohesion of the slope materials is maintained. However in the event of intense prolonged rainfall numerous small rock falls, soil and debris slides will occur along road cuts particularly the coastal roads. A few large rockfalls will occur along road cuts the especially along the south coast West End road.

PLATE 6.2: Cut slope prone to rockslides

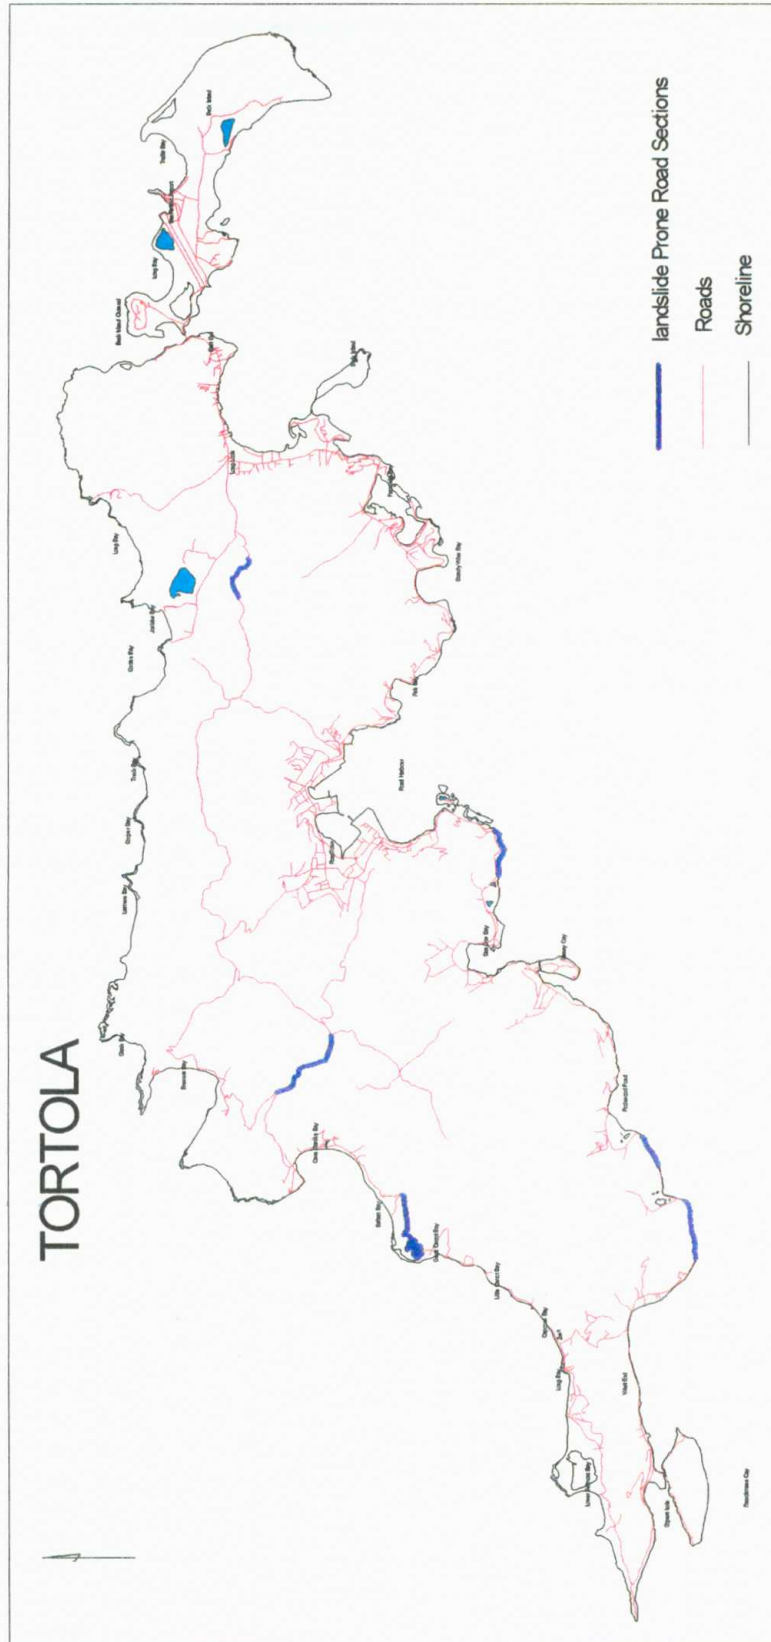
MAP 6.1

The strong association between hill slope modification and the occurrence of landslides in the BVI is such that the distribution of landslides is determined to a large extent by the location of these modifications. This means that they are located mostly along roads which have been built along steep slopes. **Map 6.1** shows the sections of roads in Tortola where landslides are most likely to occur. These susceptible locations have been determined based on the occurrence of landslides in these areas in the past and the general condition of the modified hills lopes.
