3.0 WATER SUPPLY SYSTEM SEISMIC VULNERABILITY

3.2 TREATMENT PLANTS AND PUMPING STATIONS

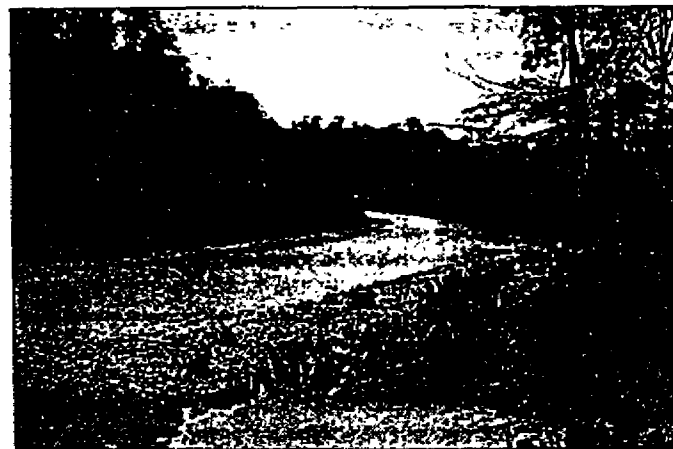
Photographs 3-1 and 3-2. Watershed providing water to Limon, Costa Rica water treatment plant had extensive landsliding, resulting in turbidity increases in the Rio Bannano to 2,400 NTU.

If water from a watershed becomes unusable, system operational flexibility becomes important. Alternate supplies or alternate intake sites (above the source of the contamination) are useful. For example, the City of Everett, Washington can draw water directly from their river source, or take it from a large off-stream impoundment. Limon, Costa Rica reactivated their groundwater supply after the 1991 earthquake raised turbidity in the watershed.

Treatment flexibility may allow treatment of more turbid raw water supplies. Operating a plant at lower loading rates and/or

adding additional or different coagulants may allow the plant to produce water with acceptable drinking water quality. While these alternatives may be more expensive than "normal" operation, they may allow the purveyor to get through the disaster.

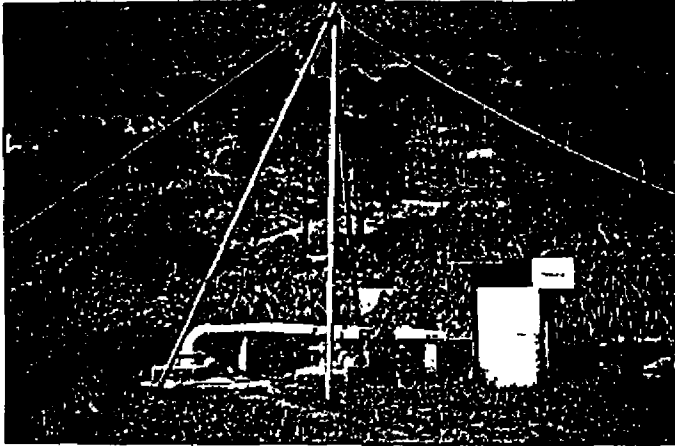
Photograph 3-6. A-frame over well used to pull broken pump in Baguio, Philippines.

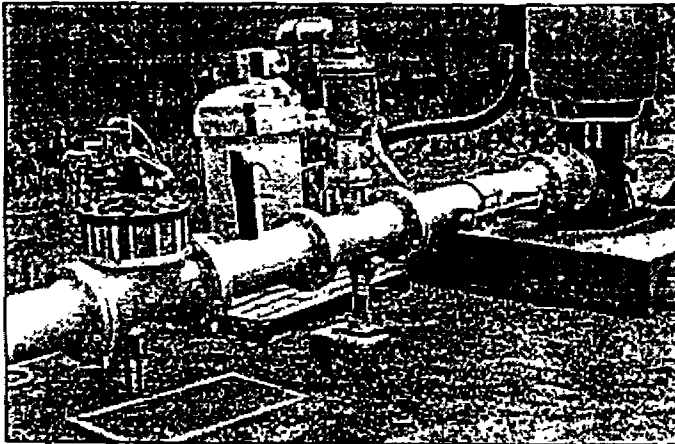
Photograph 3-7. Settlement around well casing resulted in leaking well discharge pipe in Landers earthquake.

Pumps should be constructed of steel rather than cast iron, allowing them to absorb energy from shaking. The pump discharge head (on the top of the well) should be also be steel rather than cast iron. Provide flexibility between the well casing and surrounding building slab, and the well casing and connecting piping.

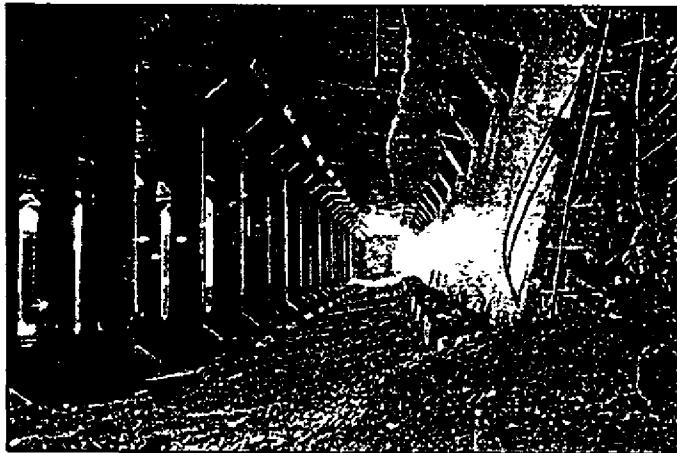
Photograph 3-9. Inside of Jensen Water Treatment Plant clearwell damaged as a result of geotechnical failure.

The facility should be located so as to avoid soils that may densify. Structures should be founded on a consistent foundation throughout. Otherwise, structures should be designed to resist expected soil failure or with provision to accommodate the expected movement.

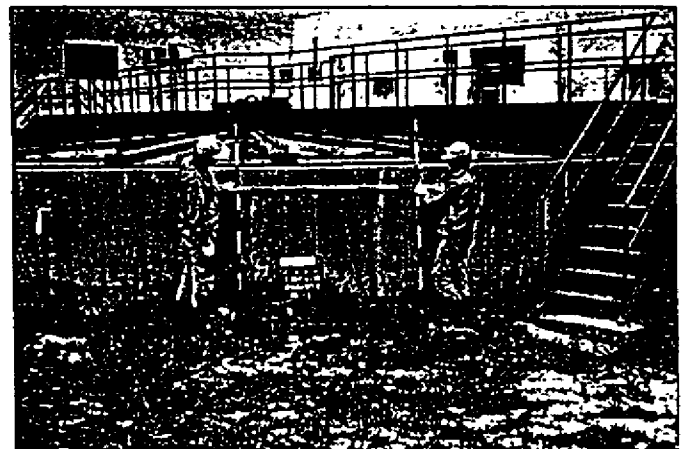
Photograph 3-11. Floating wastewater tank resulting from liquefaction in Niigata.

Liquefaction may cause underground structures in areas of high groundwater to float or subside differentially. Refer to Chapter 2.0 for a discussion on liquefaction mitigation. Keeping tank full offers some mitigation from flotation.

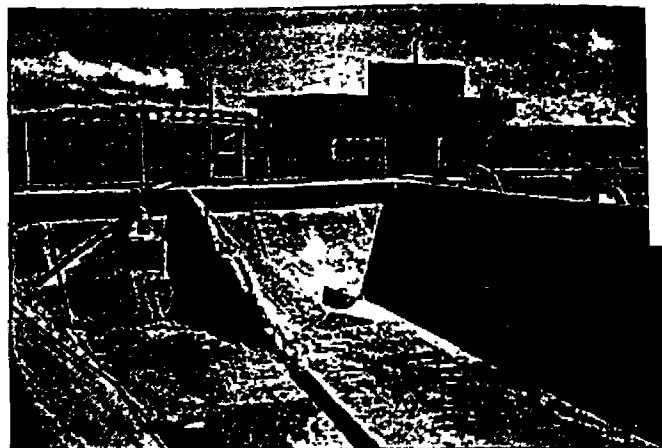
Photograph 3-13. Water treatment plant tank baffle collapsed in Baguio, Philippines.

Baffles and other immersed elements should be designed to either withstand the large loading or, more reasonably, to break away and be quickly replaced. Break-away elements should be secured to keep them from falling to the tank bottom and jamming sludge collector mechanisms. (Kennedy/Jenks/Chilton 1990a) There is no reasonable approach to accommodate sloshing for floating digester covers.

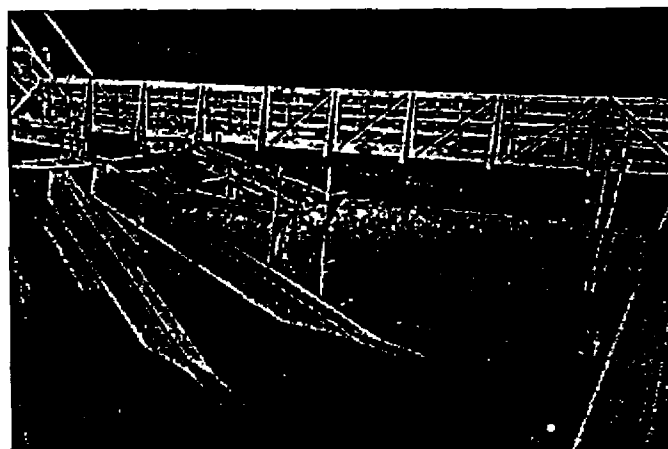
Process tank baffles and other immersed and floating elements have been damaged from the effects of very significant hydraulic loading acting on the element.

Photograph 3-14. Hydraulic loading heavily damaged reactor/clarifier mechanism at Rinconada Water Treatment Plant.

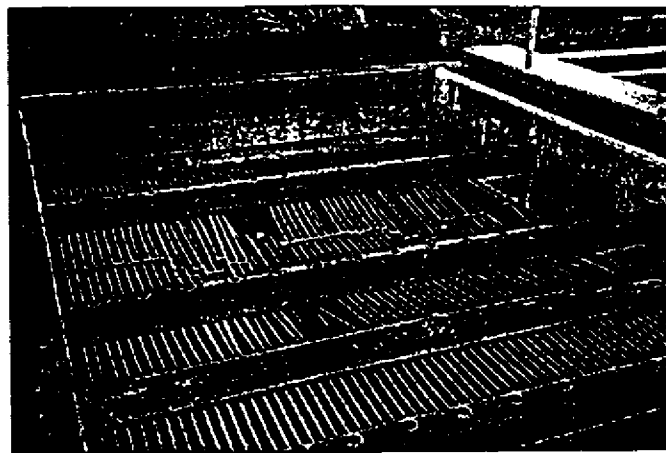
Photographs 3-17 and 3-18. Flocculator baffles and clarifier inclined plates damaged in Limon, Costa Rica Water Treatment Plant.

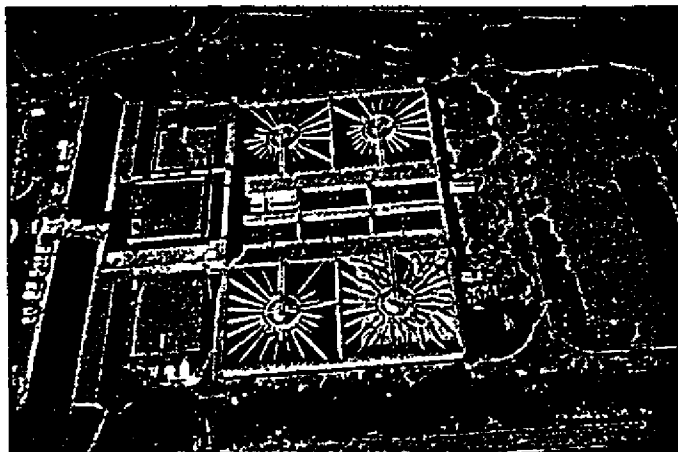
Photograph 3-16. Aerial view of Rinconada plant shows a number of failed launders in three tanks. The fourth tank was out of service and was not damaged.

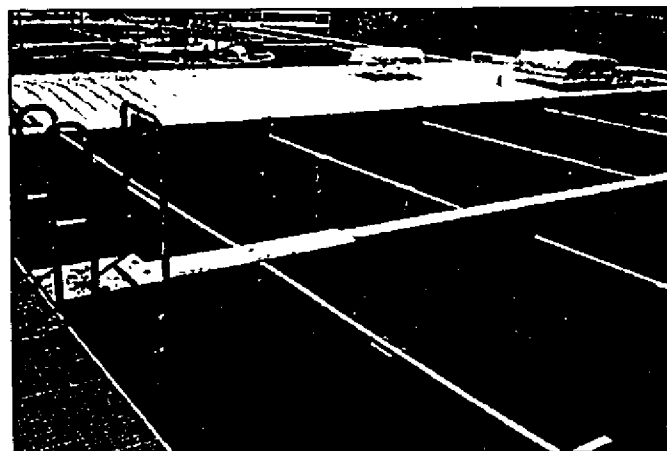
Photograph 3-19. Repaired flocculator wooden baffles had been broken like match sticks at Montevina Water Treatment Plant in the Loma Prieta earthquake.

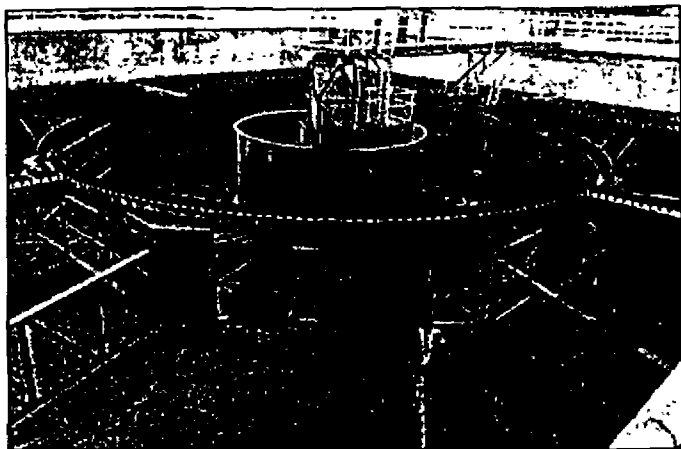
Photograph 3-20. Damaged baffles in secondary clarifier from Loma Prieta earthquake.

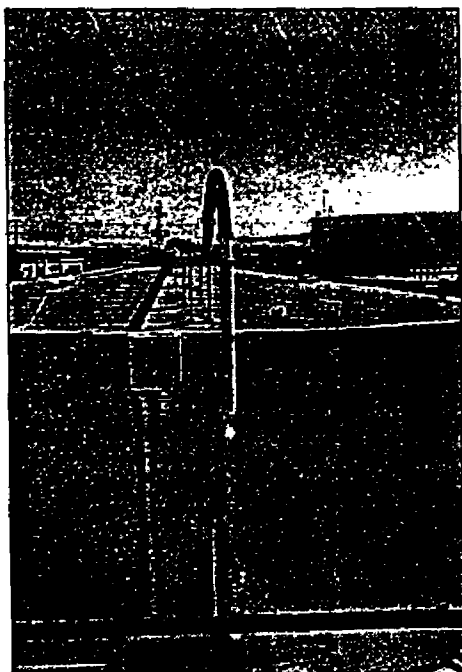
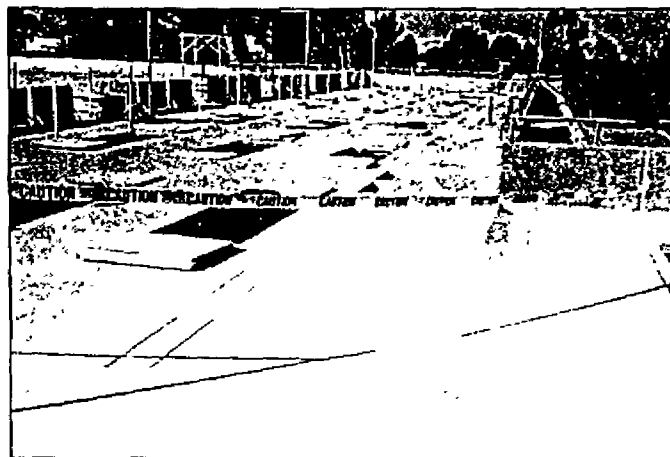
Photograph 3-24. Sloshing water pushed access hatches out of their frames, causing them to fall into the primary wastewater tank at Palo Alto in the Loma Prieta earthquake. Hatches had to be removed before the sludge collector could be operated.

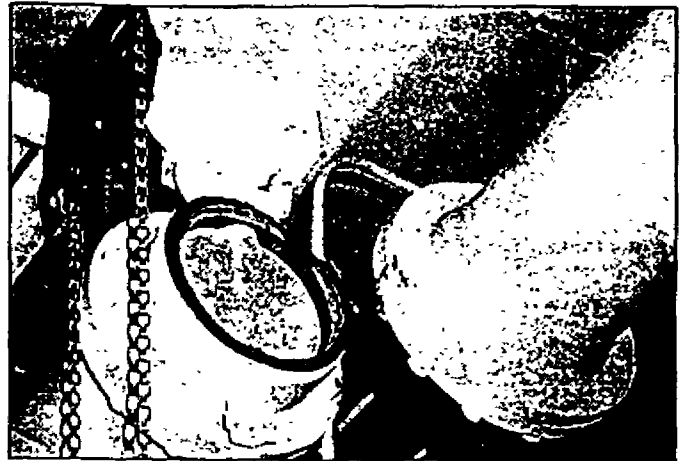
Rod-supported plant piping swings, breaking at weak points such as threaded connections and cast iron valves. Support plant piping in three orthogonal directions in accordance with UBC and Sheet Metal and Air Conditioning Association (SMACNA) requirements. Equipment and pipe connections move relative to each other, and will cause the system to break at the weak point. Provide flexible connections. Flexibility should be provided in connections and piping where they span across expansion joints or between structures on different foundations.

Photograph 3-26. Broken plant piping at Olive View Hospital in San Fernando earthquake.

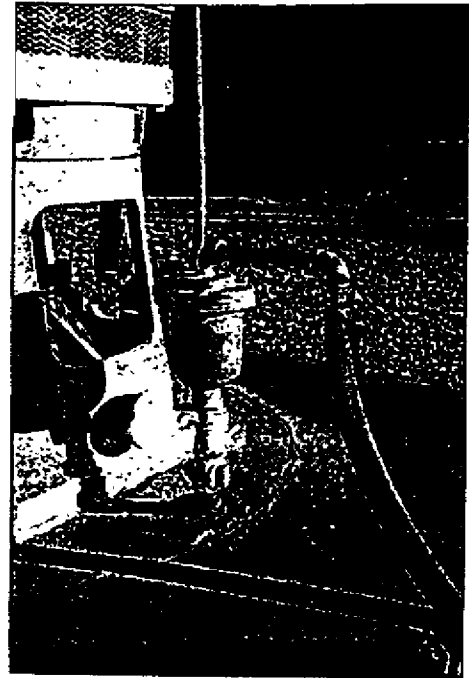
Pipe appurtenances such as air release valves respond as inverted pendulums, amplifying ground motions, and breaking. Anchor them.

Photograph 3-30. Heavy air release valve supported on small diameter pipe broke off in Loma Prieta earthquake.

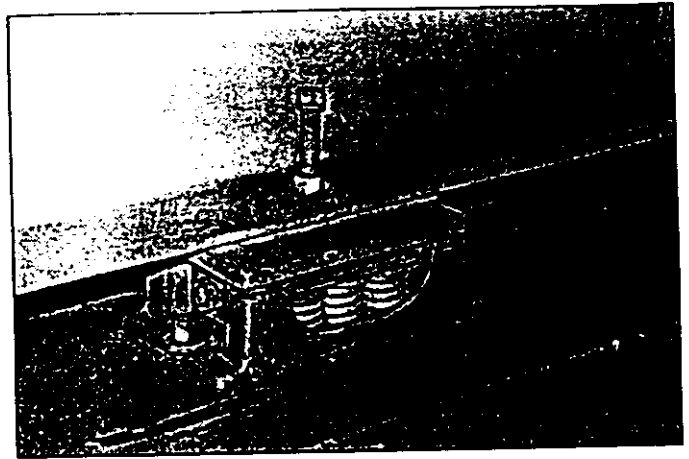
Photographs 3-32, 3-33, and 3-34. Spring vibration on emergency generator damaged in Whittier earthquake.

Emergency generators require functionality of a series of support systems. Vibration isolators not designed for seismic loading are vulnerable. Use snubbers on vibration isolated bases or anchor directly to the floor. Review the vulnerability (i.e., anchorage, support, flexibility) of fuel, cooling, starting (i.e., batteries or compressed air), and exhaust systems.

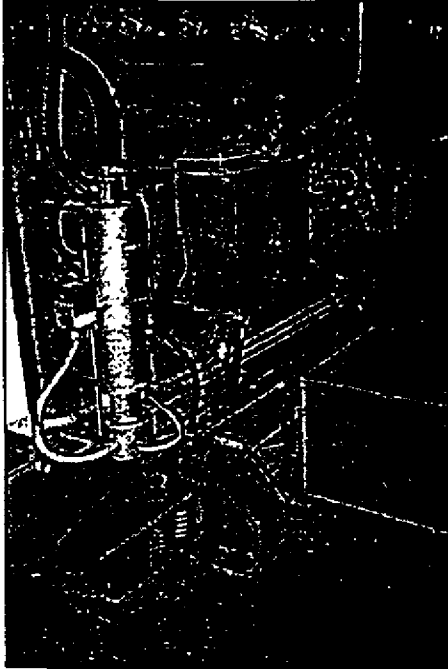
Photograph 3-37. Fuel tank bounced around, severing piping, and draining, in Baguio, Philippines water booster pump station.

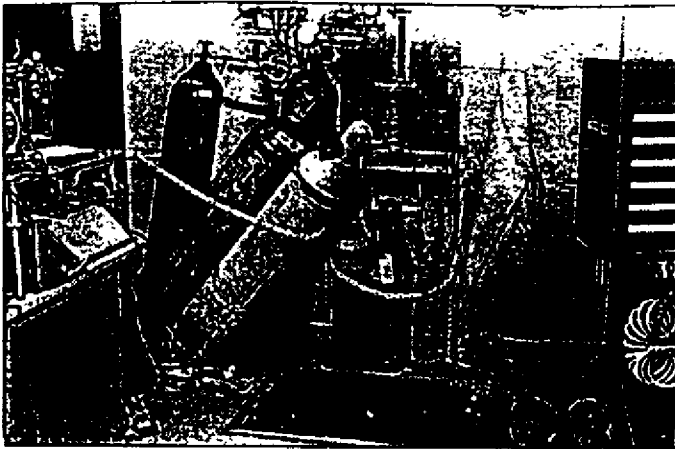
Photograph 3-38. Fallen compressed gas cylinders with single chain.

Chlorine cylinders (150 lb) topple, breaking connecting piping. Restrain them top and bottom. Chlorine containers (1 ton) roll/slide, breaking connecting piping/pig tails. Anchor them with chain binders or nylon straps. Alternatively, use sodium hypochlorite systems. Gaseous chlorine containment and stabilization in the 1991 Uniform Fire Code (UFC) are recommended. Provide Chlorine Institute repair kits stored outside the potentially hazardous area.

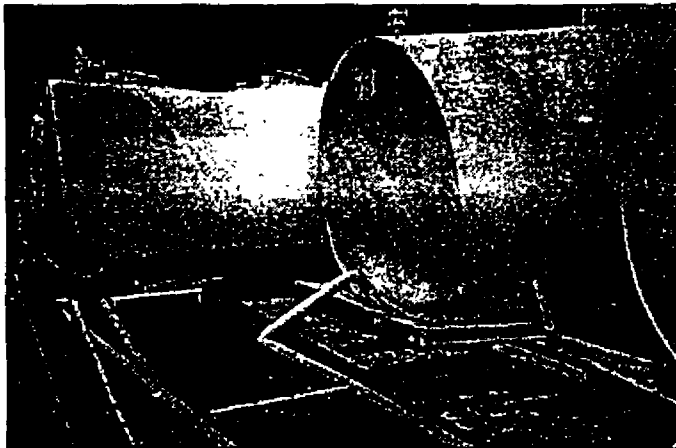
Photograph 3-43. Collapsed horizontal fuel tanks without adequate longitudinal saddle support structures in Limon, Costa Rica.

Large horizontal tanks such as chlorine, liquid natural gas, propane, diesel, or surge tanks may slide, breaking connecting piping. Provide adequate load transfer from the tank to the foundation, particularly longitudinally. Restrain them to saddles to prevent slippage and rupture of attached piping.

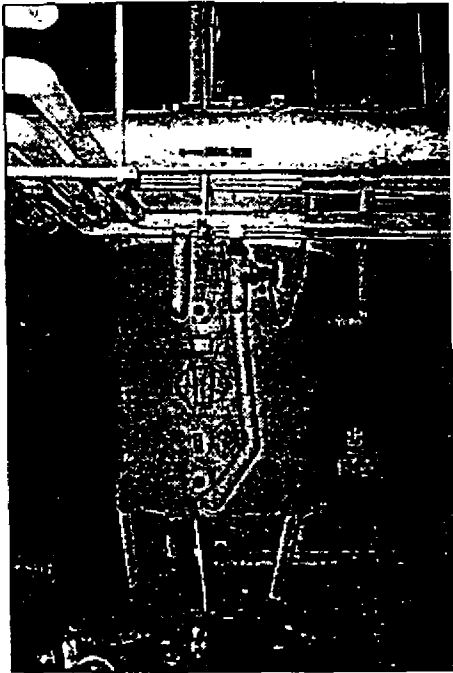
Photograph 3-46. Unbraced tank legs buckled in San Fernando earthquake.

The legs of equipment and small tanks without cross bracing may bend and collapse. Provide cross bracing on the legs.

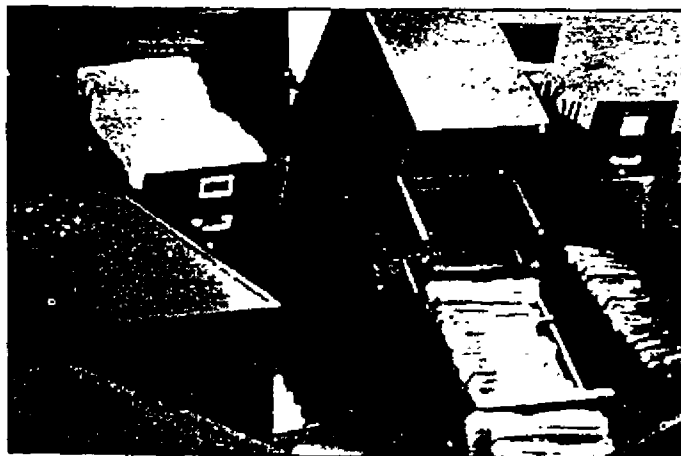
Photograph 3-50. File cabinet drawers opened and cabinets toppled in Loma Prieta earthquake.

Laboratory equipment, chemicals, and other supplies should be secured. Office equipment/computers may slide on to the floor. Anchor them to the desk. File cabinet drawers may roll open, and topple. Use latching file drawers, and tie adjacent file cabinets together.

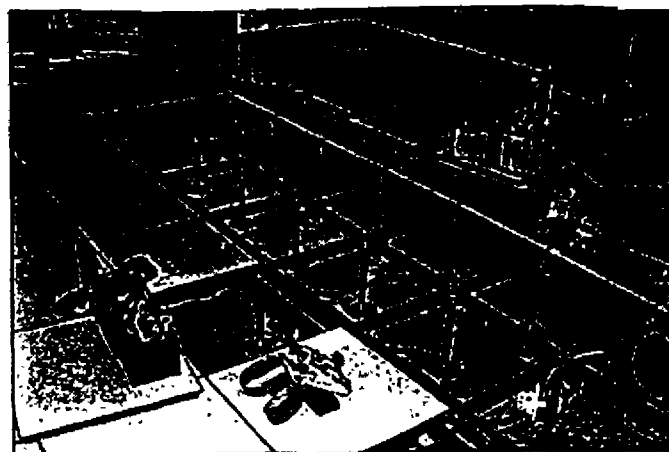
Photograph 3-51. Raised computer floors vulnerable to collapse.

Raised computer floors not specifically designed for lateral seismic loading are vulnerable to collapse. One alternative is to positively anchor the computer itself to the floor.

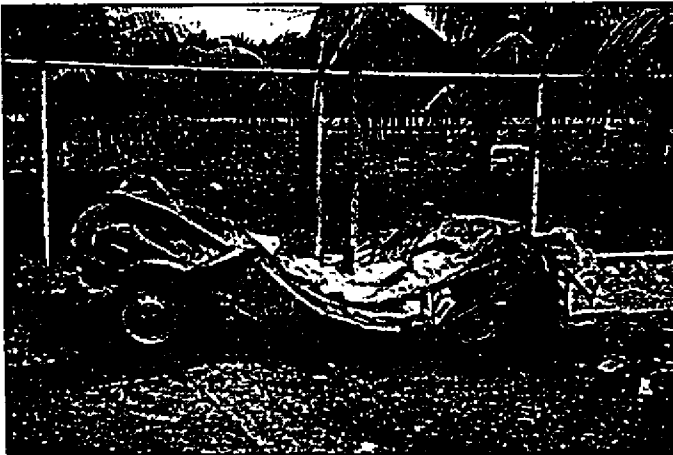
Photographs 3-53 and 3-54. Stacked rolls of paper fell on car in Limon, Costa Rica.

Storage shelving may topple and/or stored materials fall to the floor. Design/evaluate pallet racks in accordance with UBC requirements. Provide lips to keep stored material on the shelf.

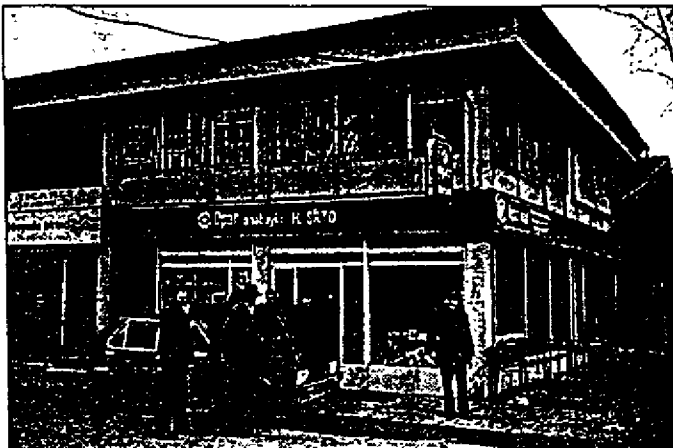
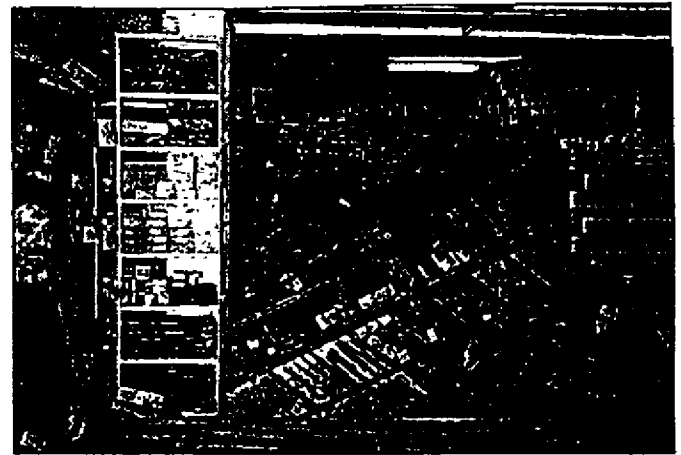
Photograph 3-55 and 3-56. Auto parts store shelving overturned in Erzincan, Turkey earthquake.

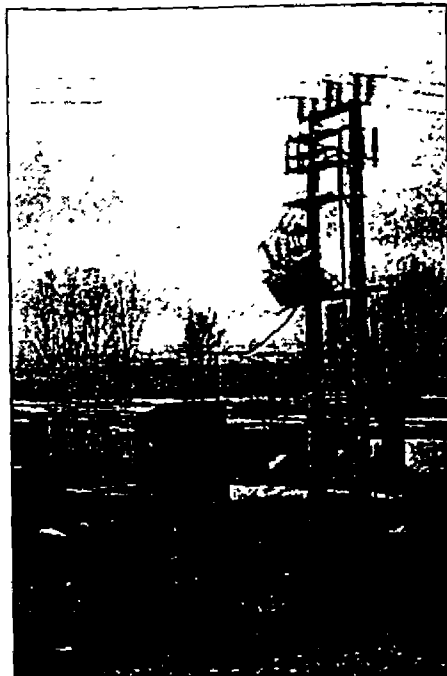
Photographs 3-58 and 3-59. Unanchored transformer (at large wastewater pump station) vulnerable to such earthquake forces as in Costa Rica.

Unanchored transformer units may slide/topple. Pole-mounted transformers that are anchored may also fall, or the pole itself may topple due to soil liquefaction. Work with the local power company to anchor transformers and assess the liquefaction susceptibility of the site.

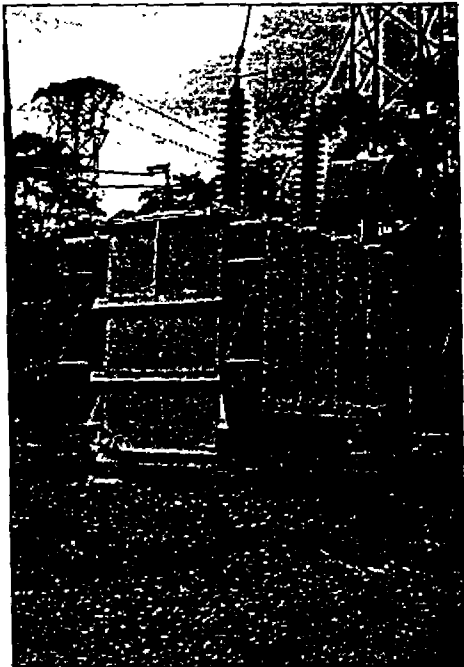
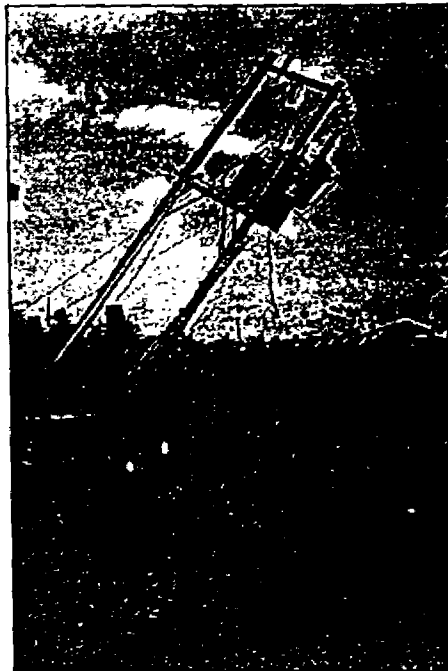
Photographs 3-60 and 3-61. Unanchored pole platform transformer toppled in Erzincan, Turkey. Pole with transformer toppled as a result of liquefaction at its base in Costa Rica.
