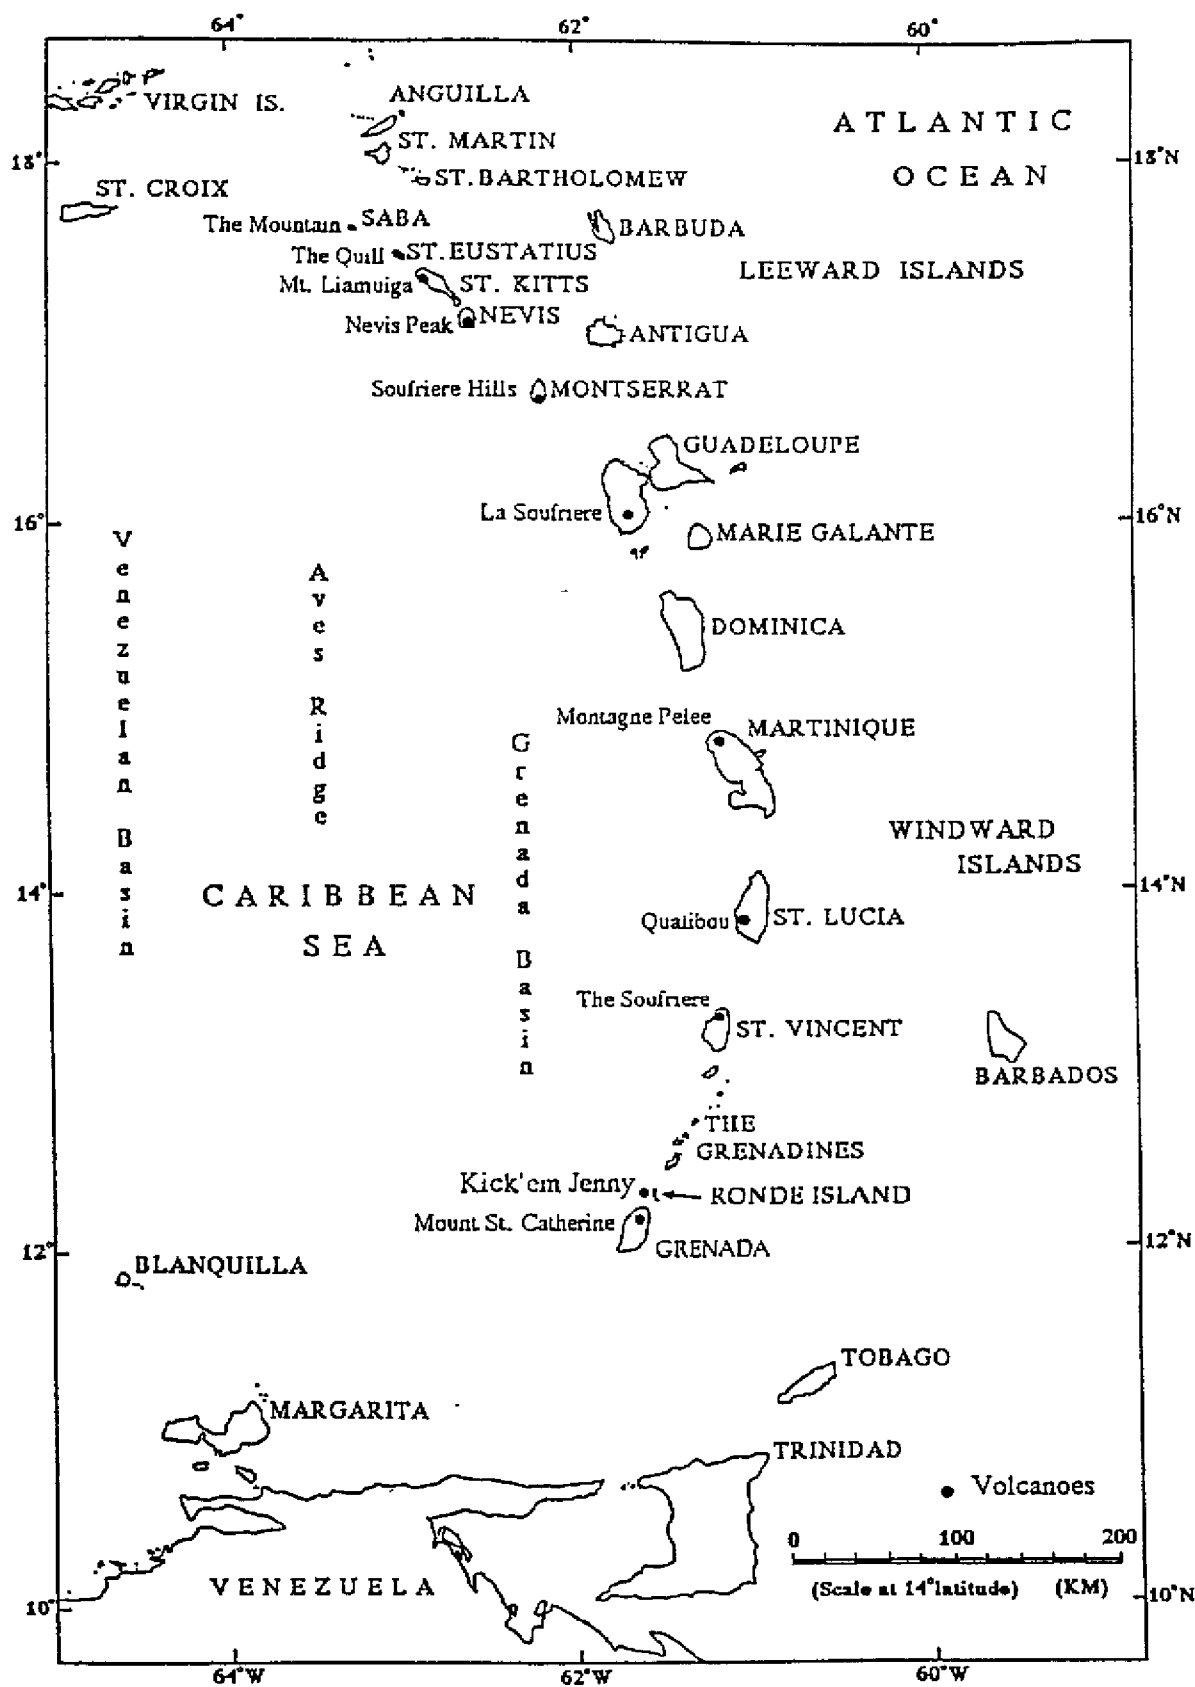
| Fig 12 | Location of Main Volcanic Centres in the Lesser Antilles |

Outline map of the Lesser Antilles
showing locations of main volcanic centres
(Martin S Smith and John Shepherd, Dec 1992)

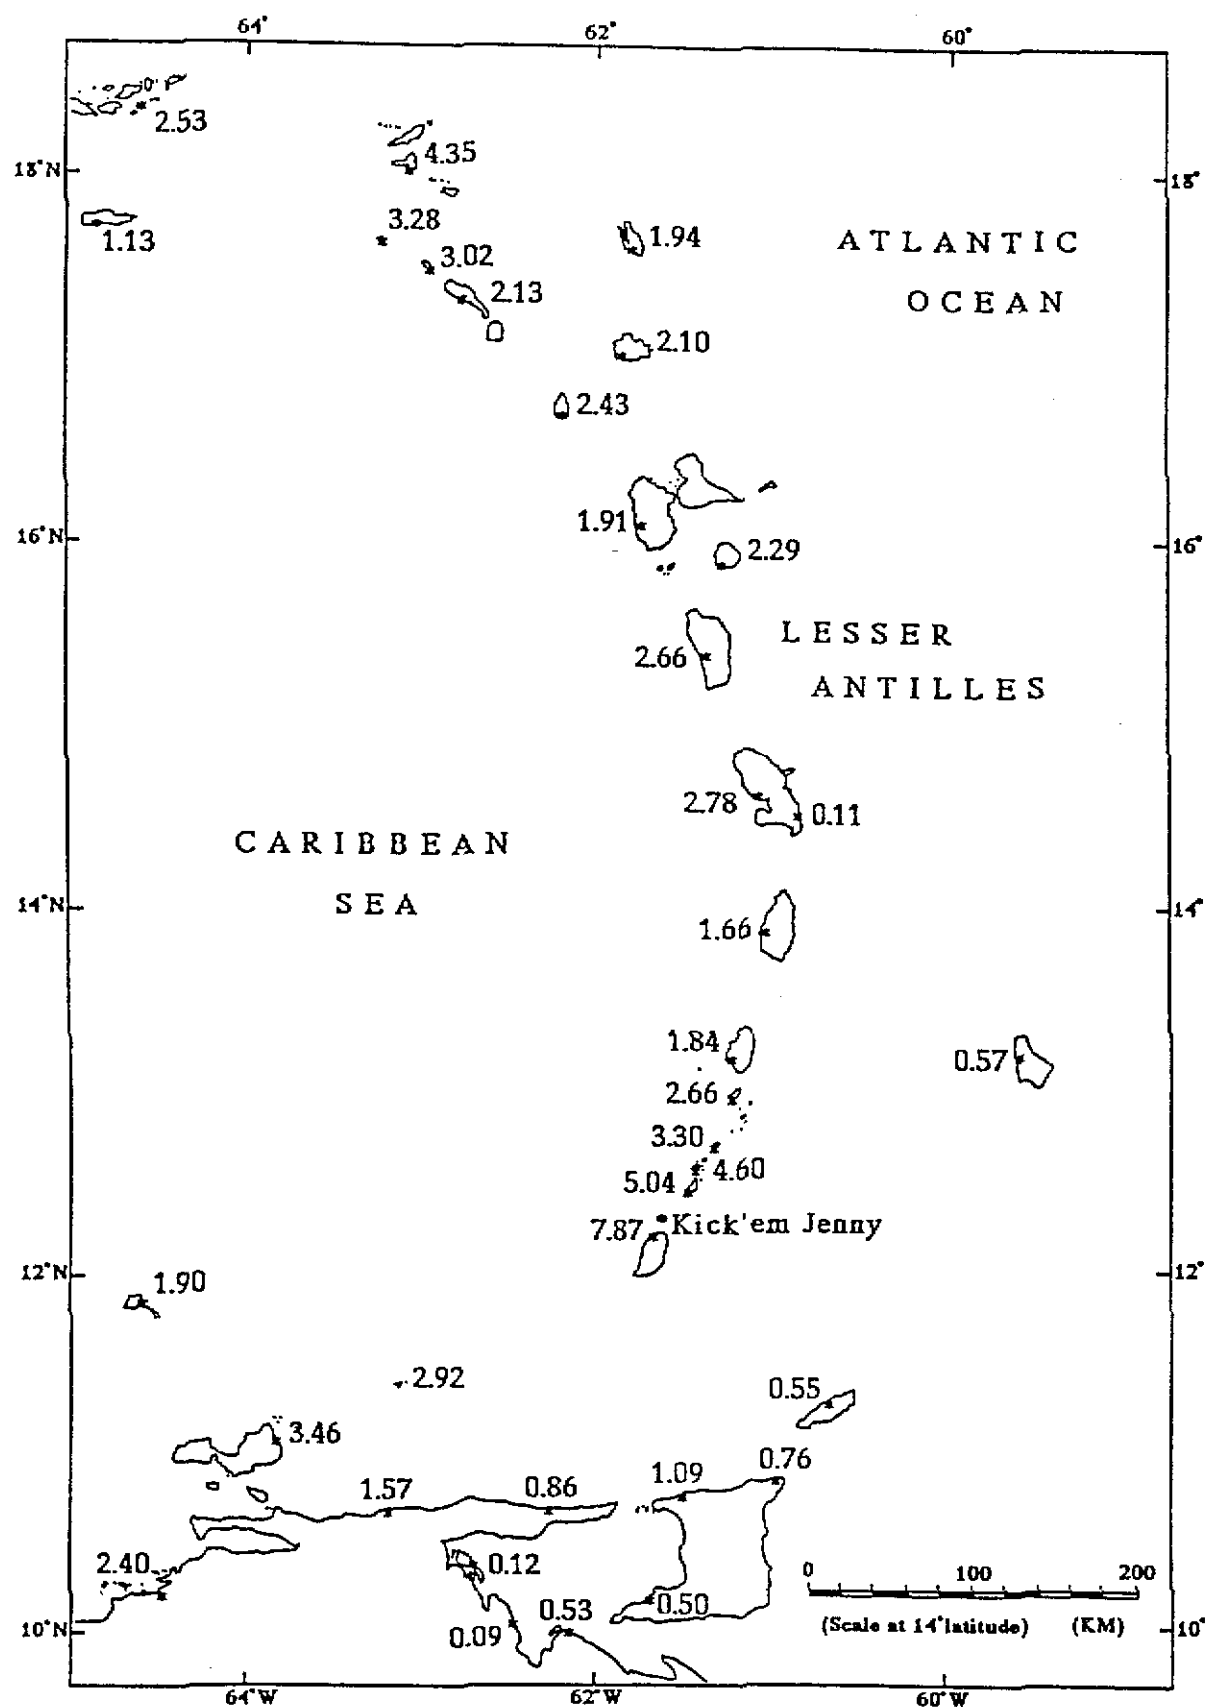
| Fig 13 | Run-up Values for Tsunamis for a "realistic" Kick 'em Jenny Event |

Final run-up values in metres for a 'realistic' scenario event
at Kick'em Jenny (VEI = 3)
(Martin S Smith and John Shepherd, Dec 1992)
