8.4.2. Stava, Italy (1985)

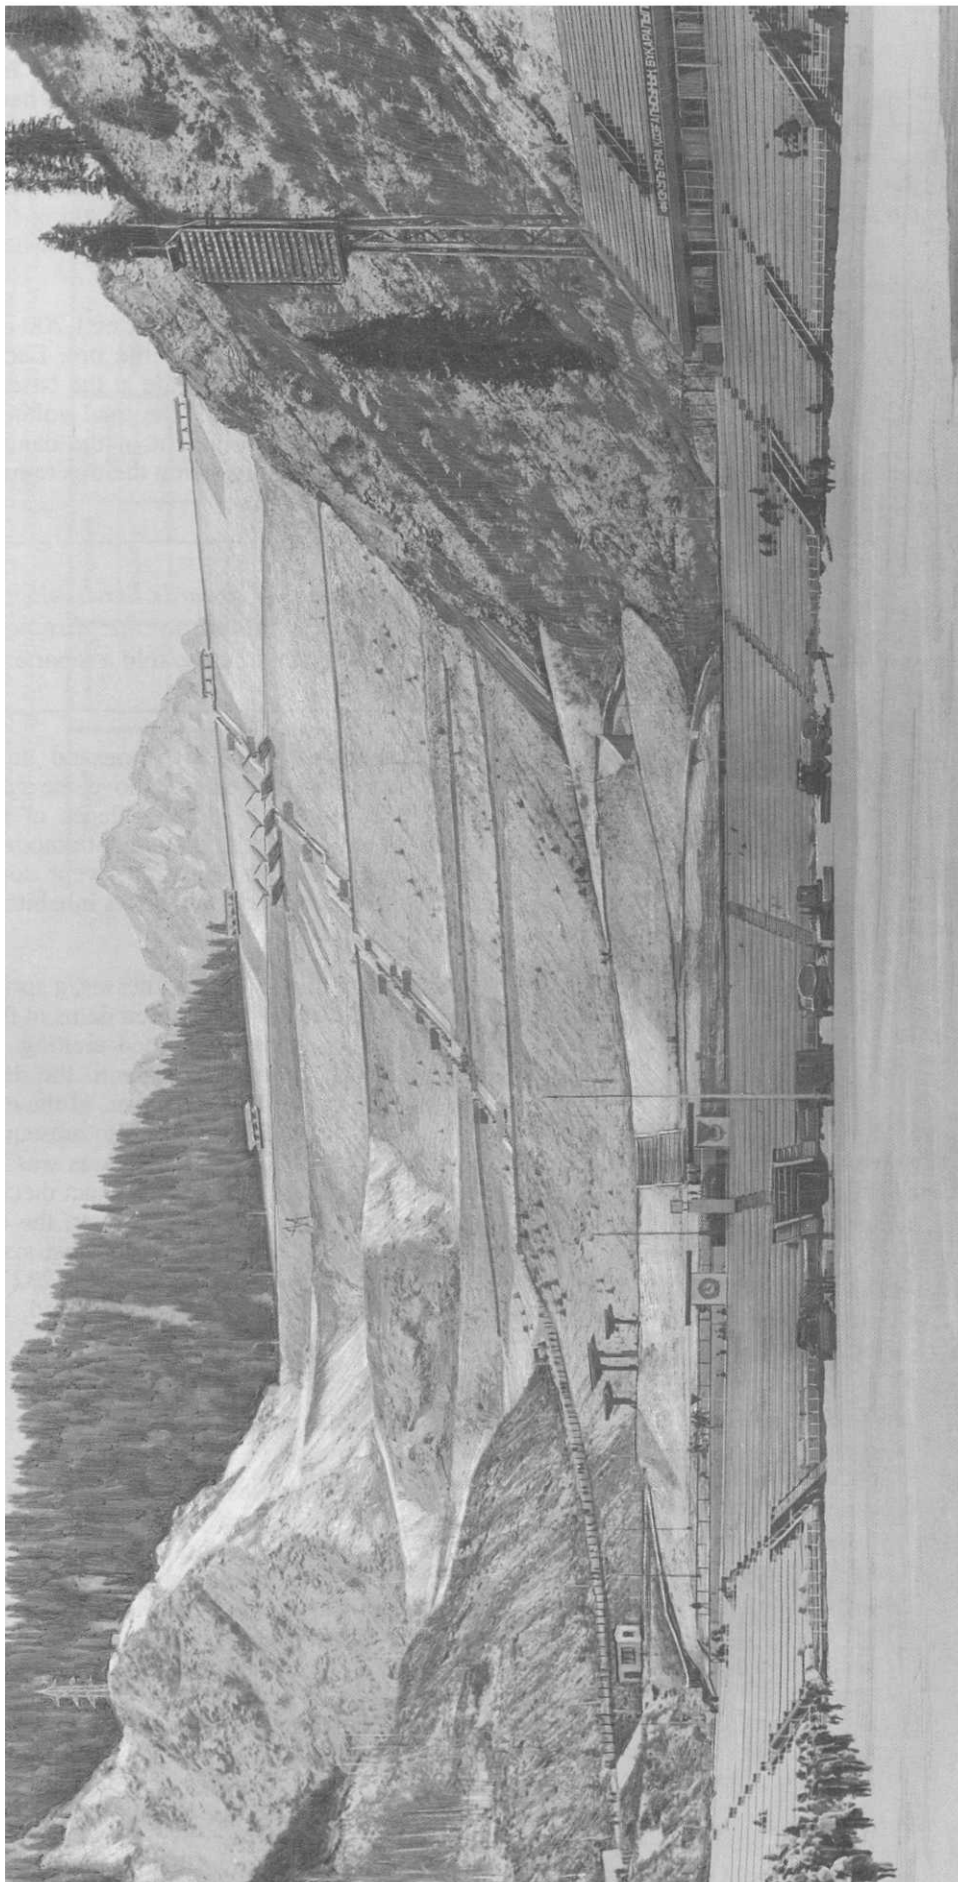
- The *Medeo dam*, measuring 150 m high, 800 m wide at the base, and 530 m long at the crest, with a capacity of 12.6 million m³ (see Fig. 8.49 (a)).
 - The *Damba steel-frame cell dam* and sand-check dyke built at the point where the river flows out of the mountains.

FIGURE 8.49 (a) Medeo dam viewed from downstream (Malaya Almatinka River).

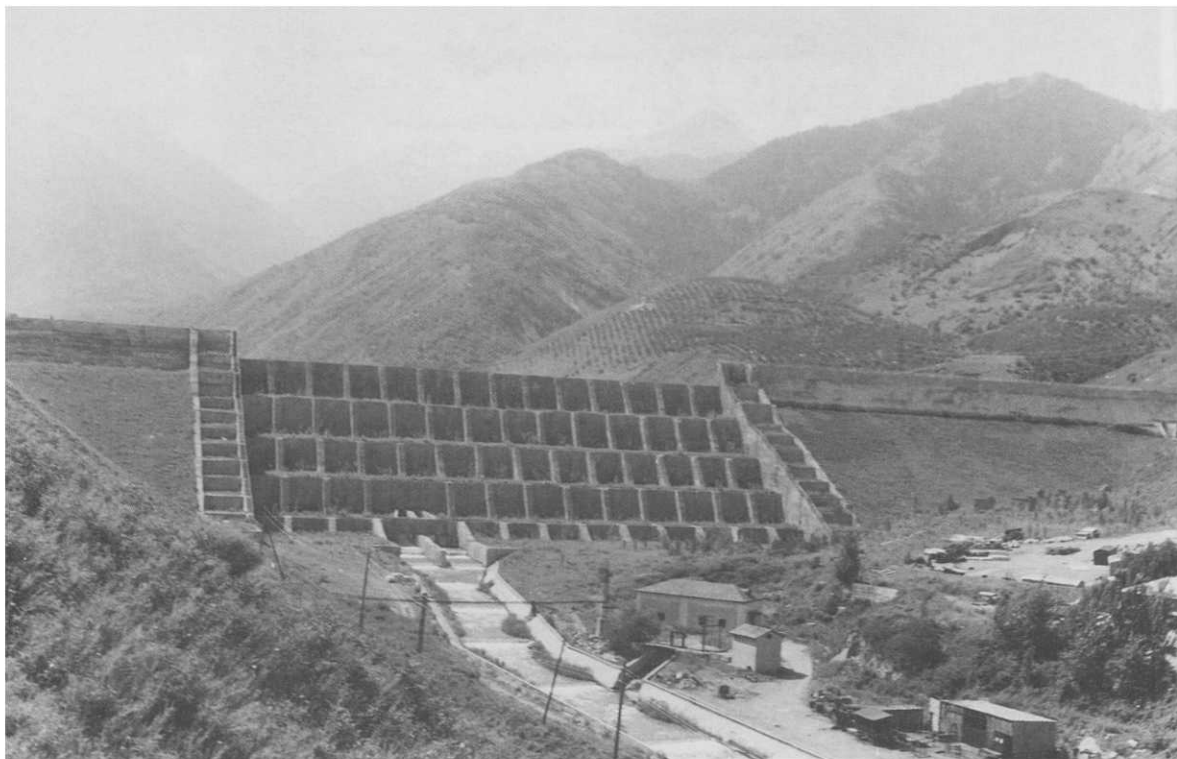
- A *reinforced concrete cell dam* 40 m high, 200 m wide at the base and 402 m long at the crest, with a capacity of 100,000 m³ (see Fig. 8.49 (b)).
- *River banks* within the city limits were built up with stabilizing reinforced concrete and sand-check dykes (see Fig. 8.49 (c) (i), (ii), (iii)).

FIGURE 8.49 (b) Mudflow protection barrage (steel-cell structure)—Bolshaya Almatinka River.

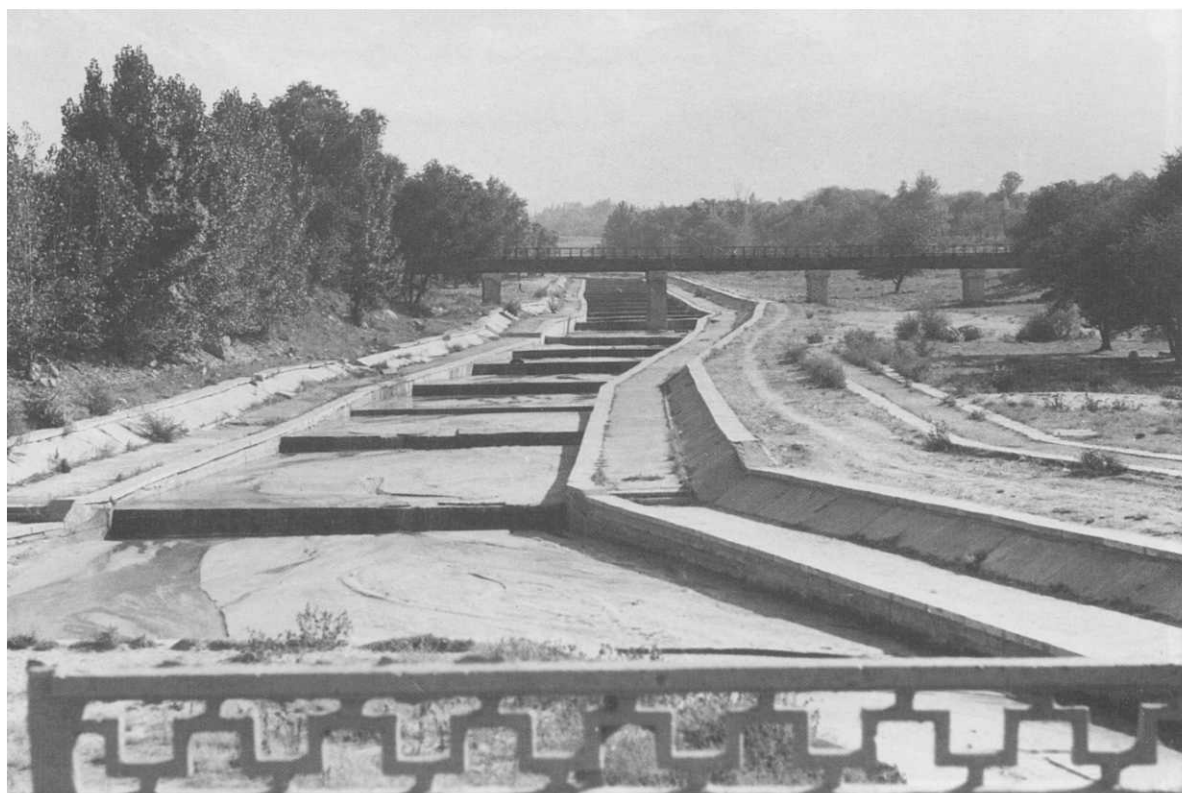
FIGURE 8.49 (c) (i) Flow stabilization structure on Bolshaya Almatinka River.

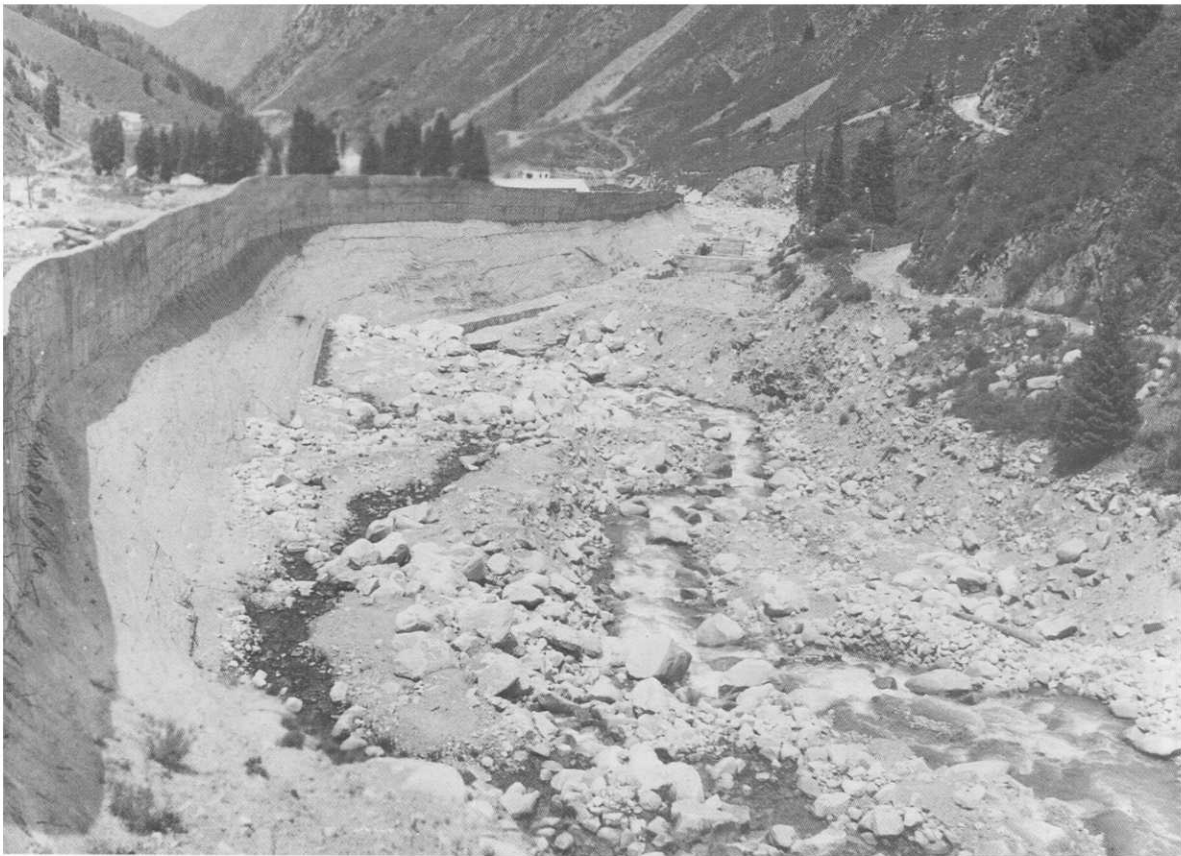
FIGURE 8.49 (c) (ii) Mudflow protection wall on the Bolshaya Almatinka River constructed after the mudflow disaster of 1977.

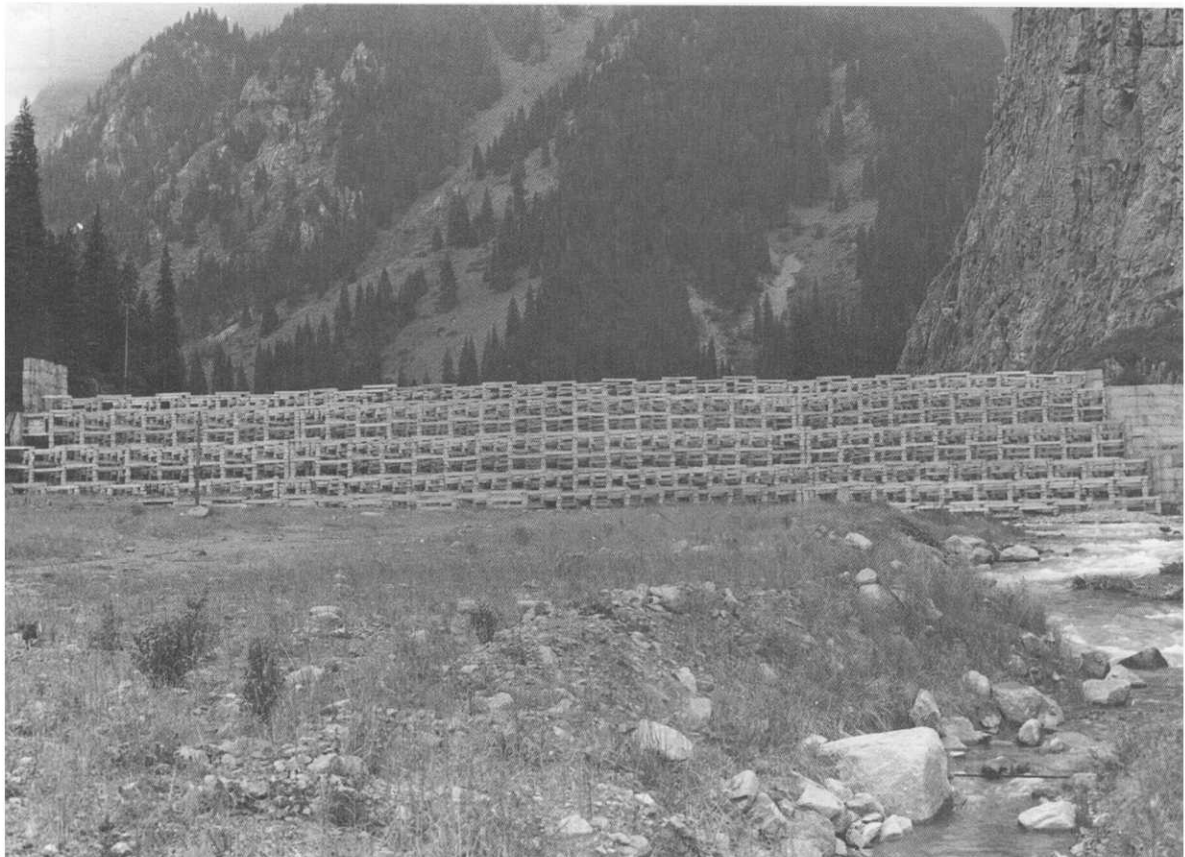
FIGURE 8.49 (c) (iii) Steel-cell barrage on Issyk River near Almaty City.
Location: Almaty, Kazakhstan. Photo: State Committee for Emergencies, Kazakhstan.

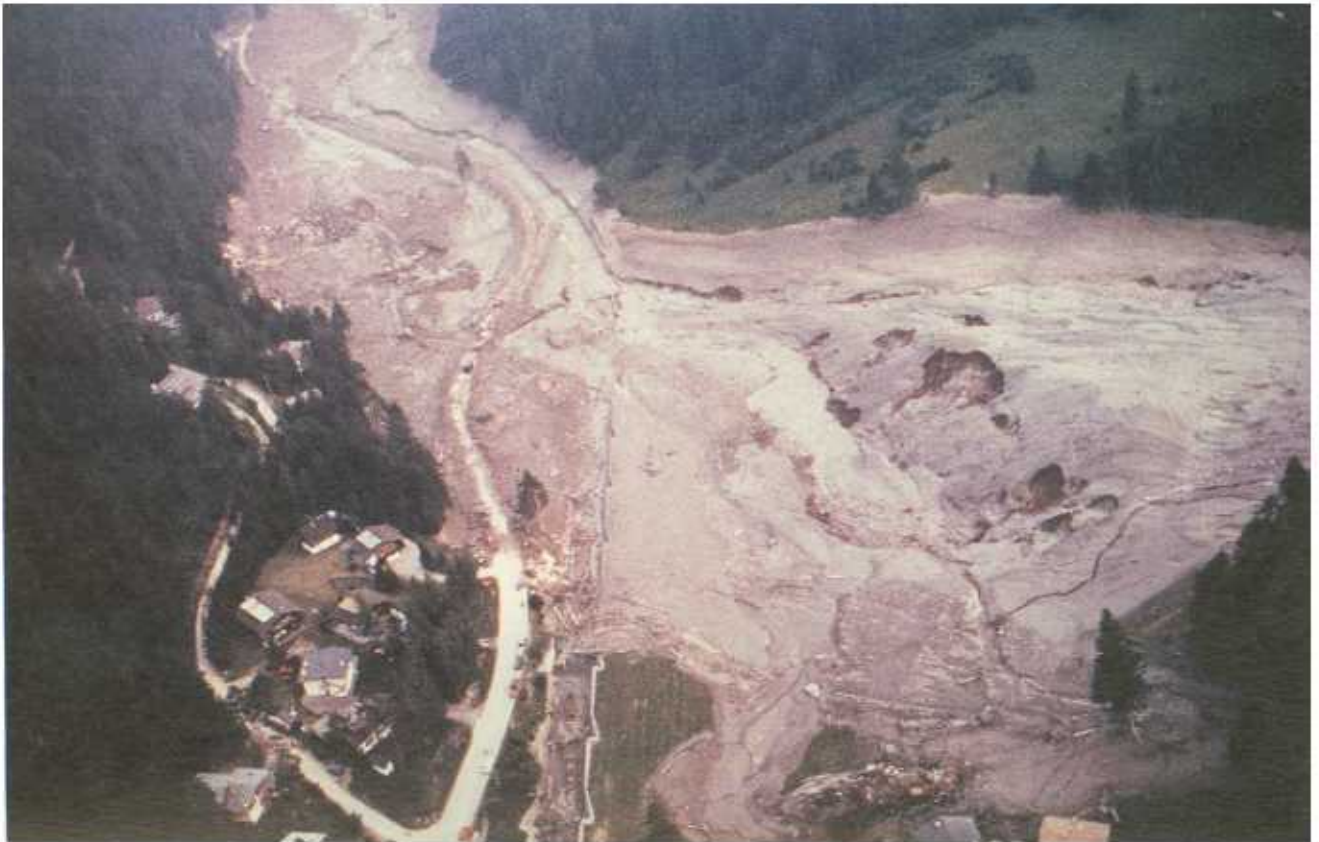
Two hundred and fifty thousand cubic metres of water, stored in two basins above the valley, had suddenly been released by the collapse of the dams. The water, which carried an equivalent amount of mud, created a wave 30 m high which swept down the valley. After its passage, Stava and all its inhabitants had ceased to exist (Fig 8.51).

FIGURE 8.51 Stava after the 1985 mudflow. Photo: ANSA
