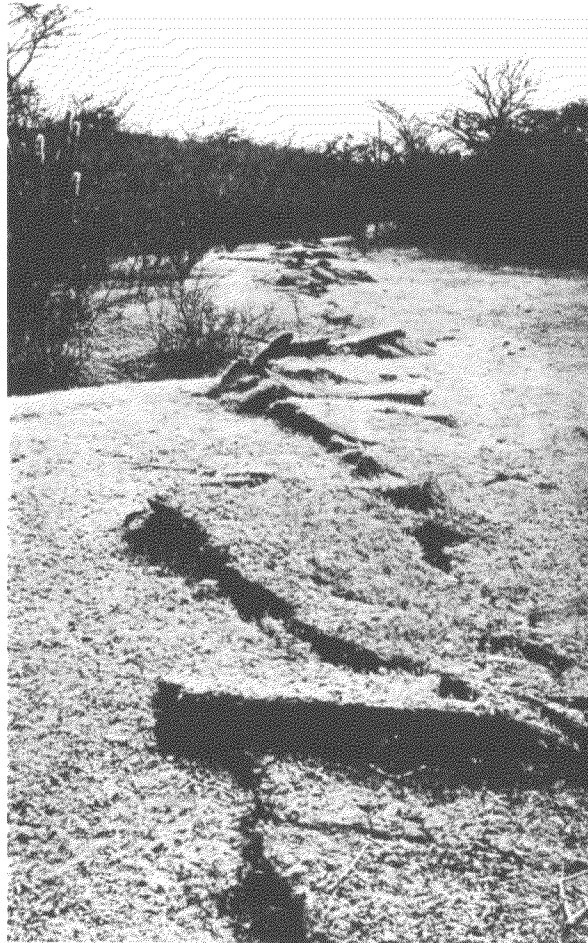
Figure 5. Oppositely directed overthrust slabs of soil along en echelon fissures.

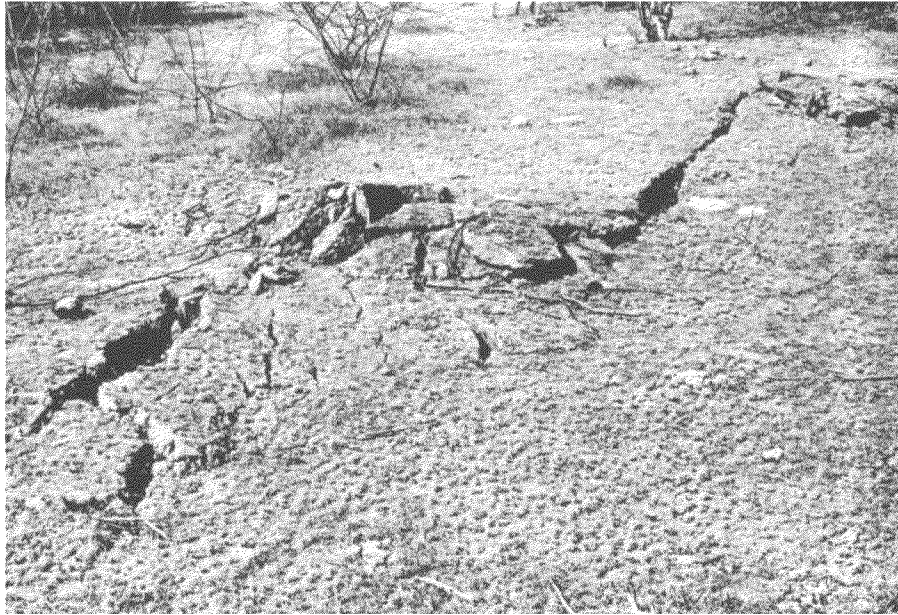
Figure 4. Pressure ridge connecting ends of two en echelon fissures.

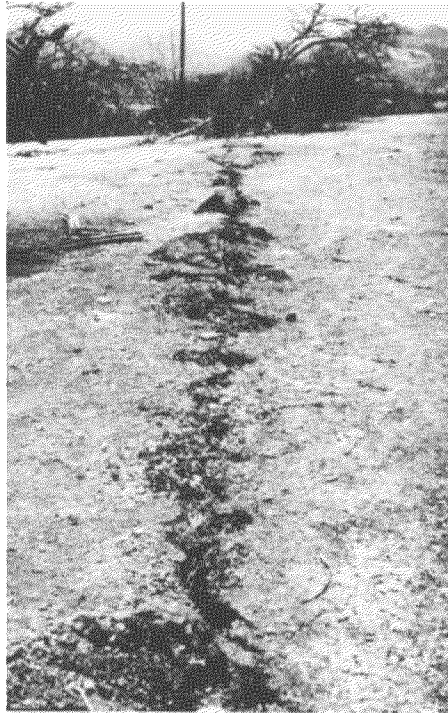
Figure 6. Relatively straight trace of surface rupture in soil of low cohesion. En echelon pattern of fissures, which is common in more cohesive soils, is nearly absent here.
