#### 4. Typical failures, typical design mistakes

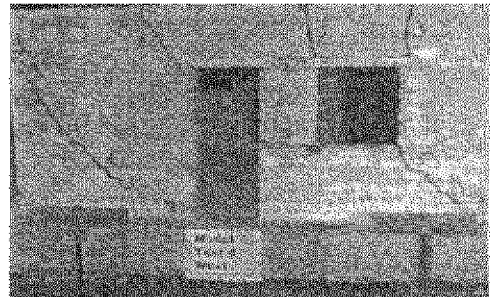
4-1 to 4-3 Typical failures caused by seismic movements (Tolles et al. 2000)

Typical failures, which occurred with simulated seismic movements on models in the scale of 1:5 are to be seen in Figs. 4-1 to 4-3. The most significant are:

- diagonal cracks lead from the edges of windows to the bottom of the wall,
- the lintel often destabilizes the walls, especially if it is not long enough and does not have sufficient bond with the wall,
- if the wall between window and door or between opening and corner is not long enough, it might break,
- if the wall has no ring beam at the top it breaks easily when suffering perpendicular loads which produce bending.

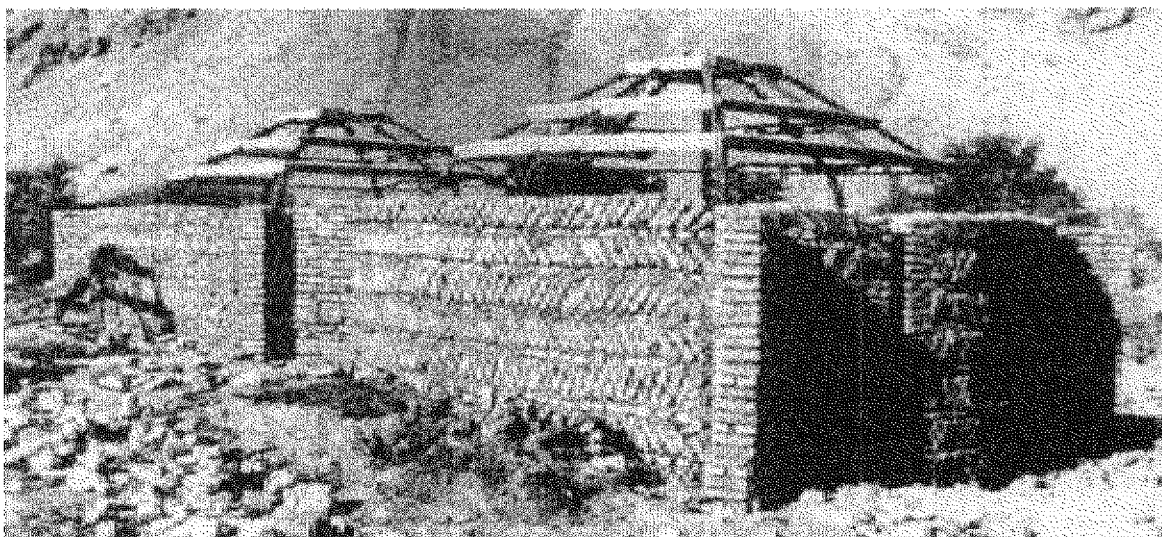
4-4 Earthquake-proof houses, Afghanistan (Sibtain 1982)

The houses shown in Fig. 4-4 seem to be well designed with the stabilizing buttresses at the corner. But without a ring beam they do not have sufficient stability against seismic shocks, as Fig. 4-5 and 4-6 show.
