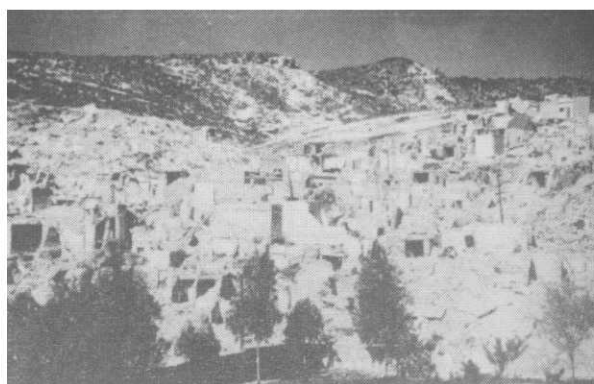
Damaged Houses (By courtesy of Dr Driss BENSARI)

Buildings in Agadir can be categorized as follows: old houses and brick houses of poor quality which were completely destroyed; small buildings which had been built with inappropriate techniques and; thirty modern buildings, constructed under the strict supervision of insurance companies, of which only two were destroyed. Most of the damage was due to the fact that earthquake-resistant techniques had not been adopted into building construction.

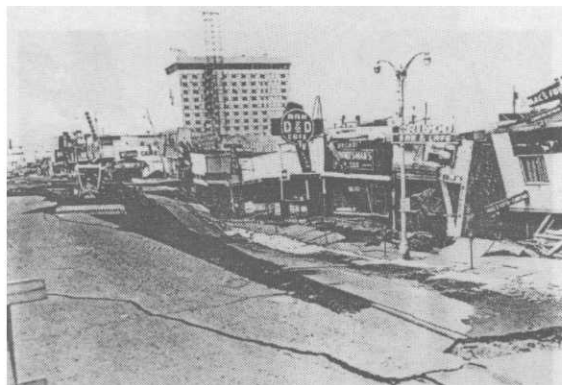
The 4th Avenue Landslide Area ("The Alaska Earthquake" The National Board of Fire Underwriters and Pacific Fire Rating Bureau, 1964)

A strong earthquake with a magnitude of 8.4 occurred in Prince William Sound (latitude 61°1'N, longitude 147°5'W) at 17:36, 27 March (local time). Moment magnitude M_w was 9.2, which is second only to the 1960 Chilean Earthquake, in the 20th century. Landslides occurred at many places along the coasts and on the sea bottom. The longer axis of the area of crustal movement was 700 km in an east-west direction, including Kodiak Island. Crustal upheaval of 2.4 m was reported at the south-west point of Montague Island in Anchorage. 9 persons were killed. Low wooden houses, reinforced concrete apartment houses, and school buildings received widespread damage. It was pointed out that any walls made of hollow concrete blocks without filling and joints of concrete columns and beams had no resistance against earthquake.

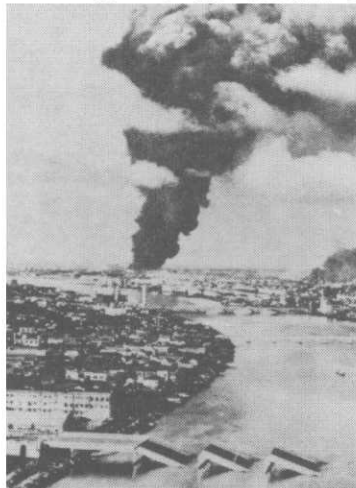
The Burning Niigata Oil Refinery of Showa Oil Co. Ltd. ("Record of the Niigata Earthquake", Niigata Nippo, 1964)

本震は、新潟県の北50kmの地点に発生した。被害は、新潟・山形県を中心に9県に及んだ。この地震による被害は、死者29名(新潟14名、山形9名、秋田6名)、負傷者510名、全壊建物3,557棟、半壊建物12,237棟に達した。住宅への被害が多かったのは、新潟市・村上市(神林村)・中条町・水原町及び山形県の酒田市・鶴岡市・遊佐町・温海町の各都市である。特に、神林村の塩谷部落では全戸数316のうち全半壊152にのぼった。津波が本震の約15分後から日本海沿岸各地を襲い、島根県隠岐島でも水田が冠水した。火災は、新潟市で9件発生し、内8件は直ちに消火されたか大火に至らなかった。しかし、地震直後に発生した昭和石油新潟製油所の火災は、15日後の7月1日17時によく鎮火した。この火災は、97基の石油タンクを焼損し、隣接する平和町、船江町、臨港町の住宅332世帯を類焼した。火災による石油タンクの焼失は、143基に達した。

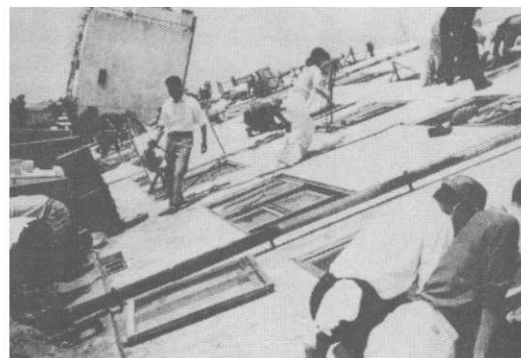
A Toppling over 4-Story Reinforced Concrete Apartment at Kawagishi in Niigata City ("Record of the Niigata Earthquake", Niigata Nippo, 1964)

この地震の特徴として、液状化現象がある。新潟市及び酒田市等の低湿地において砂と水を噴き出し、砂が1mも堆積した。その顕著な例としては、新潟市川岸町の鉄筋コンクリート4階建アパートがそのまま傾き倒れたものであった。新潟市にあった1,500棟の鉄筋コンクリート建物のうち310棟が被害を受け、さらにそのうちの2/3が液状化の被害を受けた。

The feature of the earthquake was the liquefaction phenomenon. Sand and water blew out in low and damp places in Niigata and Sakata cities, and sand was piled to a height of 1 m. In one well-known case, a four-story apartment block at Kawagishi in Niigata city toppled over on to its side, virtually in fact. This was due to soil liquefaction. Of the 1,500 reinforced concrete buildings in Niigata, 310 were damaged. Two-thirds of this total were caused by the liquefaction phenomena resulting from the earthquake.
