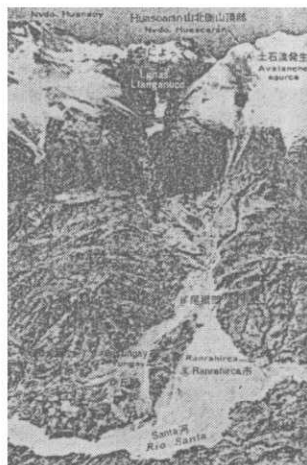
Avalanches and Rockslides on Mt Huascaran

A mass of ice at the 5,500-6,000 m level on Mt. Huascaran (6,768 m), the highest mountain in Peru, fell, slid on a glacier and dropped a further 10 km. It took only three minutes to reach Yungay and Ranrahirca. It killed 17,000 persons in Yungay and 1,800 in Ranrahirca. In Yungay, only four hundred persons out of the 20,000 population survived. The avalanche also reached the opposite hill of the Santa Valley 83 m away. Three-10 m thick earth and sand layers covered an area of 8 km². The total volume of the landslide was 50-100 million tons. The downstream area of the Santa Valley was also affected.

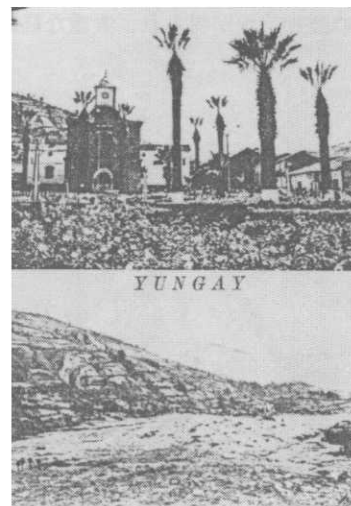
Top Yungay City before the Earthquake
Bottom Ruins of Yungay City after the Earthquake

The government of Peru prohibited the excavation of the former settlement of Yungay, and constructed new small-scale settlements on the nearby hillside. From the experience of this earthquake, the government of Peru has recently designate the 31st of May as the day for disaster prevention.

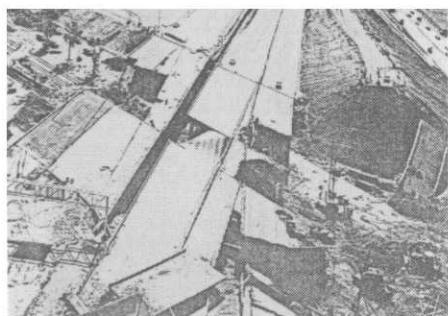
Destroyed Elevated Bridge at Highway Intersection (Robert Lacopi, "Earthquake Country", Lane Publishing Co., pp.138)

建物被害は、学校、病院、住宅等広範に及び、大破建物は5,400棟以上である。土木施設の被害としては、サン・フェルナンド市の中心から3kmにあるヴァン・ノーマン・ダム：Van Norman Dam (アースダム)の堰堤が崩れ、決壊の危険性があったため、下流の住民8万世帯に避難命令が発令されたが、迅速な措置によって、ことなきを得た。さらに、山麓部のインターチェンジにおける高架橋の落橋が目立ち、電話局の被害や変圧器の転倒等により、通信・電力にも大きな影響が出た。また、サン・フェルナンド市では、500ヵ所以上でガス管が損傷し、28ヵ所で出火（出火件数の合計は62ヵ所）し、約12km²、12,000世帯に影響を及ぼした。

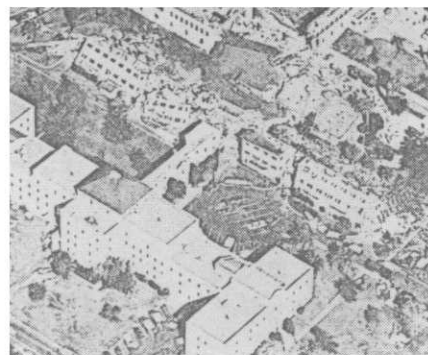
Collapsed Sylmar Veteran's Hospital (Robert Lacopi, "Earthquake Country", Lane Publishing Co., pp.37)

The epicentre was 45 km north-north-west of Los Angeles, or 12 km north-north-east of San Fernando. The damaged area was an elliptical shape with a major axis of 70 km and a minor of 40 km. The major cause of death was the collapse of Sylmar Veteran's Hospital.

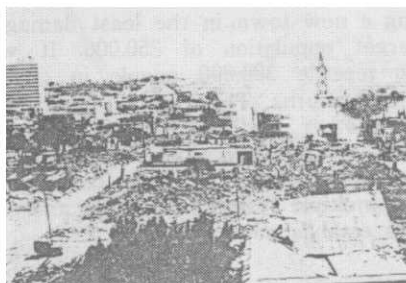
Managua City after the Earthquake (S. Murakami and K.Ito. "Earthquake and People", Dobun-shoin, 1984, pp.57)

Damaged buildings were primarily traditional ones, such as Dagesal (wooden structure with soiled walls) and schools, hospitals and public facilities built in the 1960s. Dagesal had been recommended more than Adobe structures for earthquake resistance. However, the thick roofs and ceilings for insulation used in Dagesal structures fell during the earthquake, and increased the number of victims. Furthermore, fires broke out in the city and lasted for 3 days, burning 50,000 houses. Together with the damage directly caused by the earthquake, 75 per cent of the city was severely damaged.

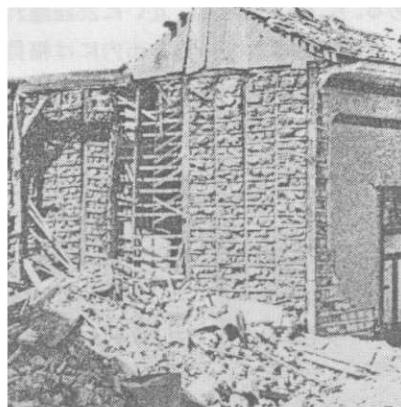
A Damaged Dagesal Building (S. Murakami and K.Ito. "Earthquake and People", Dobun-shoin, 1984, pp.57)
