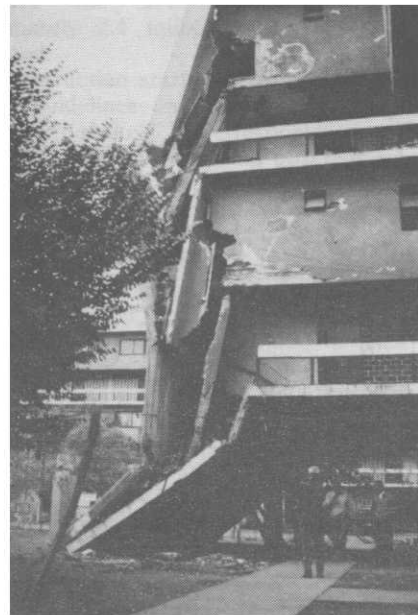
Collapsed Piloti of Reinforced Concrete building in Santiago City. By courtesy of Prof. Shibata.

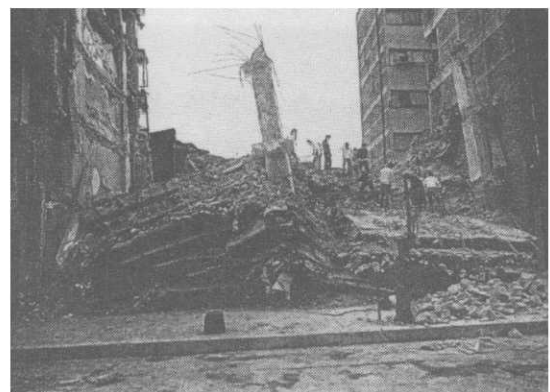
A Collapsed Building like a Sandwich (Earthquake Mexico '85'. The Munich Reinsurance Company, 1986)
