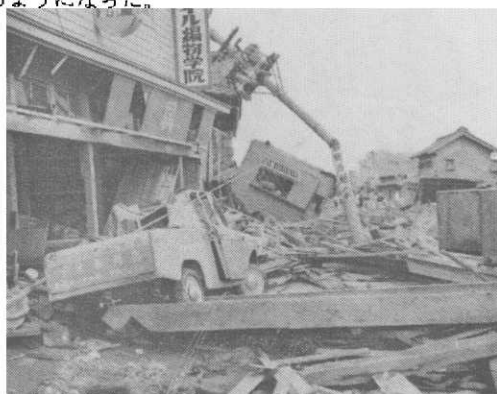
Wretched sight of Ofunato, Iwate Pref ("Report on the Chilean Tsunami of May 24, 1960, as observed along the coast of Japan", Committee for Field Investigation of the Chilean Tsunami of 1968 1961, pp 397)

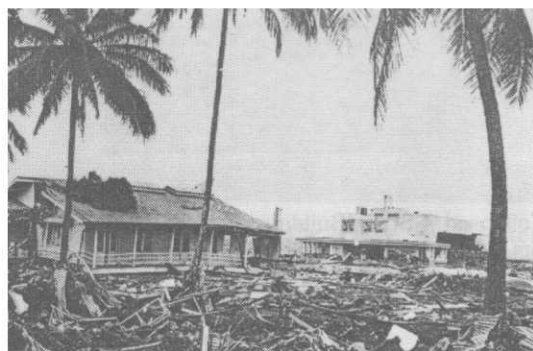
The remains of the Hilo Boys Club, left, with the Hilo Theatre in the background ("The Big Wave", The Hilo Tribune-Herald Ltd., 1960)
