### 被害概要

### The Landslide and Resulting Damage

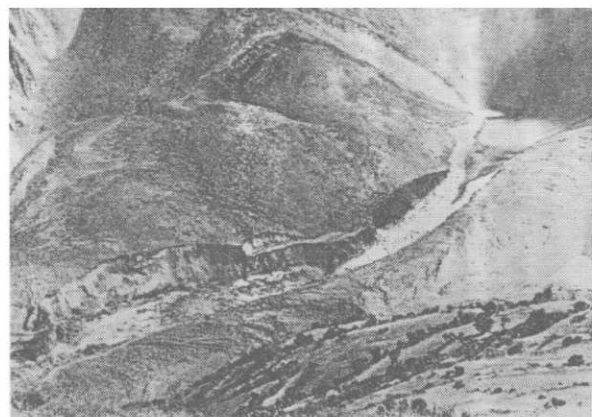
View to West of Breaching of Slide Dam near Time of Maximum Discharge, 8 June 1974 (Barry Voight ed., "Mayunmarca Rockslide and Debris Flow, Peru" in Rockslides and Avalanches, 1 Natural Phenomena, Developments in Geotechnical Engineering Vol.14A, p.316)

土石流により全長 3.8km、高さ 150m の堰ができ、その貯水量は約 6.7 億  $\text{m}^3$ 、上流 3.7km にまで及んだ。この堰は地滑り後 44 日間に決壊し、その最大流量は 1 万  $\text{m}^3/\text{s}$  であったが、幸いにも人命は失われなかった。

The 3.8 km long dam caused by the landslide, stood about 150 m above the river channel and impounded water of an estimated volume of 670  $\text{m}^3$ , and extended 3.8 km upstream. The dam was breached 44 days after the landslide, releasing a peak discharge of about 10,000  $\text{m}^3$  per second. No casualties were reported.
