# 5. TSUNAMI

## QUICK AND FURIOUS ATTACKS OF SURGES

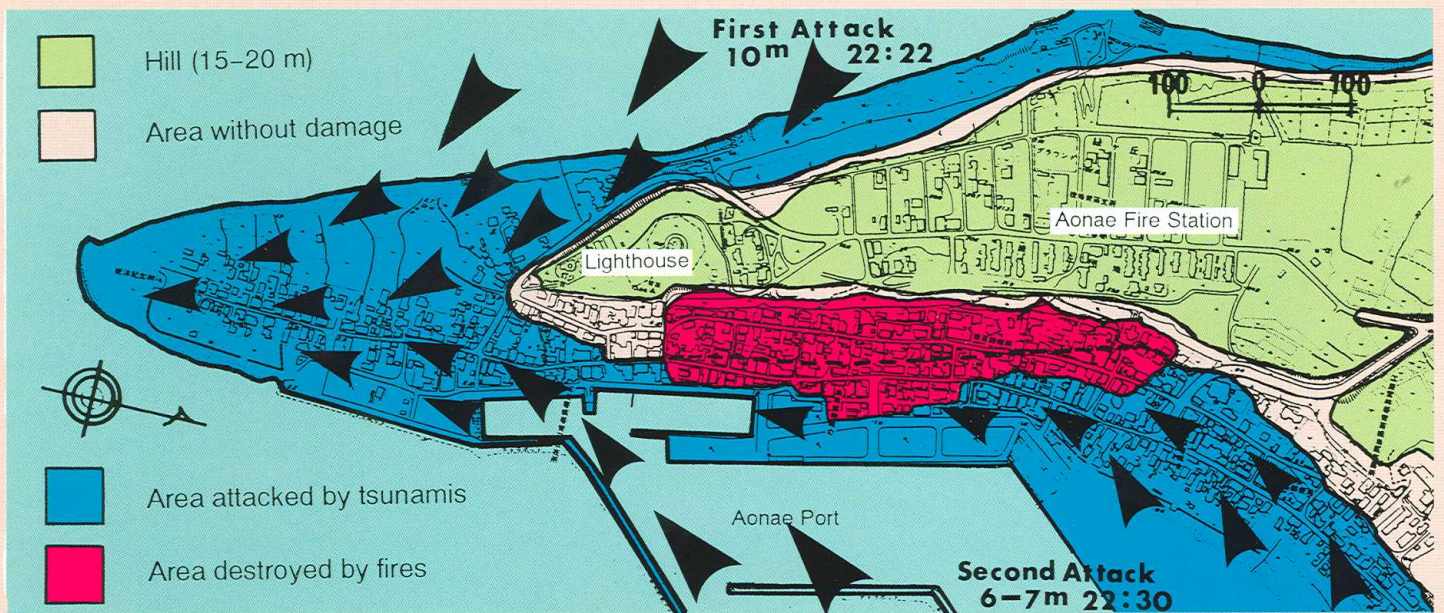
Attacks by tsunami on Aonae community

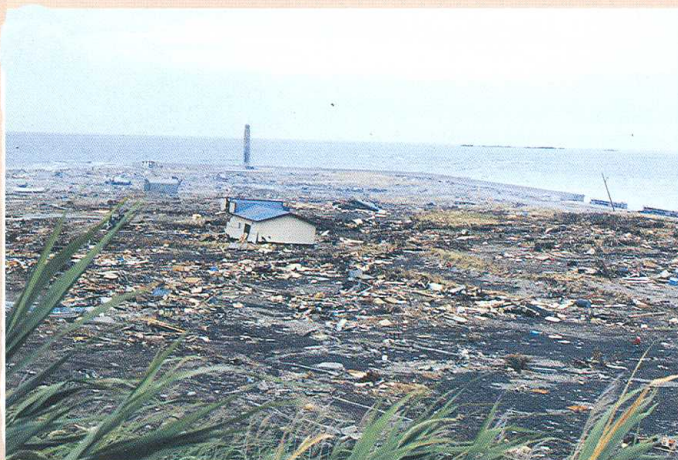
Devastation by tsunami at south end of Aonae community

The first attack of tsunami which was 10 m high, arrived from the west around five minutes after the shock. Most of the houses built on the south end of Aonae community were washed away and destroyed in an instant (photo right). The second surge coming along the east coast attacked the most densely built-up area on the east block of Aonae around eight minutes after the shock. The port break-seas guarding the centre part of the built-up area seemed to be effective in mitigating the force of the tsunami. Approximately 200 houses in the lower area of this community were protected from the violence of the surge. Unfortunately, however, most of the remaining houses were destroyed by the fire that developed later (photo below).

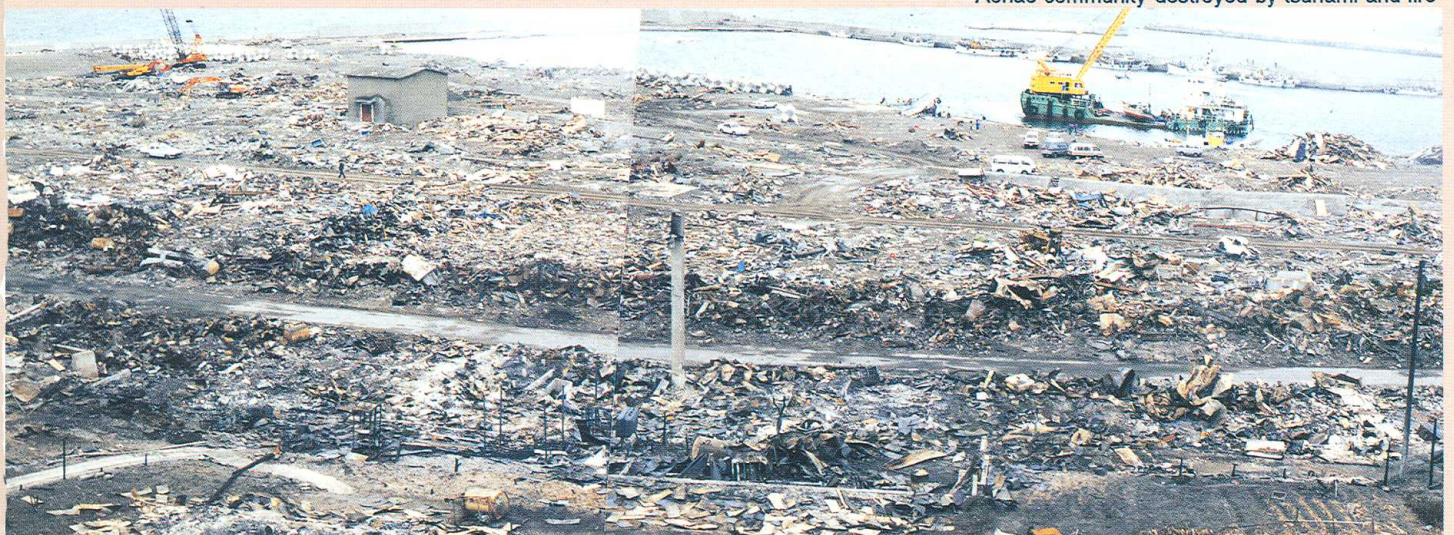
Aonae community destroyed by tsunami and fire
