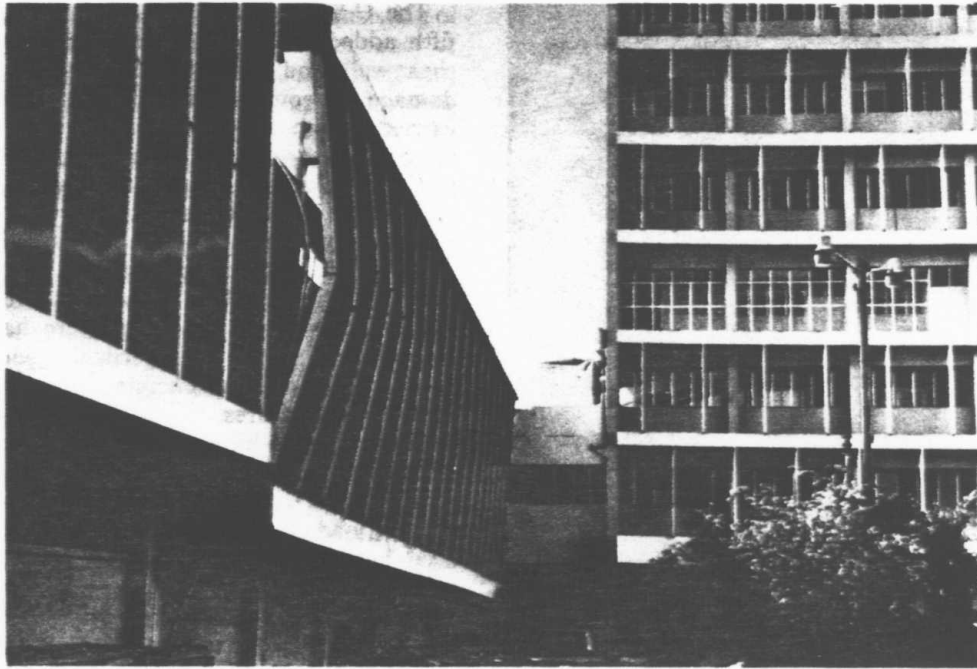
Fig. 7. Collapsed annex building at Benjamin Bloom Hospital.

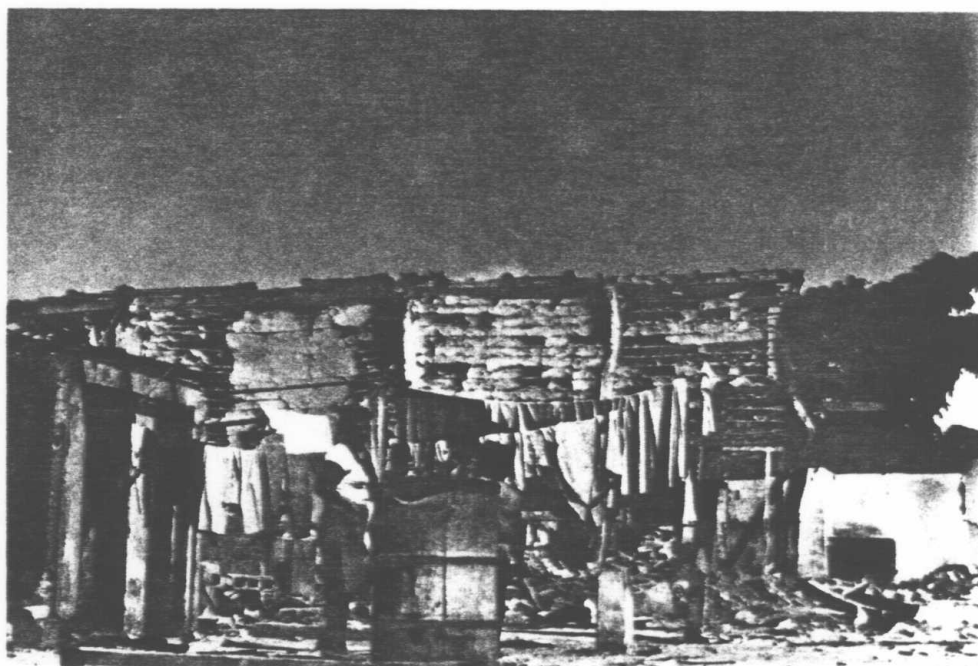
Fig. 9. Bahareque house.

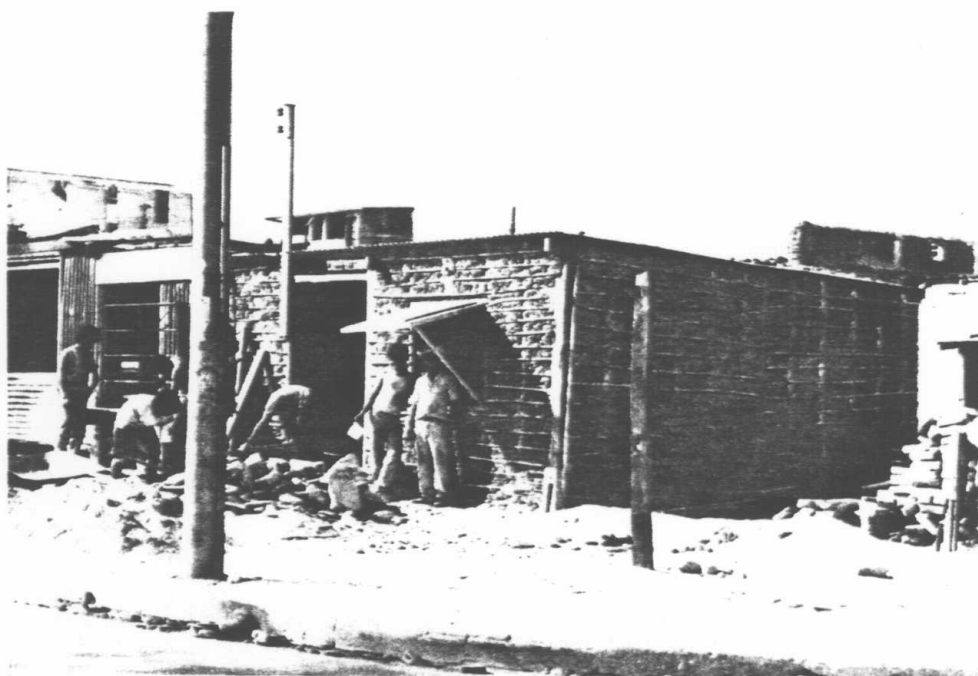
Fig. 10. Bahareque house; rebuilt within three weeks of earthquake.

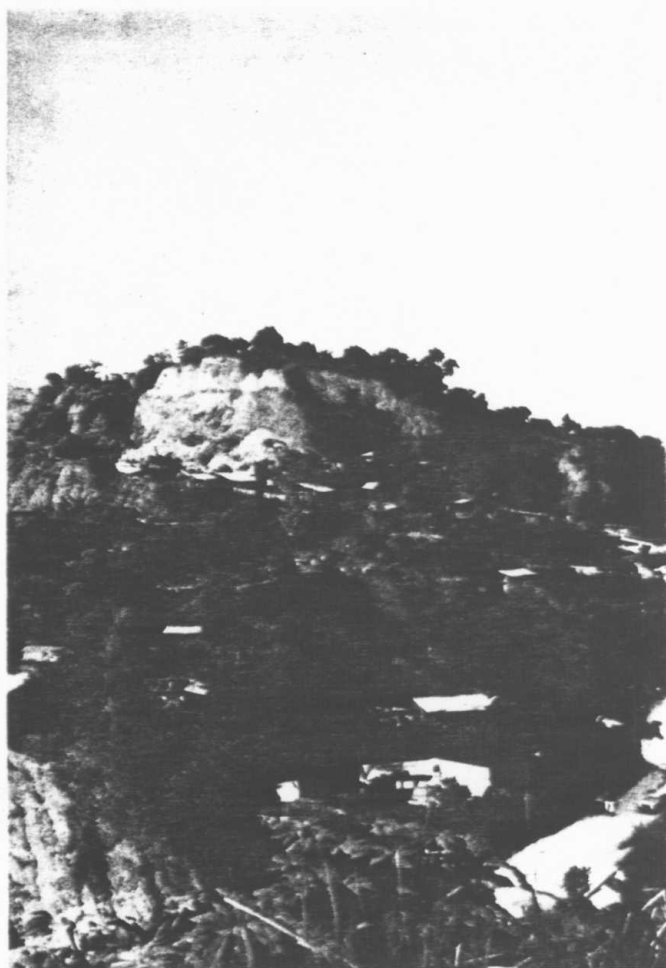
Fig. 11. Poor housing in southern districts.

Apart from the poor quality of construction, another factor that contributed to the large number of houses damaged is the terrain on which many of the poor are obliged to live. In the southern parts of the city shanty towns sprawl across the faces of steep ridges where the houses are built on terraces cut out of the hillsides (Fig. 11). Apart from the fact that such ridges can have the effect of amplifying the ground motions, the instability of the vertical cuts can

also result in damage to small structures founded on them. In one of the southern districts, Santa Marta, a row of houses was destroyed by a landslide along the ravine or whose banks they were founded. This ravine had been cut deeper and steeper over the years by flood waters from the Cerro de San Jacinto. Also in Santa Marta were a few houses that sank into liquefied ground; this appeared to be the result of the ground being water-logged around a leaking water mains (Fig. 12). Nowhere else were there any signs of liquefaction.
