**APPENDIX A**  
**WALKDOWN INSPECTION REPORT**

**SYSTEM**  
**NITROGEN SUPPLY TO BUILDING XYZ**

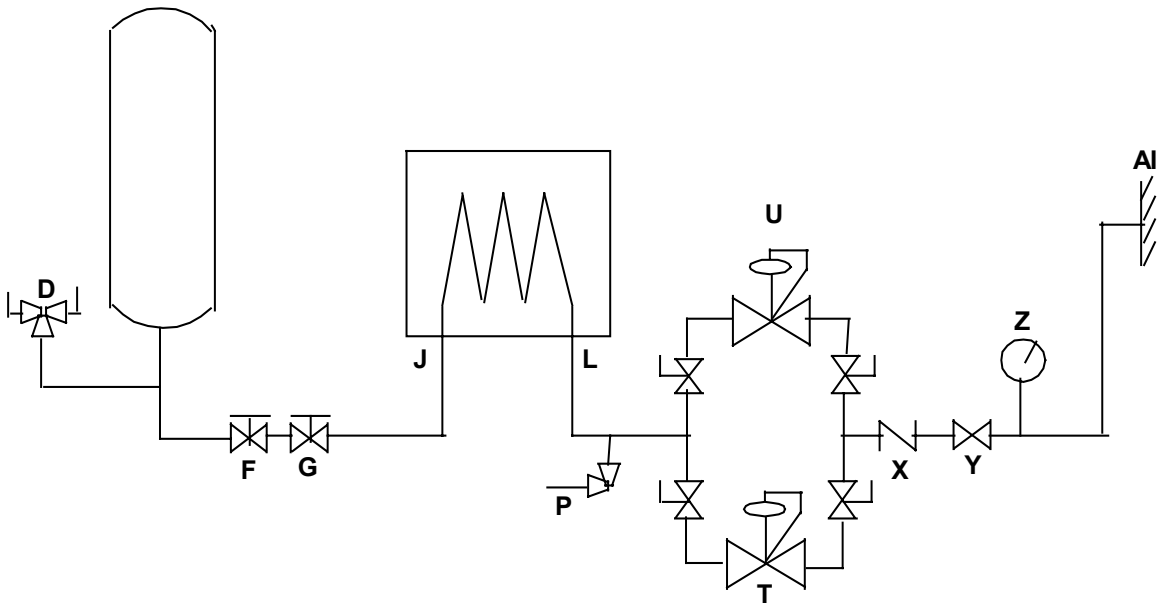
*Figure D-1 System Schematic*

A = liquid nitrogen vessel outlet

B = reducer and elbow on 3"x2" outlet pipe

C = elbow on 2" pipe (stainless steel ASTM A372 type 316)

D = dual liquid relief valves

E = tie-back support pipe-to-tank

F = first extended stem gate valve, make XYZ, model XYZ, size XYZ, rating XYZ

G = second extended stem gate valve, make XYZ, model WYZ, size XYZ, rating XYZ

H = elbow

I = elbow to vaporizer

K = vaporizer

J = vaporizer inlet flange class 150

L = vaporizer outlet flange class 150

M = gas pipe elbow (carbon steel ASTM A106 Grade B)

N,O = pipe elbow

P = gas relief valve

Q = tee

R,S = elbows, two plug valves, make XYZ, model XYZ, size XYZ

U,T = self-actuated regulators, make XYZ, model XYZ, size XYZ

V,W = elbows, two plug valves, make XYZ, model XYZ, size XYZ

X = check valve, make XYZ, model XYZ, size XYZ

Y = plug valve, make XYZ, model XYZ, size XYZ

Z = pressure gage, make XYZ, model XYZ, reading XYZ psi, scale range XYZ psi

AA = elbow

AB, AD, AE, AF, AH = pipe clamps on two-bolt strut, make XYZ, size XYZ

AI = building penetration

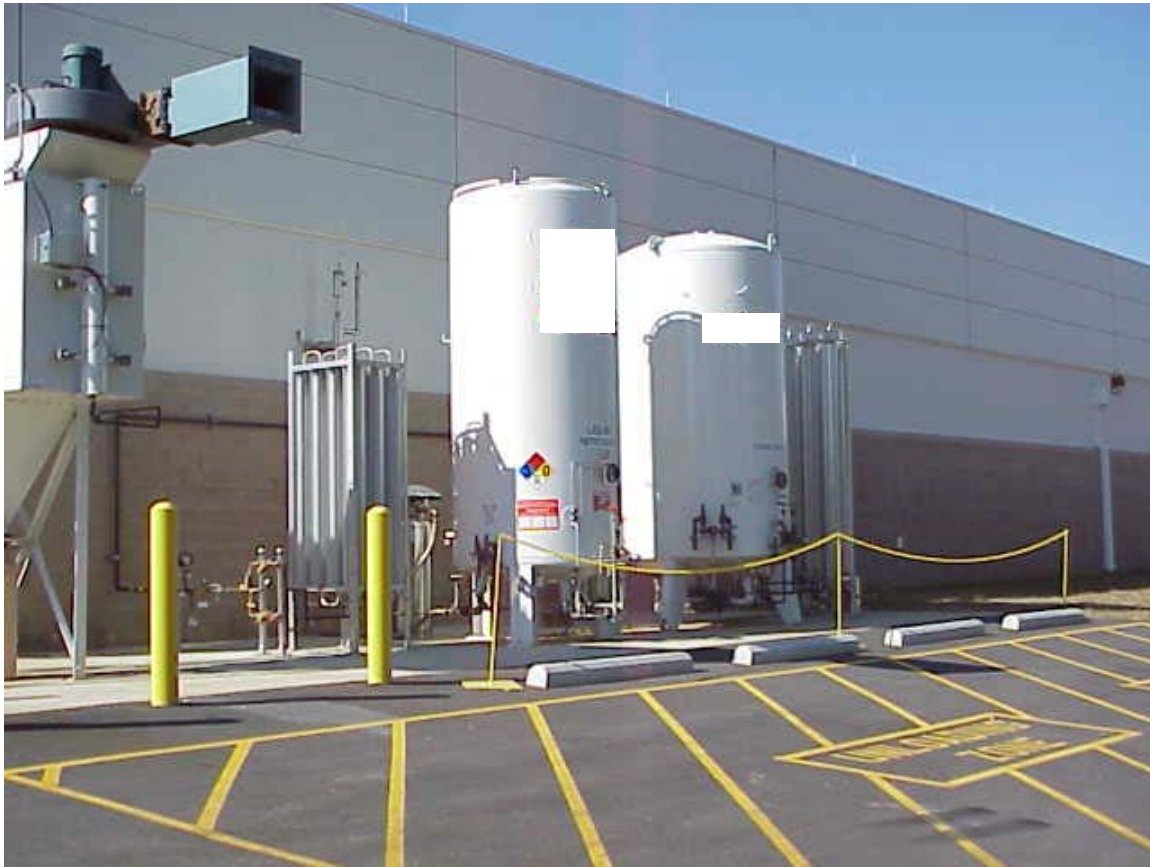
General view of liquid nitrogen vessel (forefront) and vaporizer (left of vessel).

- (1) Per input from XYZ, system maintenance mechanic, date X/Y/Z.
- (2) Per input from ABC, system supplier from experience with same systems, date X/Y/Z.
- (3) Vessel and vaporizer must be evaluated.
- (4) Per input from building analysis, ref. DEF, date X/Y/Z.
- (5) Per geotechnical evaluation ref. DEF, date X/Y/Z.
- (6) The cantilevered pressure relief valves at location C weigh 30 lb each. To be evaluated.
- (7) Two potentially credible and significant spatial seismic interactions have been identified: The building block wall, and the second vessel. They need to be evaluated.
