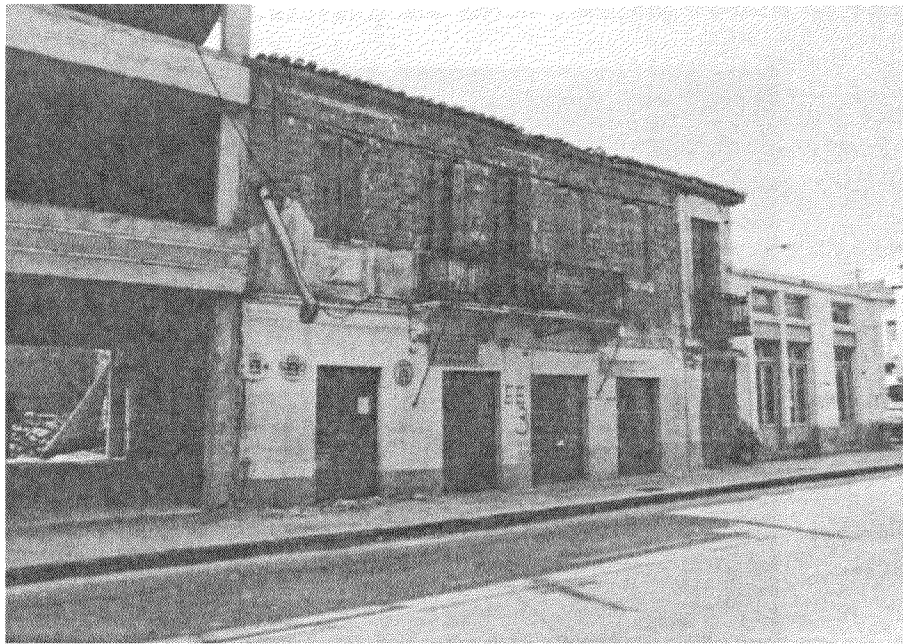
FIG. 13

In Fig. 12 through 14 other damages of two storied earthen buildings are shown after the recent earthquakes in the city of Kiaton. These buildings have suffered several strong earthquakes. Most of them have not been repaired during the last 50 years.

Old earthen building near the sea shore. The separation of the mortar is typical.

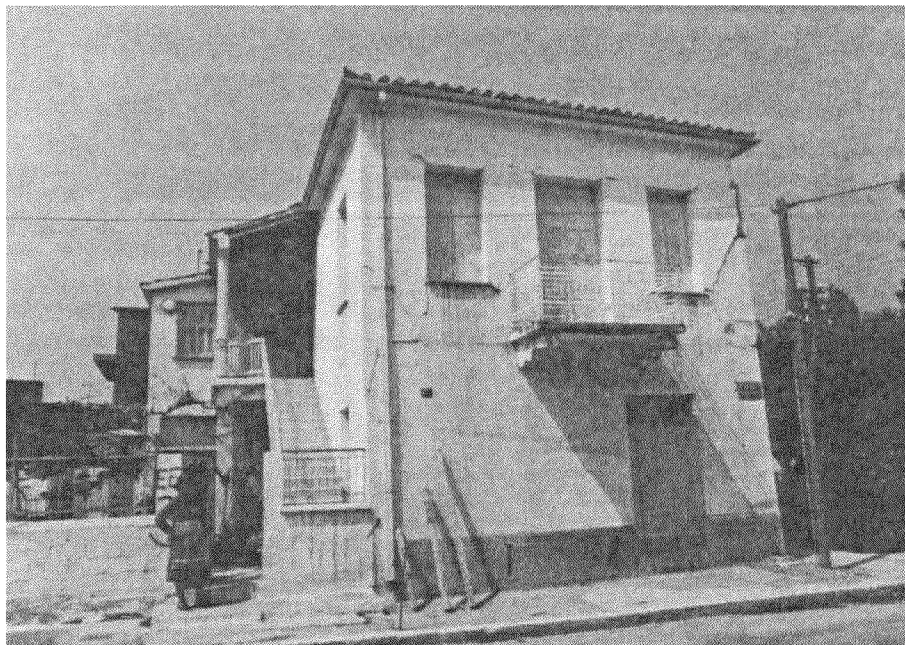
FIG. 14

A two storied earthen building, 100 years old. This building has suffered at least 3 strong earthquakes, while it was not repaired after the second one.
