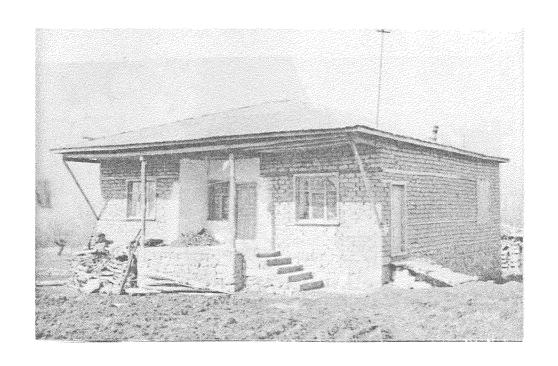
FIG. 1 A WELL - BUILT ADOBE HOUSE (Erzincan, Üzümlü town, Feb. 1978, Turkey)

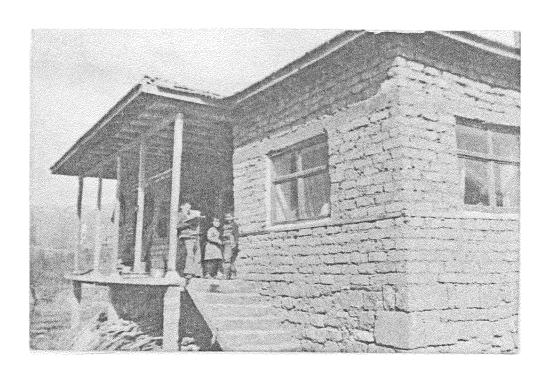
FIG. 2 A WELL - BUILT ADOBE HOUSE

(Erzincan , Üzümlü town , Feb. 1978 , Turkey)

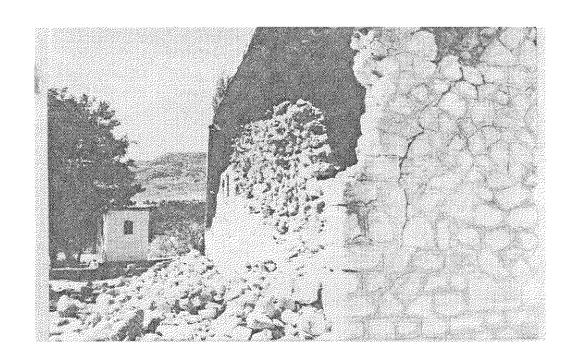
FIG. 3 INADEQUATE BOND BETWEEN TWO STONE LAYERS (Sept. 6,1975, Lice Earthquake, Turkey)

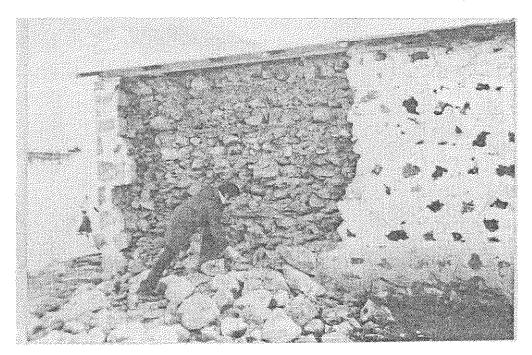
FIG. 4 INADEQUATE BOND BETWEEN TWO STONE LAYERS (March 1976, Susuz Earthquake, Turkey)
