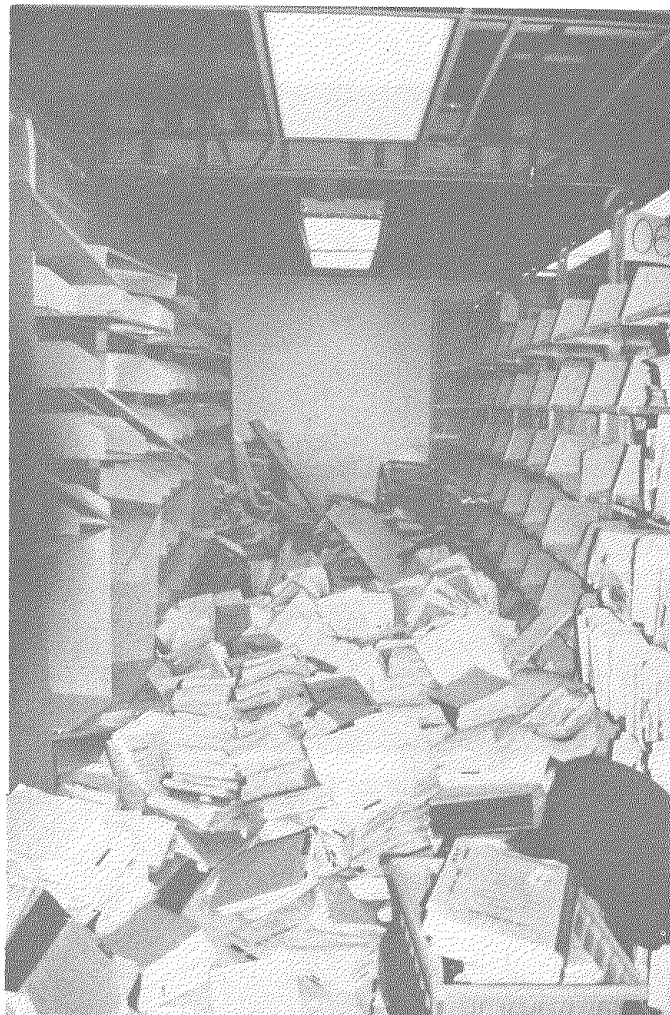
Fig. 35 Overturning of files at basement and nonstructural damage of gypsum boards in roof.
