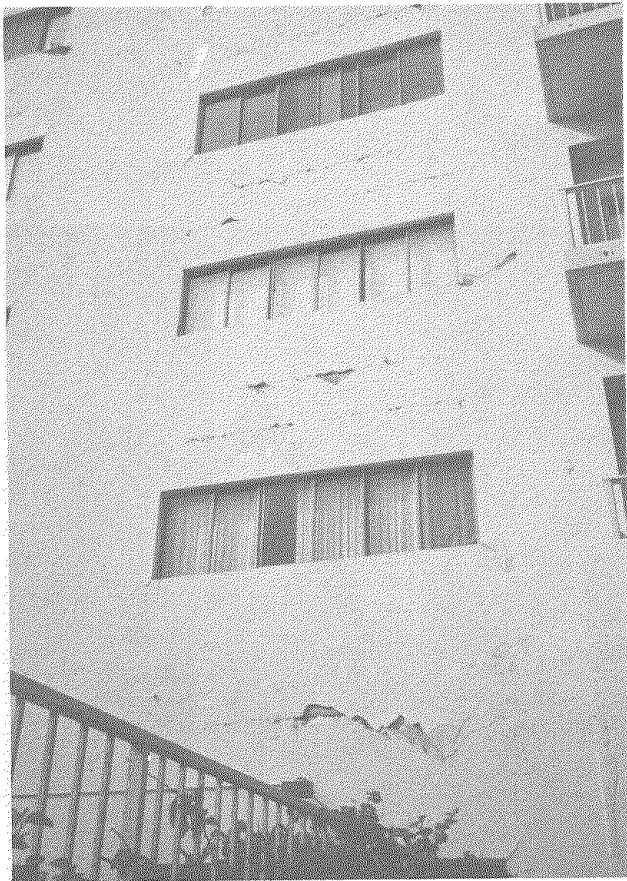
Fig. 45 Damage along construction joints, probably due to bond distress.

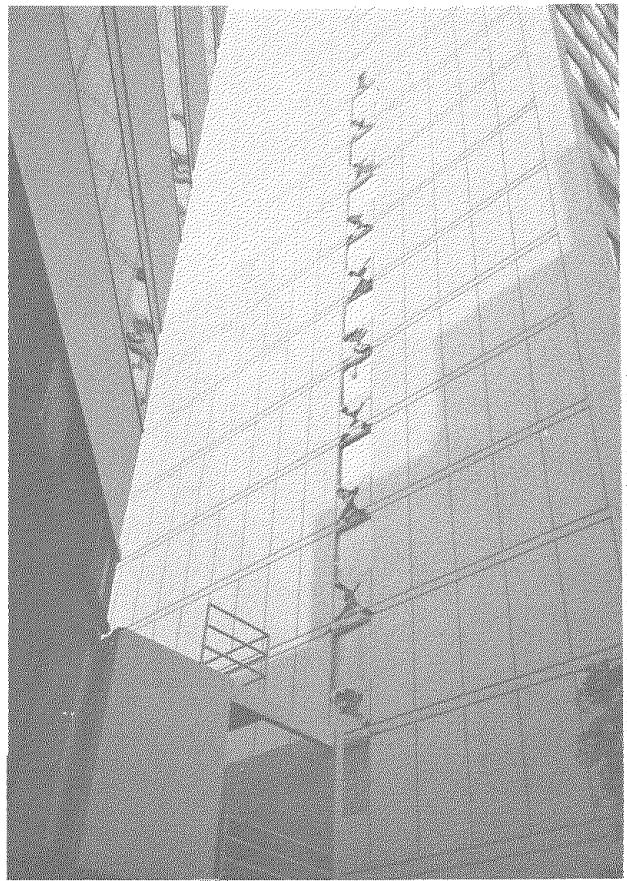
Fig. 46 Diagonal tension failure of coupling beams.

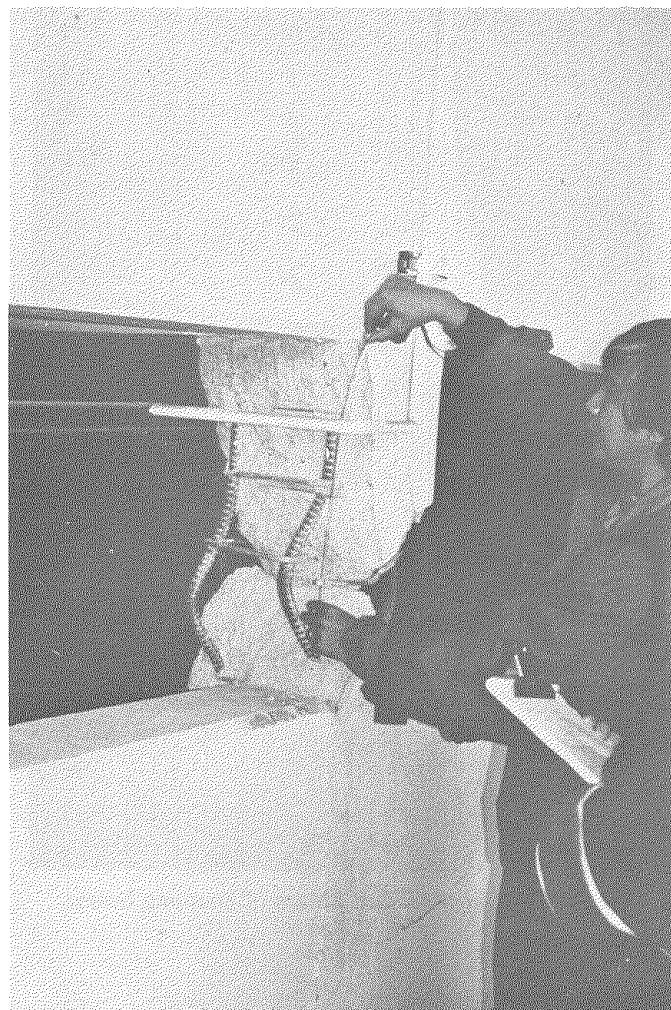
Fig .47 Short column shear failure.
