Evaluating Quito's Schools

Quito

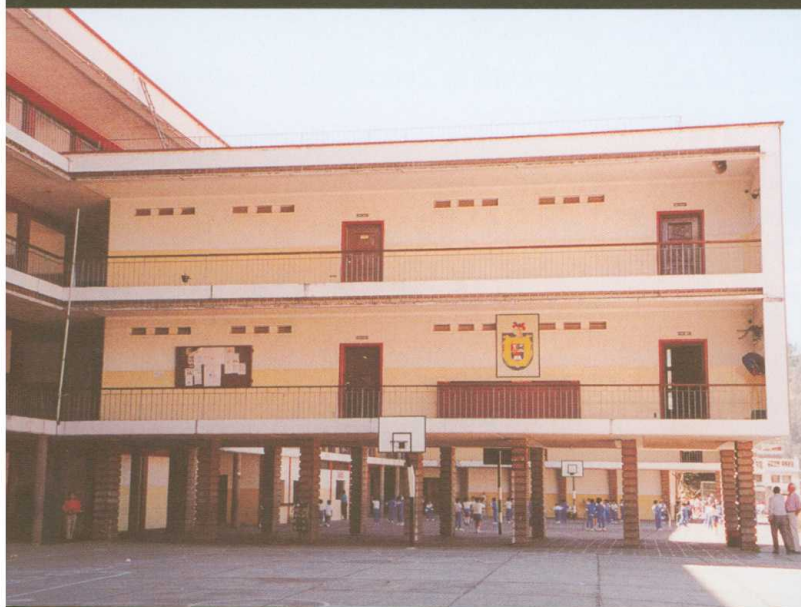
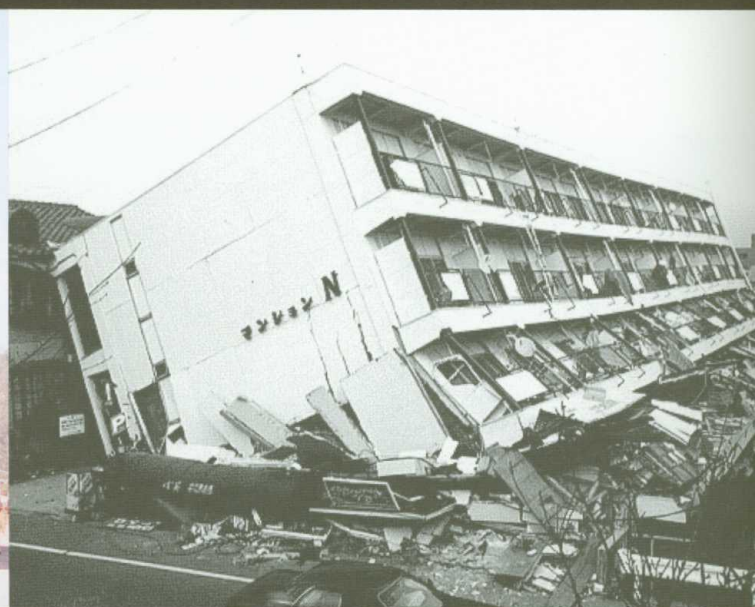
"SOFT" FIRST STORY

Two common structural deficiencies are “soft” stories (such as stories without infill walls) and “short” columns (columns effectively shortened by partial infill walls). Shown are examples of each in Quito schools, and an earthquake-damaged building that had a “soft” first story.
