Retrofit Design Detail

Location: Various locations throughout Ecuador

Prevalent Materials: Reinforced concrete

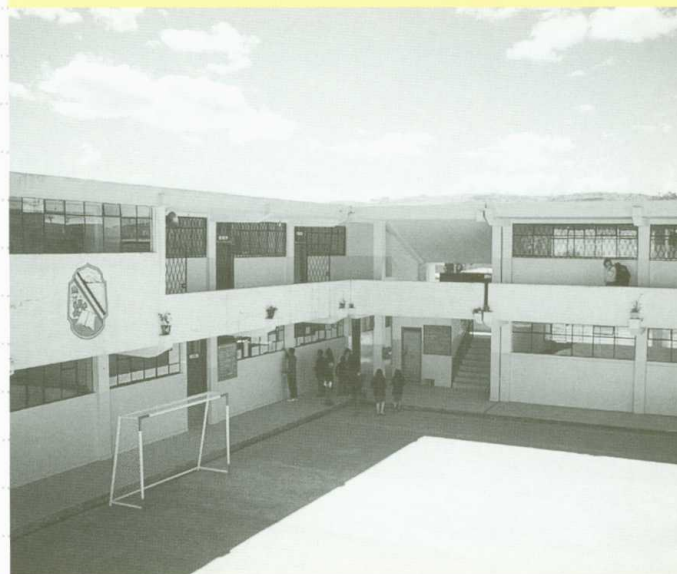
These reinforced concrete school modules are connected in various configurations to form one school building. Rectangular columns are used to form longitudinal and transverse frames. Infill walls are made up of clay bricks or cement blocks with vertical reinforcing columns. Depending on soil characteristics, the foundations are made of reinforced concrete individual or continuous spread footings. Stair shafts are usually located at the corners of adjacent modules.

Retrofit solutions for the most common deficiencies were developed. In general, the retrofit designs call for increasing the stiffness of the longitudinal walls and reducing the number of short columns by filling in some of the window openings, providing separation between columns and infill walls, and improving construction details.

Because of the modular method of construction, these buildings lack stiffness in the longitudinal direction. Window and door openings in the longitudinal direction create short columns. Design details are inadequate. For example, improper construction joint details between blocks often result in rainwater leakage. In regions of the country with high humidity or frequent rain, the first floor is typically built with large openings in the walls, creating a potentially dangerous soft-story condition. Modules are frequently altered after construction, sometimes creating additional hazards.
