Fig. 6 ILLUSTRATION OF DAMAGE TO A PRECAST CONCRETE FRAME BUILDING DUE TO POOR DETAILING AND WORKMANSHIP (EERI SLIDE LIBRARY)

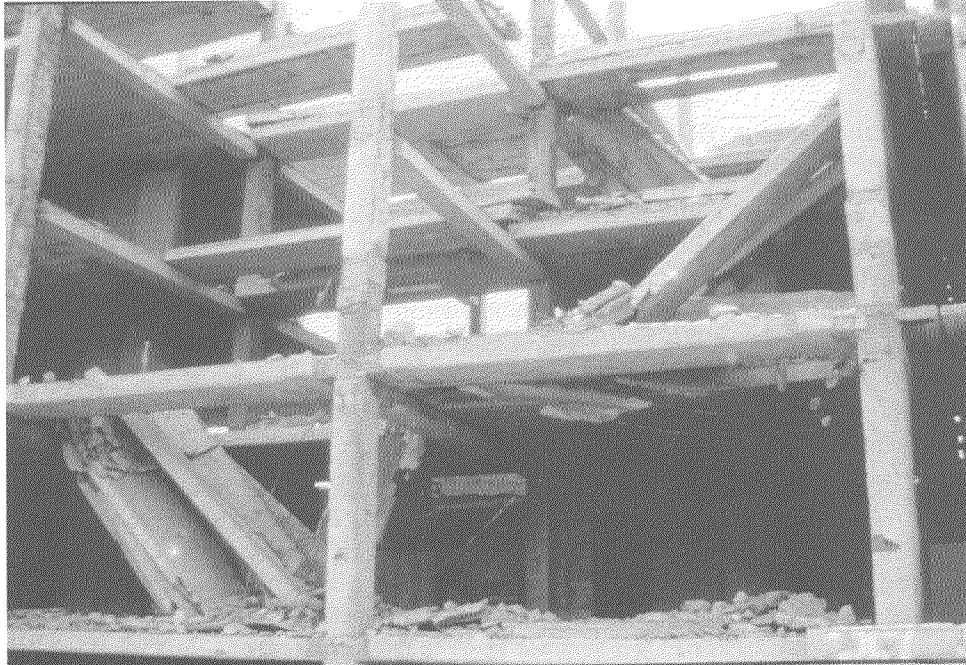
Fig. 6 (a) Collapse of a precast-concrete frame structure due to failure of poorly-connected precast elements

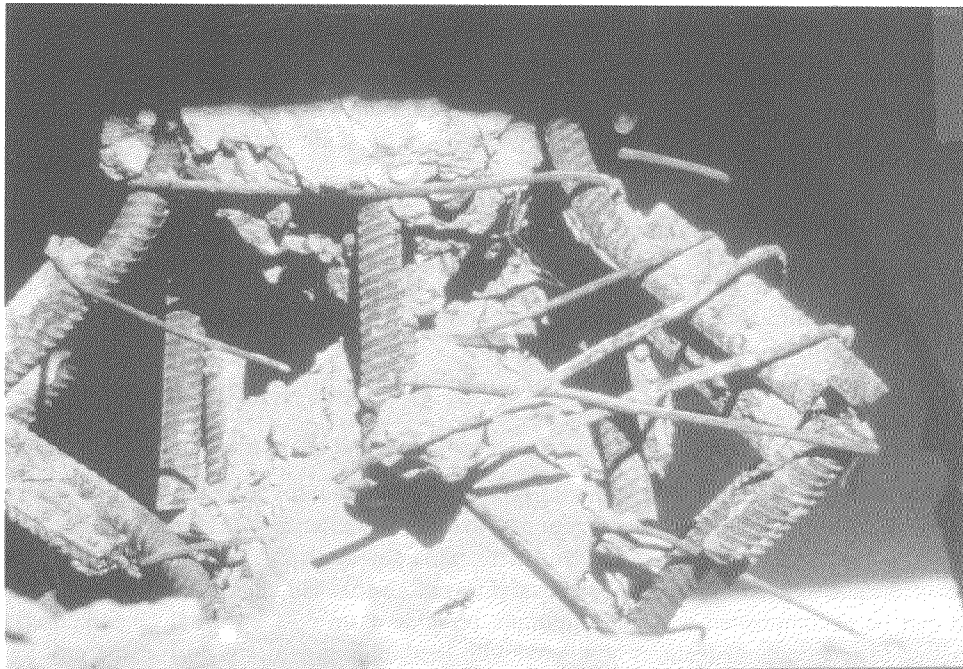
Fig. 6 (b) Failure of column-splice due to poor detailing and workmanship of ties and welding of main bars
