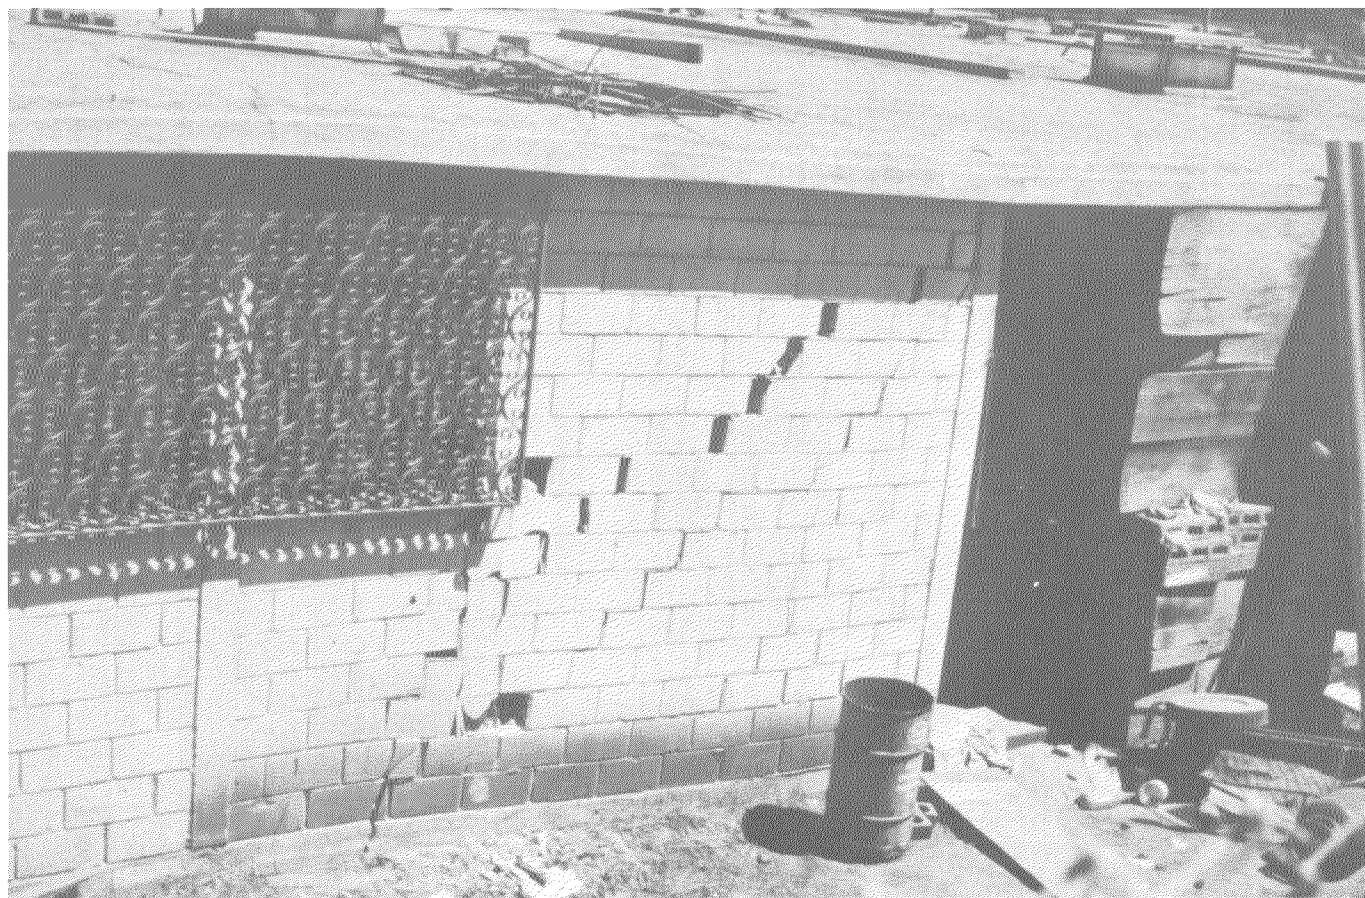
FIGURE 32.—Fault damage to the rear exterior wall and roof of a house in Guatemala City. Vertical displacement near the front of the house was 12 cm.
