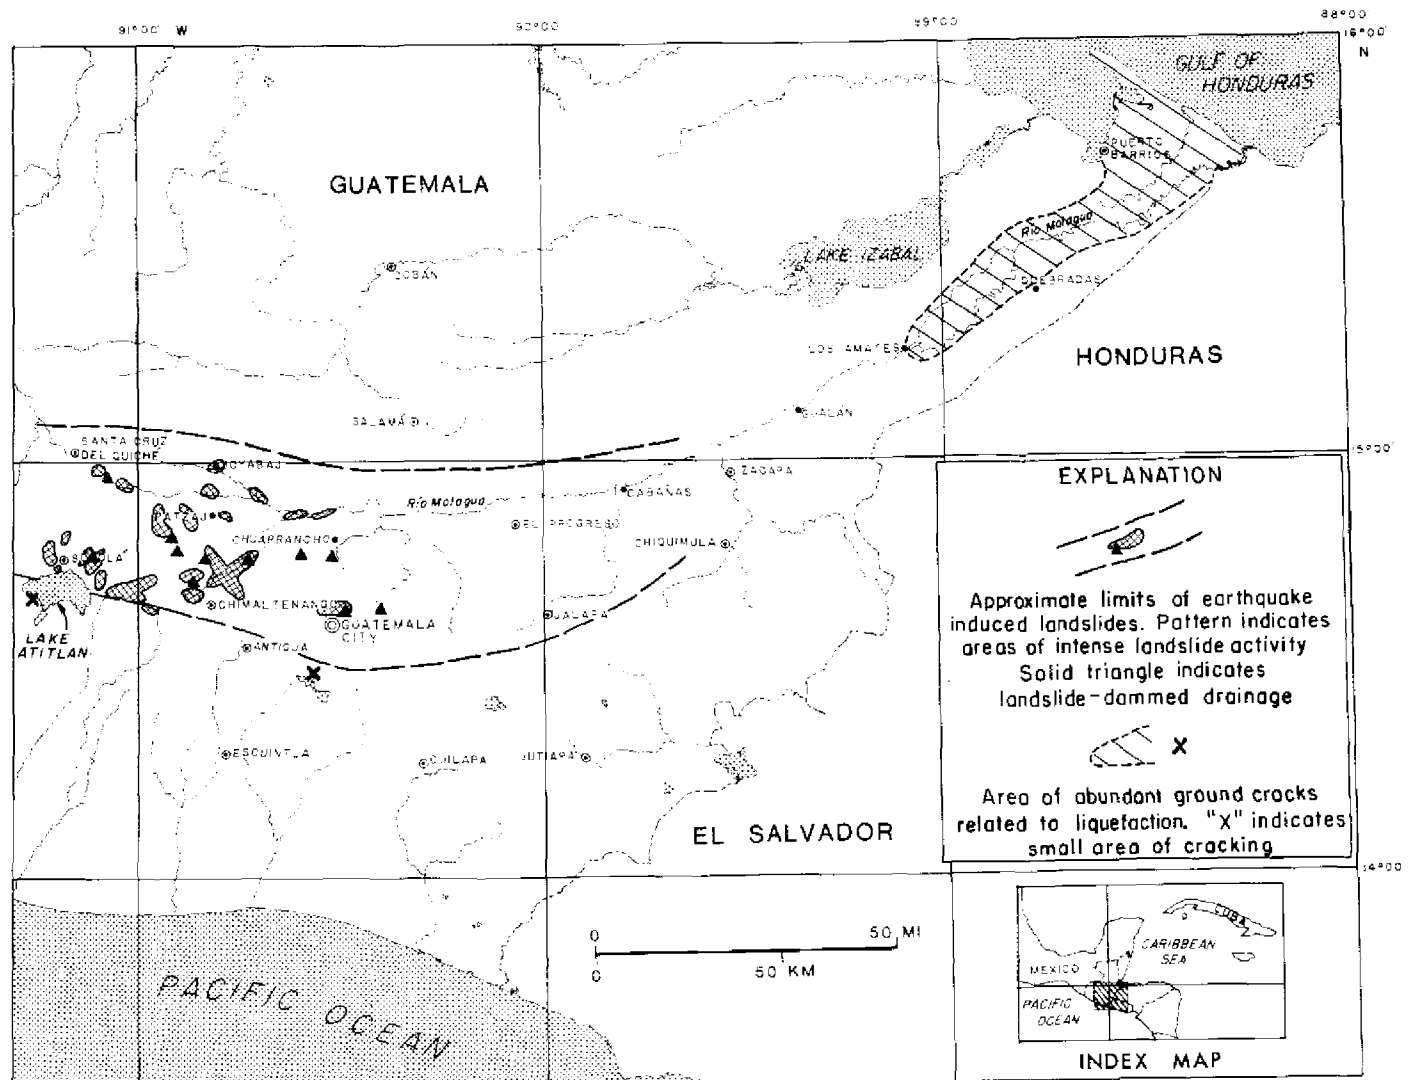
FIGURE 33.—Areas of earthquake-induced landslides and of ground cracks probably related to liquefaction of unconsolidated deposits. Landslide distribution is from a preliminary study of post-earthquake aerial photographs by Edward Harp, Ray C. Wilson, and Gerry Wieczorek of the U.S. Geological Survey.

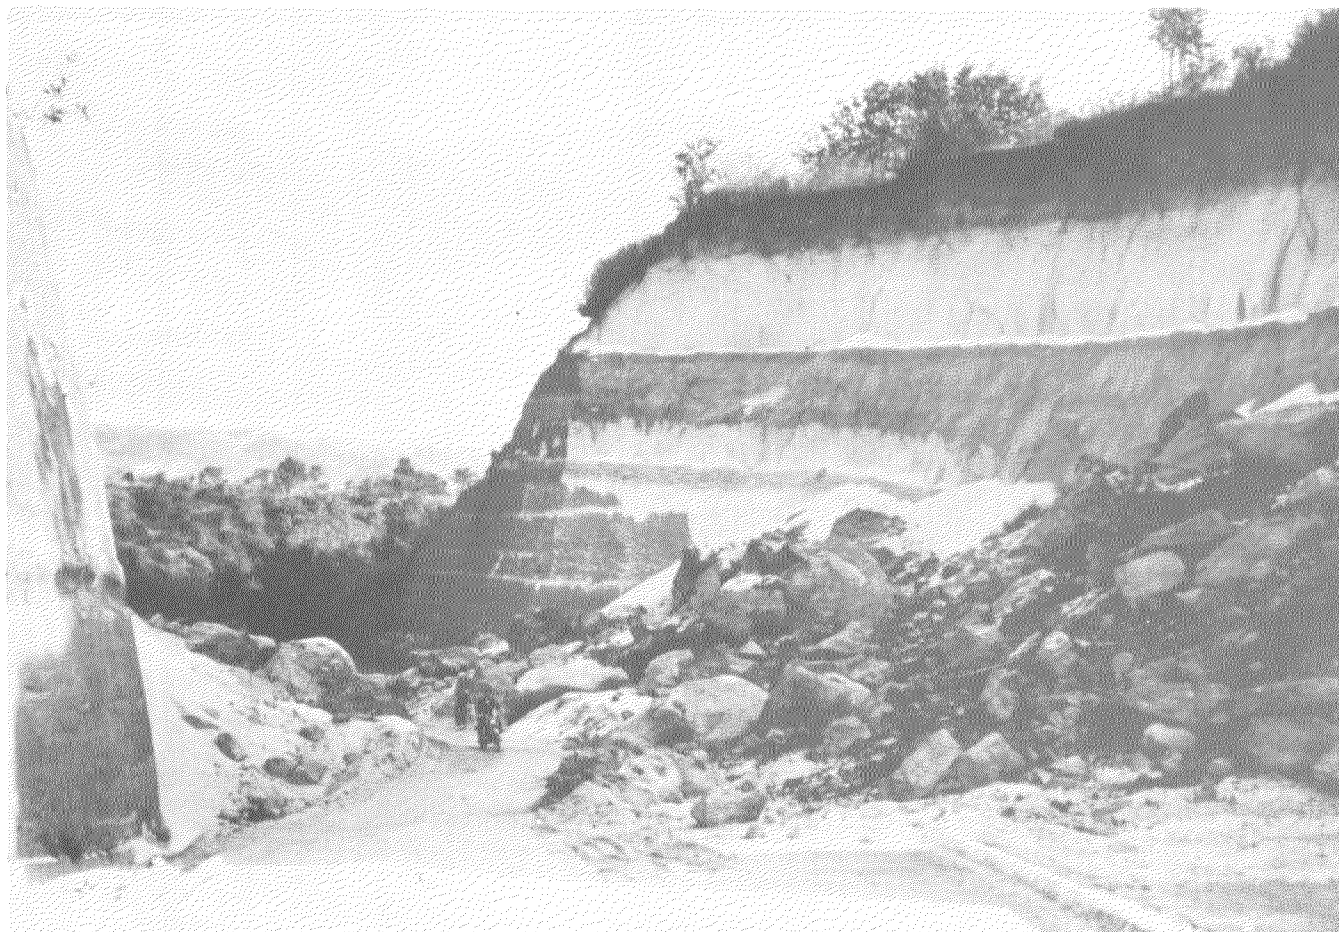
FIGURE 34.—Landslides in steep road cut in stratified pumice and ash deposits at San Cristobal, west of Guatemala City.

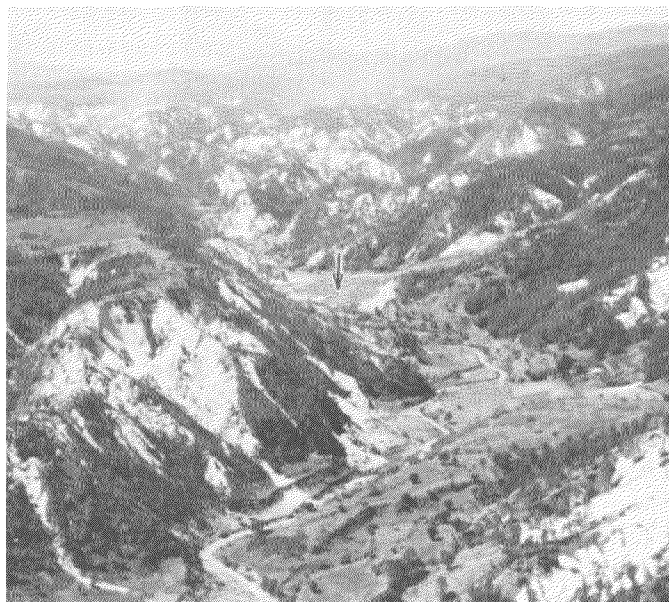
FIGURE 35.—Aerial view looking northeastward along Río Pixcayá, due north of Chimaltenango, showing numerous landslides in pyroclastic deposits. The river was partially dammed by a major landslide, shown by arrow in the middle distance. (Also see fig. 37.)

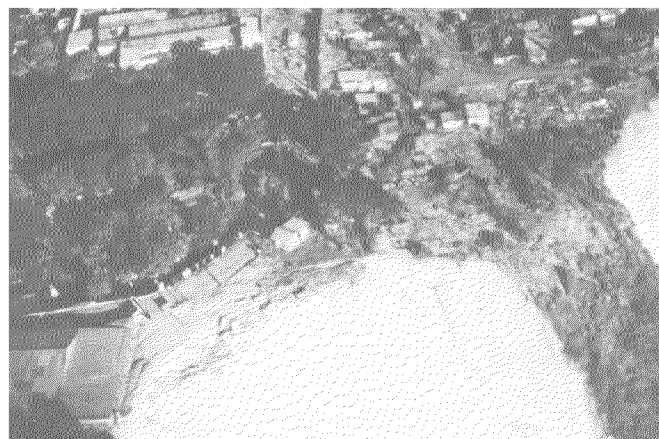
FIGURE 36.—Aerial view of landslide in pyroclastic deposits near the edge of a steep-sided gully (barranco) in Guatemala City. Slides such as this (as shown by arrow) and their associated headwall cracking caused extensive damage to homes, roads, and other facilities in the northern part of the city.
