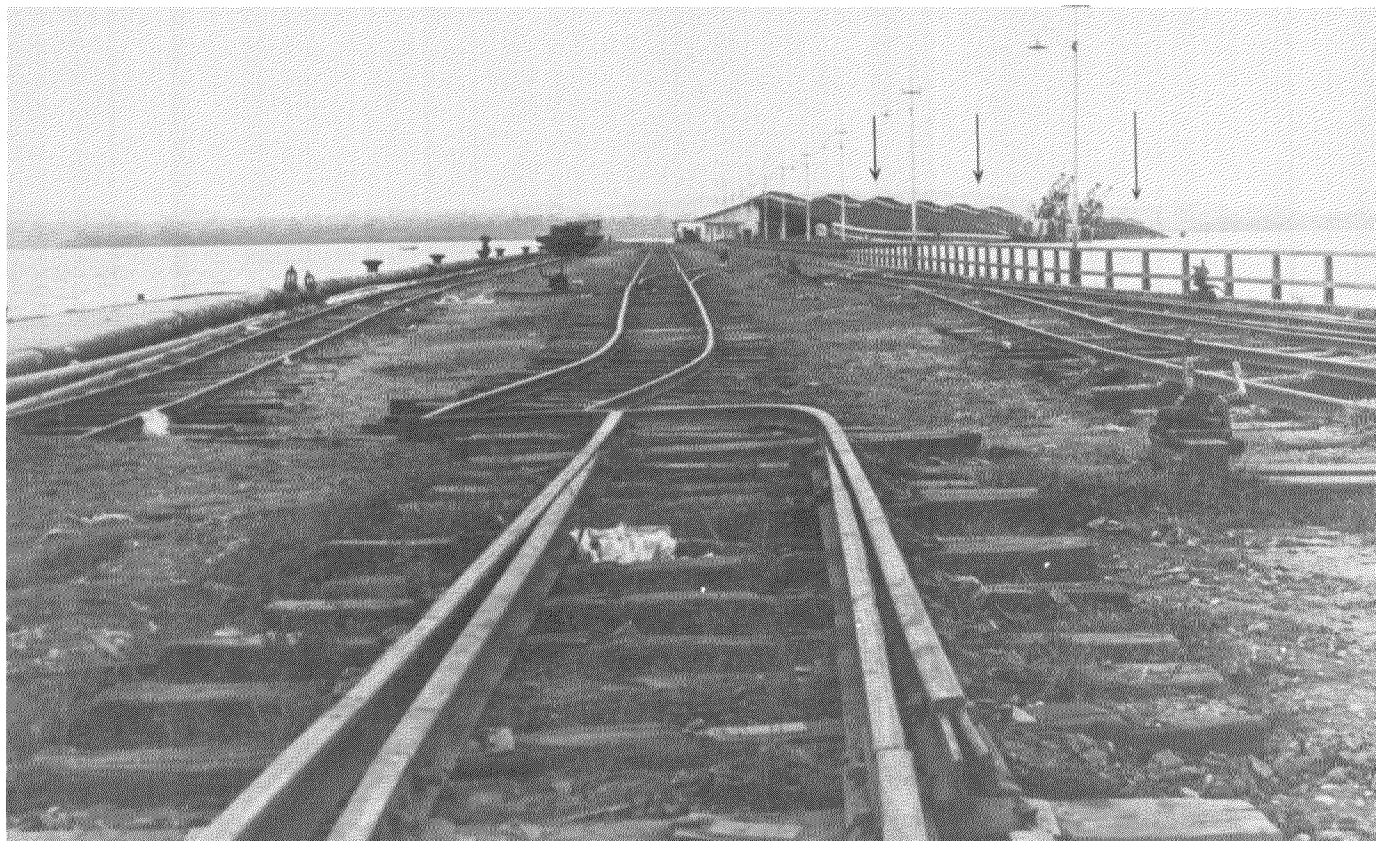
FIGURE 47.—Puerto Barrios wharf, Department of Izabal, destroyed by February 4 earthquake. Arrows show large warehouse partially submerged. See figure 40 for location of town.

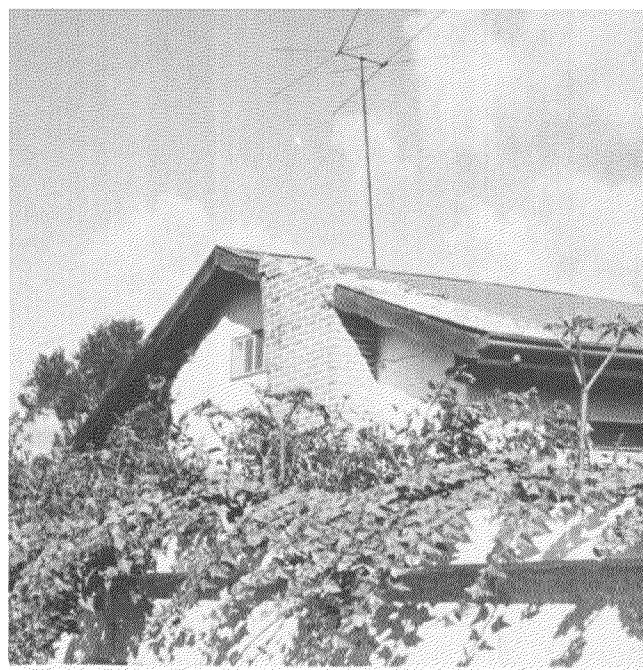
FIGURE 48.—Chimney collapse from a one-story house in Guatemala City, Zone 11.
