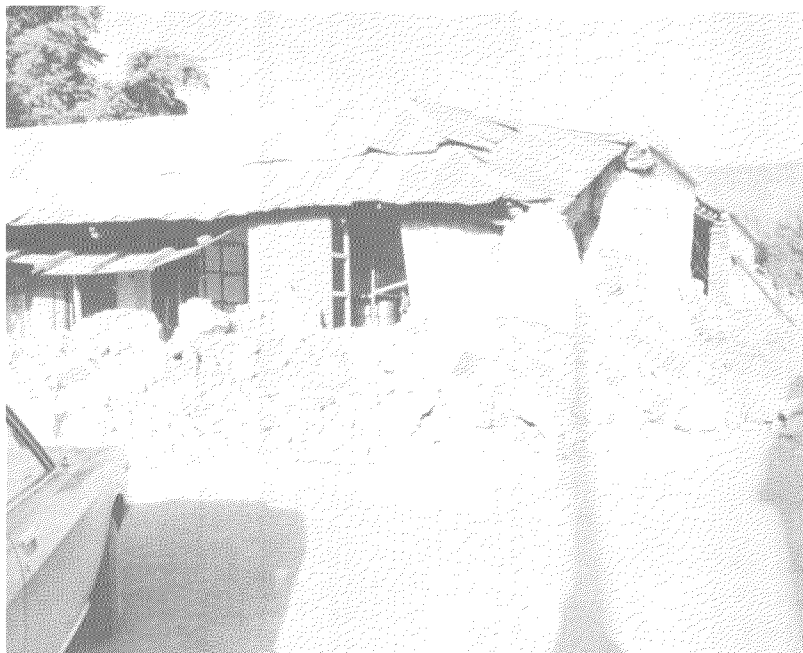
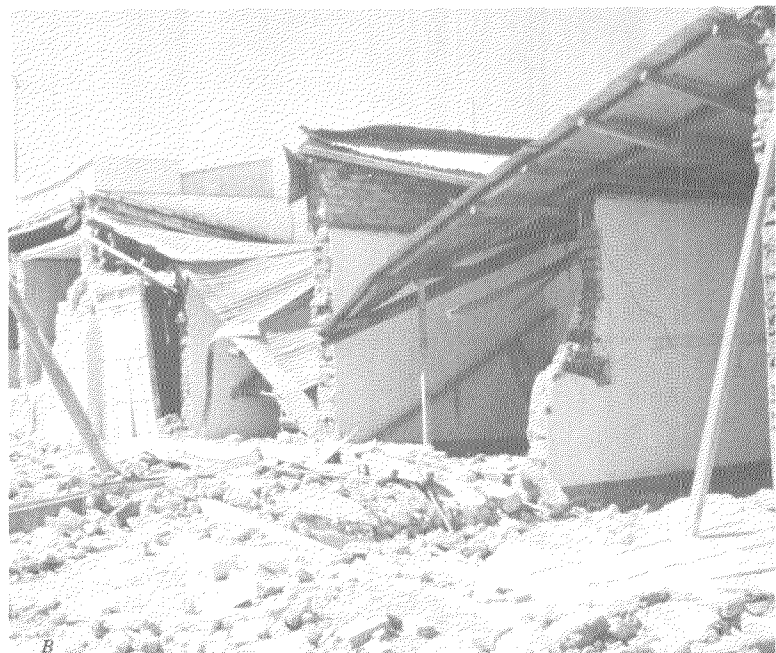
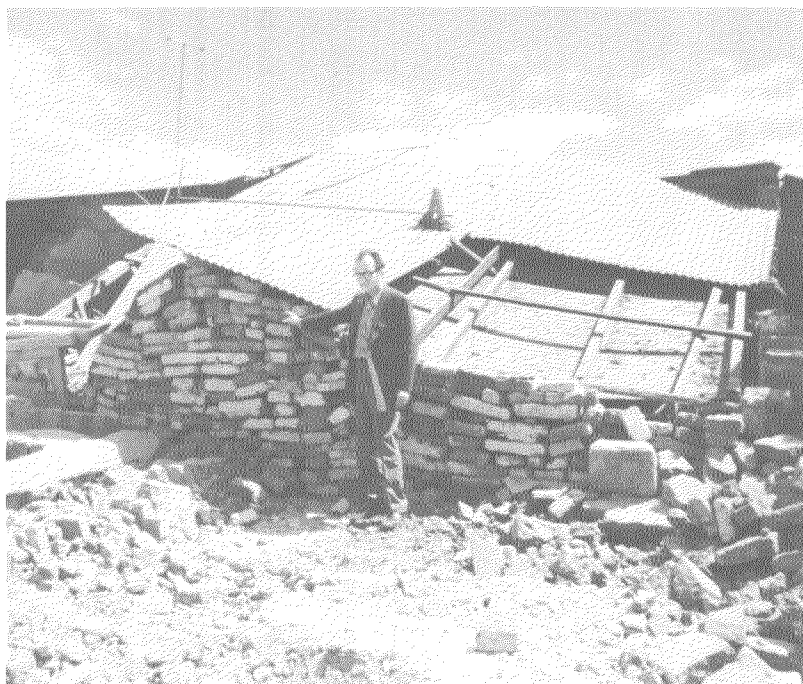
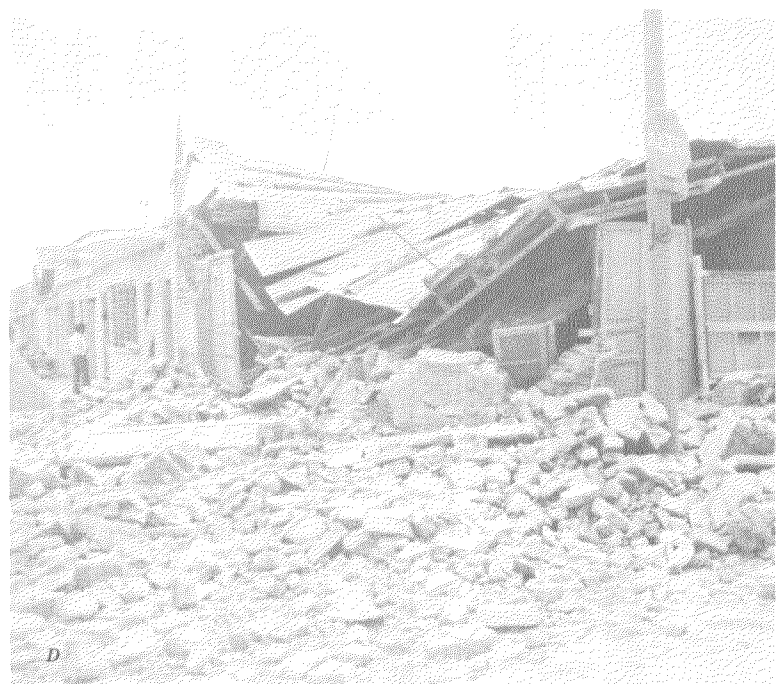
FIGURE 69.—*A*, Massive destruction of some adobe houses in Antigua, Guatemala, near the center of town. *B*, Large-scale destruction of adobe houses in Guatemala City, Calle 2 and Avenida 9A (Zone 2). *C*, Collapse of adobe houses in Guatemala City, Calle 22A and 34 Avenida (Zone 5). *D*, Collapse of adobe houses in Guatemala City, Calle 22 and Avenida 32 (Zone 5).
