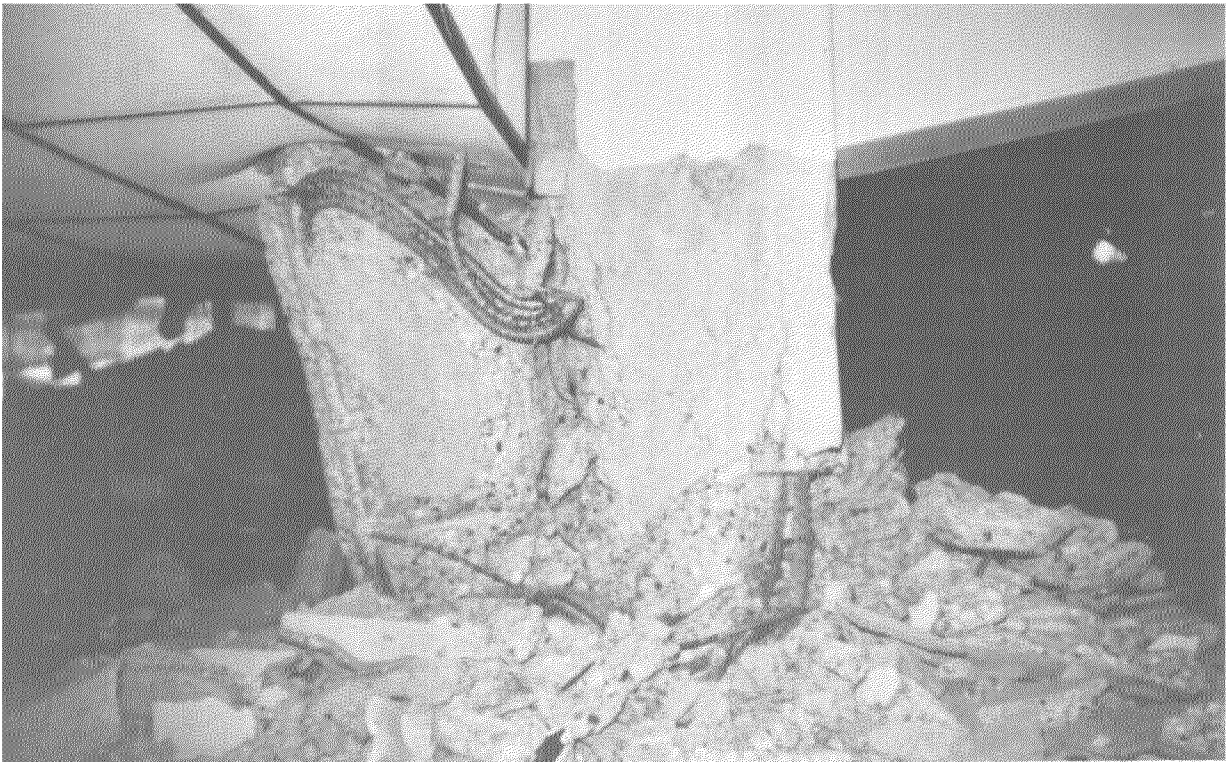
FIGURE 74.—Typical collapsed column in Hotel Terminal

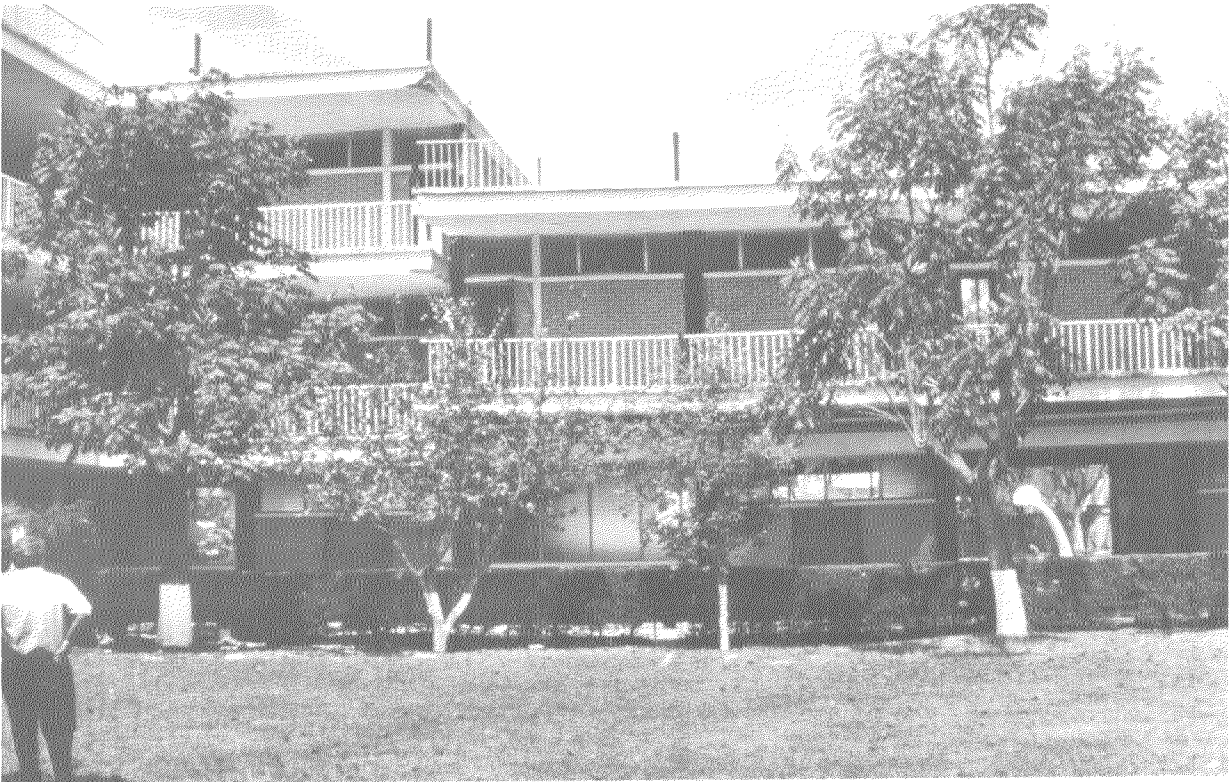
FIGURE 75.—Collapsed second story in one unit of the Catholic Boys School in Guatemala City. Roofs were originally at the same level.
