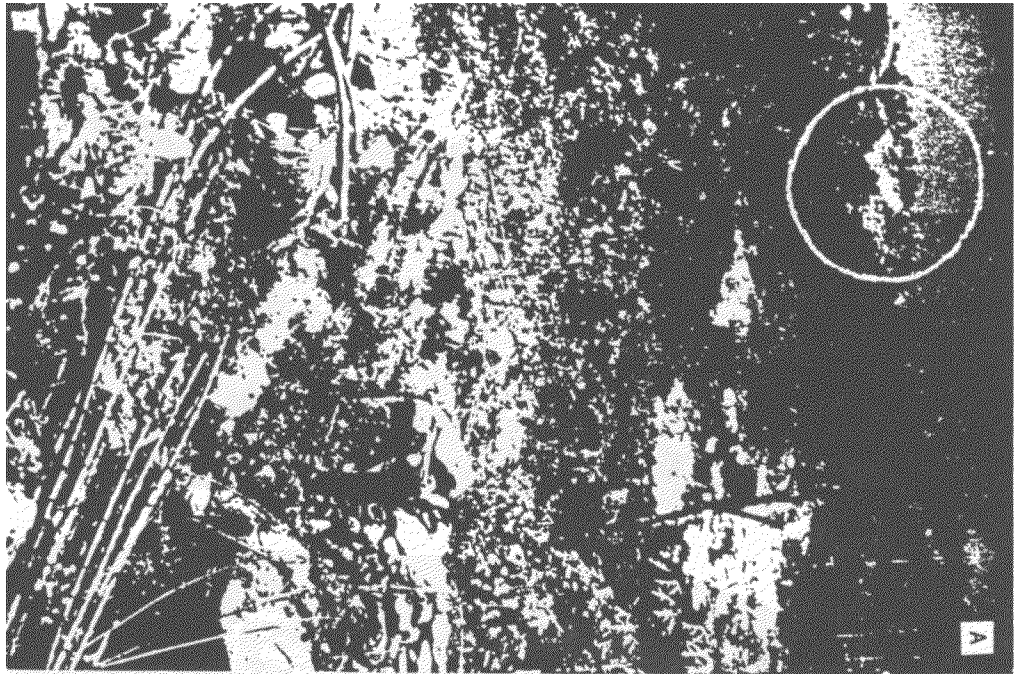
Photo 4. (A) The debris flow at Atalugankanda (Kegalle District). Encircled area shows that earth and rock have flowed from top of the ridge. (B) Future falls will threaten the houses at the foot of the ridge.
