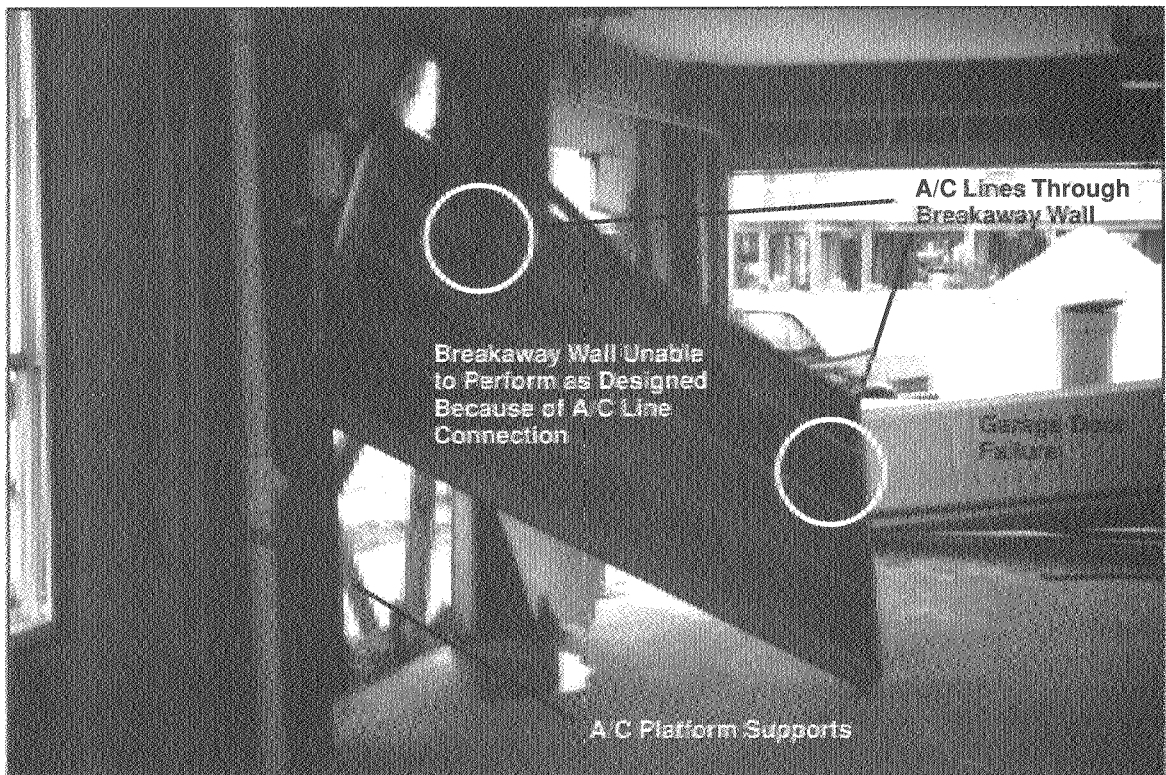
*Figure 2-13 Interior view of breakaway wall blocked by air conditioning unit and support platform (see Figure 2-11). Electric and cooling lines were extended through the breakaway panel.*

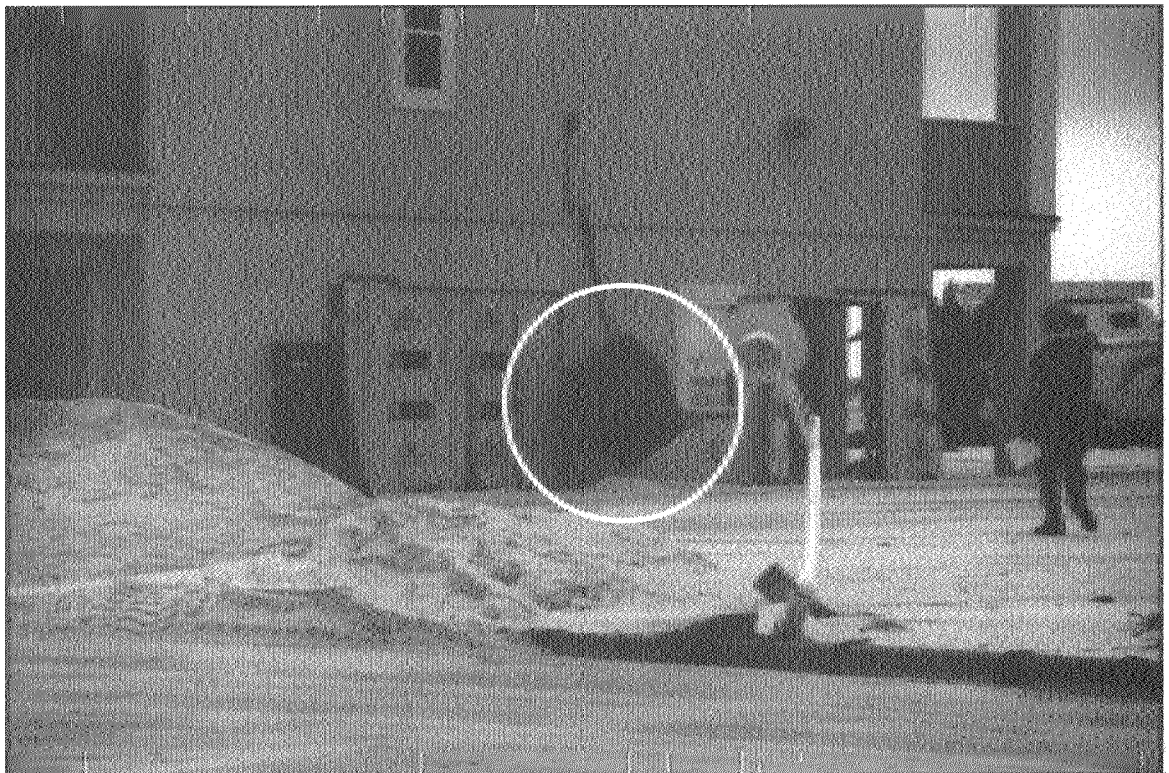
*Figure 2-14 These breakaway panels functioned as designed. Note the loss of the air conditioning unit platform.*
