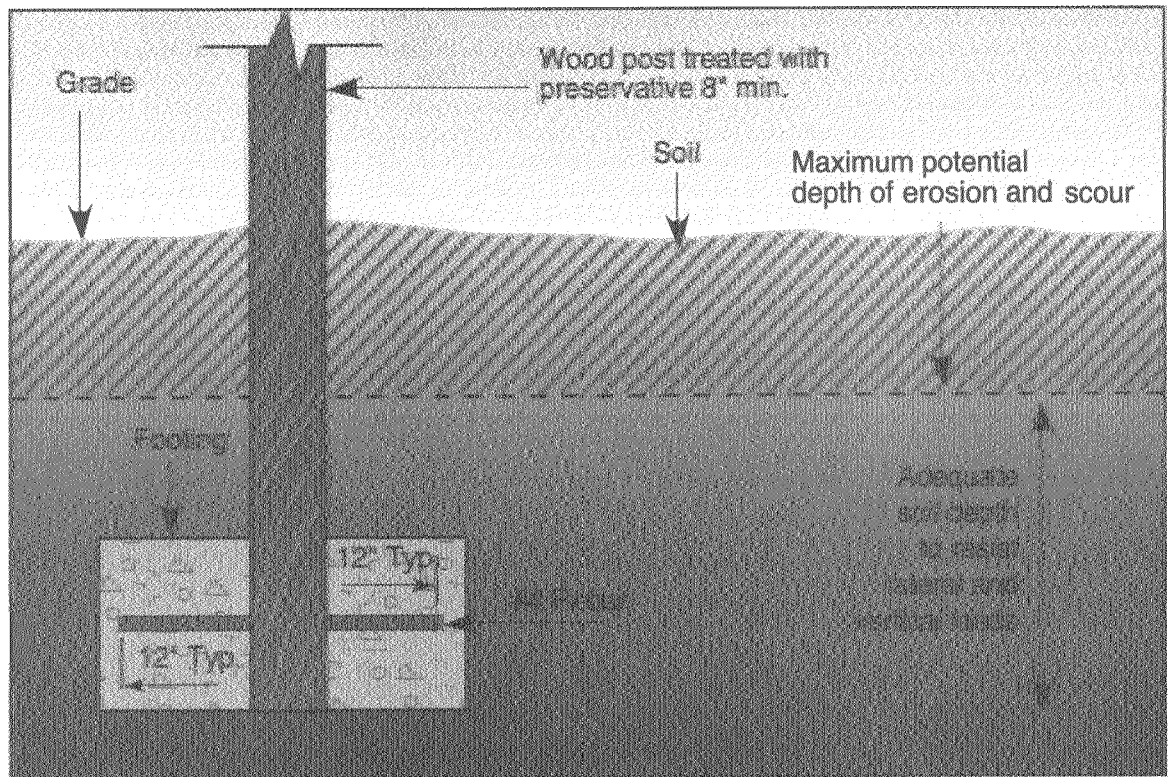
*Figure 3-6 Anchorage of post. Soil depth below maximum potential depth of scour is adequate to withstand lateral and vertical loads during the base flood (after FEMA 1993a).*
