5. EARTHQUAKE EFFECTS ON TRANSPORTATION FACILITIES

5.1 Effects on Railroads

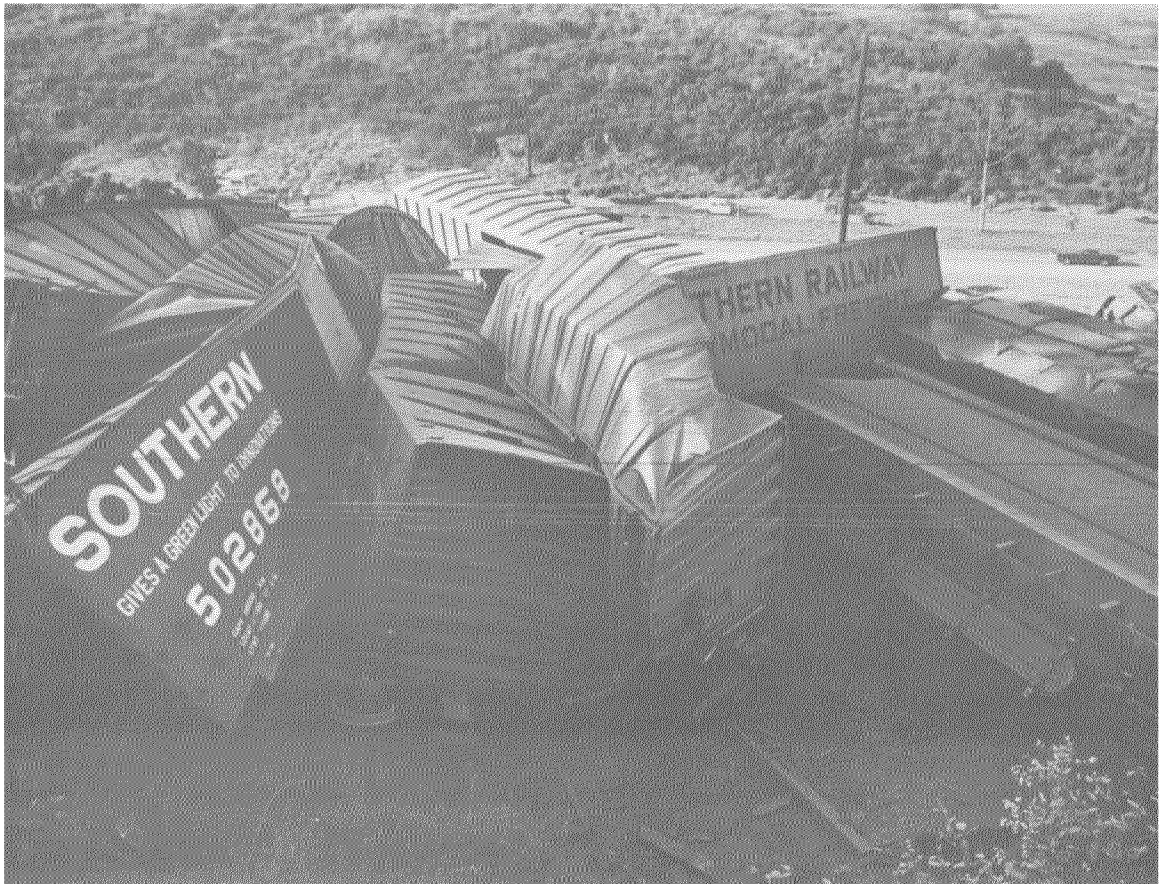
Fig. 5.1 Derailed freight train west of Goleta. View looking north toward highway. (Santa Barbara News-Press photo. Reproduced by permission).

Railway service in Santa Barbara and to areas north and south is provided by the Southern Pacific Transportation Company. The company operates a single track main line in this part of the state. The line parallels the coastline and is used for both freight and passenger service. As a result of the earthquake, a major freight train derailment occurred along this line in an unpopulated area at the location shown in Fig. 1.2. The consequent financial loss was one of the largest single losses resulting from the earthquake. The freight train was north-bound enroute from Los Angeles to Watsonville. It carried 49 empty cars and nine loaded cars containing non-hazardous freight. The train was rounding a curve at about 50 mph when the derailment occurred. The engineer reported that following the earthquake he saw a "kink" ahead in the tracks but that the train could not be stopped in time. Subsequent investigation showed that the kink may have been a result of roadbed fill failure. The south-bound evening Starlight Amtrak passenger train would have passed the same location an hour later. Damage to the derailed train was estimated to be \$380,000 and damage to the track was set at \$40,000. No injuries resulted from this accident which derailed thirty cars (Fig. 5.1) and sent a pair of wheels flying across U.S. Highway 101 which borders on the track, as seen in Fig. 5.2. The line was reopened to normal train traffic about 24 hours later.

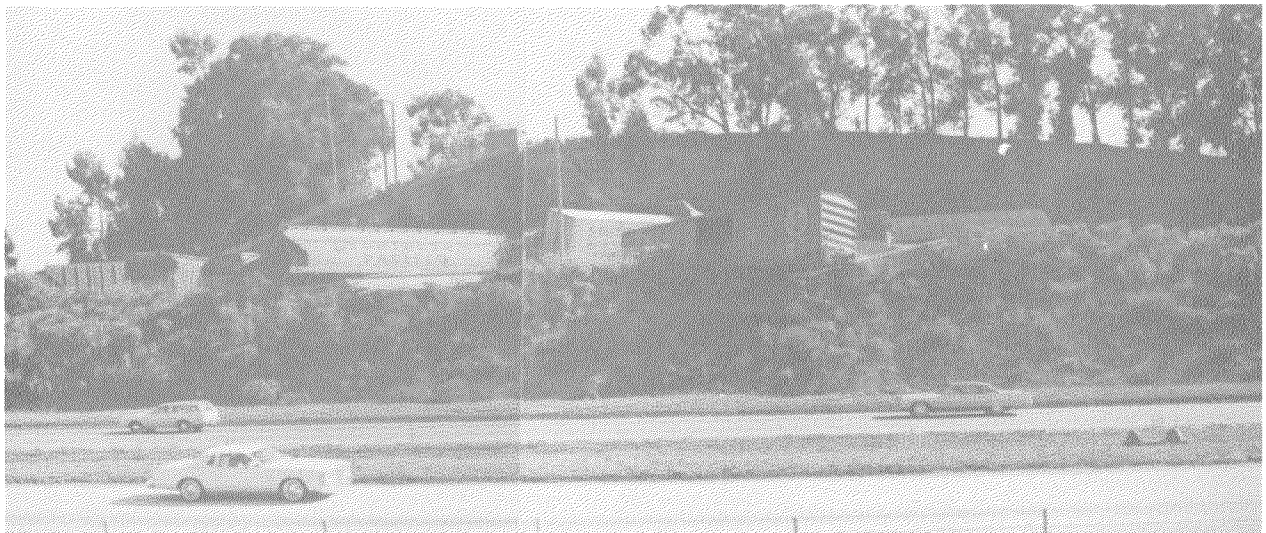
Fig. 5.2 Derailed freight train west of Goleta. (see Fig. 1.2 for location). View looking south across U.S. Highway 101. Note train wheels on highway median.
