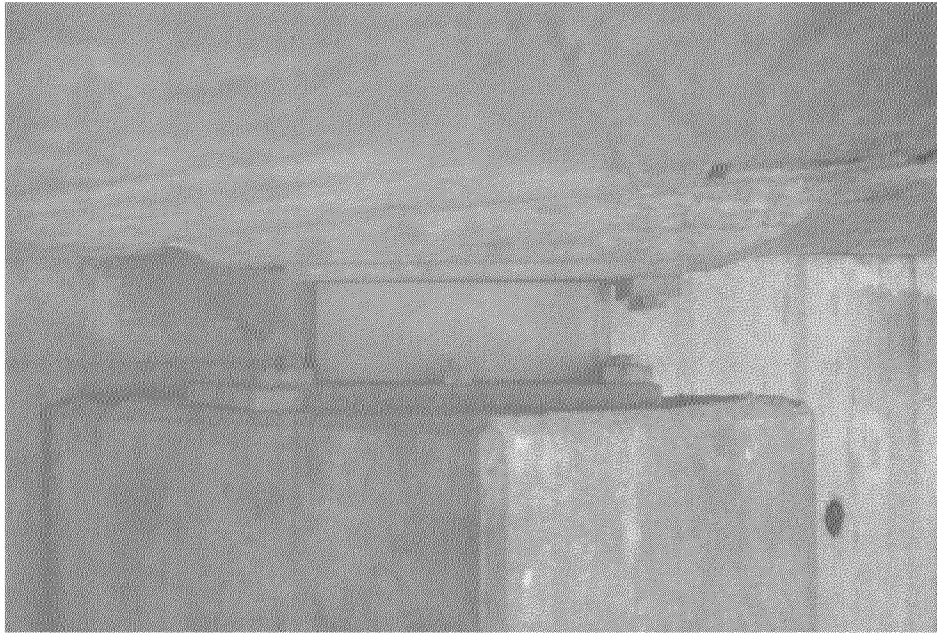
Fig. 5.7 Rocker bearing resting between sole plate above and masonry plate below, with missing keeper plate at top left (eastern end of bearing).

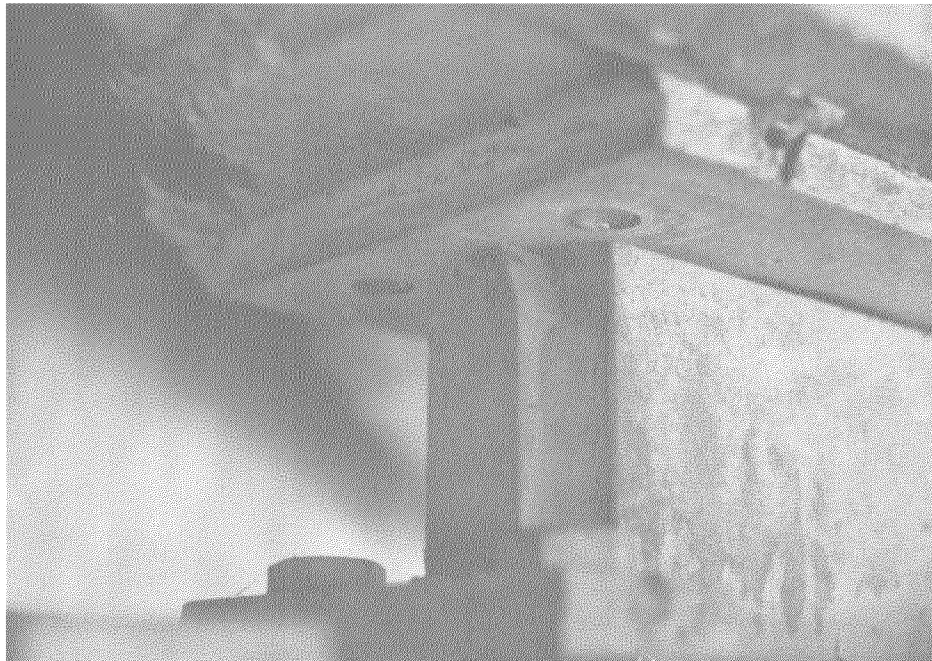
Fig. 5.8 Close-up of rocker bearing showing remnants of sheared keeper plate bolts at top.
