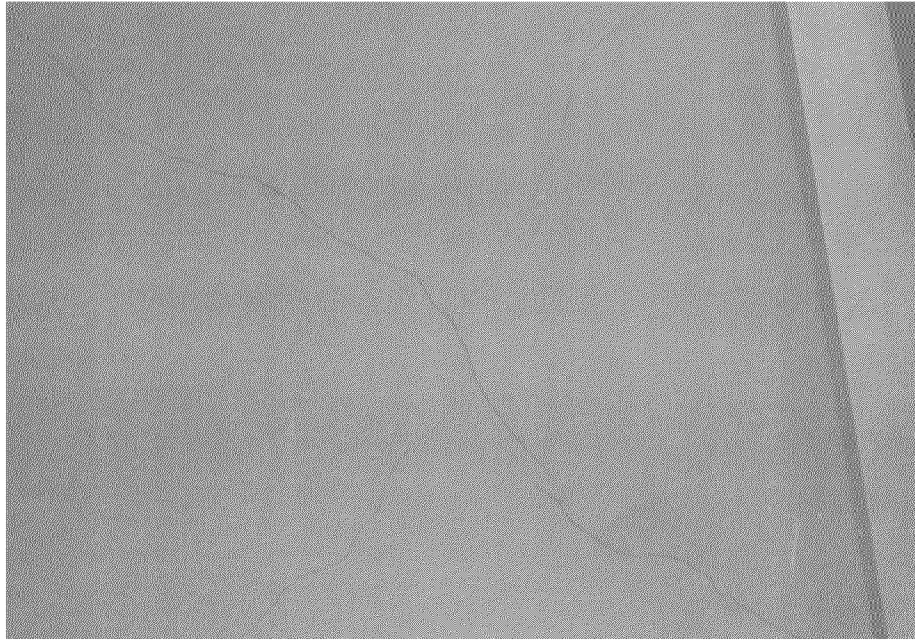
Fig. 7.13 Close up of cracking of shear wall in Fig. 7.12. Orientation is provided by the vertical black-board frame at right.

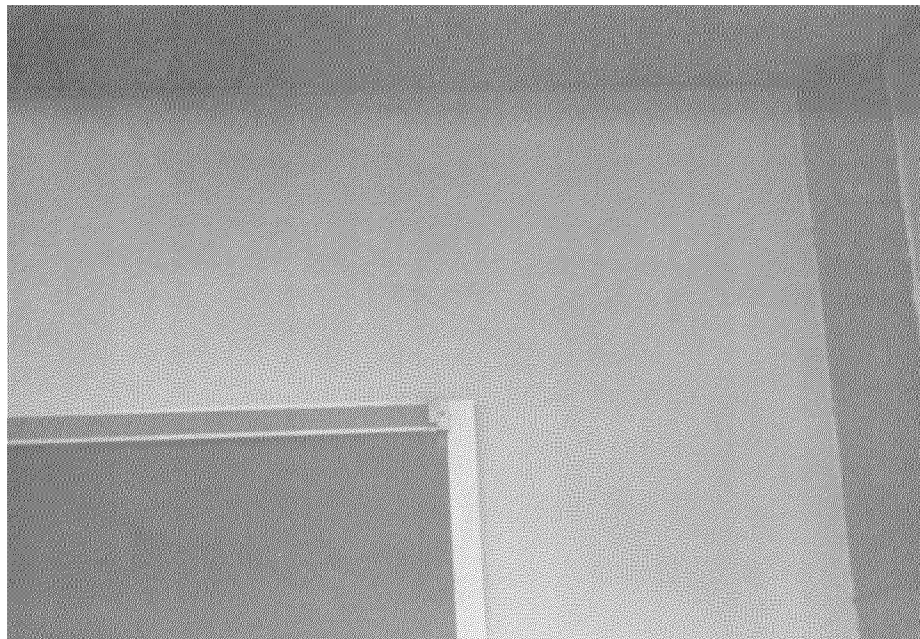
Fig. 7.14 More diagonal cracking of the same shear wall shown in Figs. 7.12 and 7.13.
