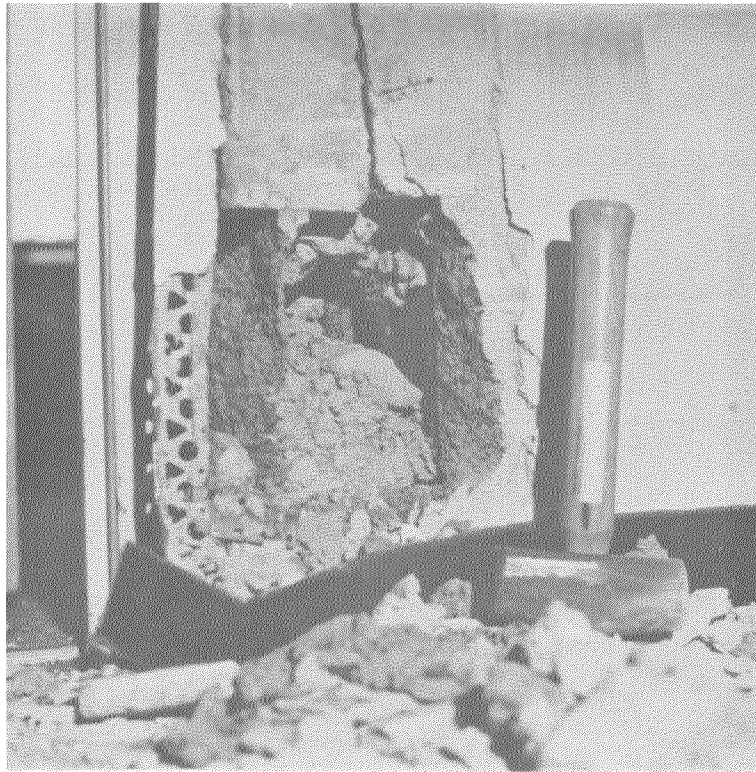
Fig. 7.22 Face of concrete block removed to expose ungrouted reinforcing steel, shear wall in Anacapa Residence Hall.

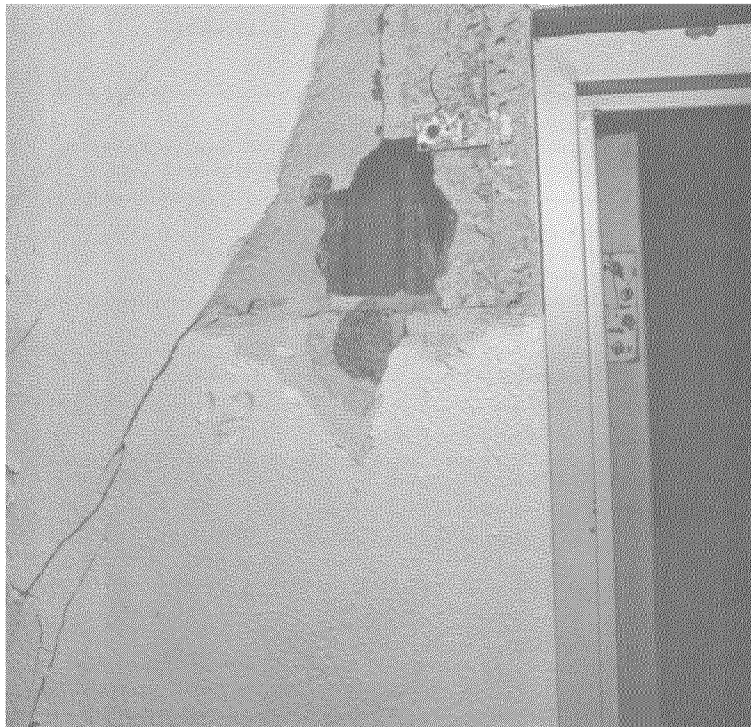
Fig. 7.23 Another example of ungrouted reinforcing steel, shear wall in Anacapa Residence Hall.
