## 8. ARCHITECTURAL, EQUIPMENT AND PROPERTY DAMAGE

### 8.1 Property Damage

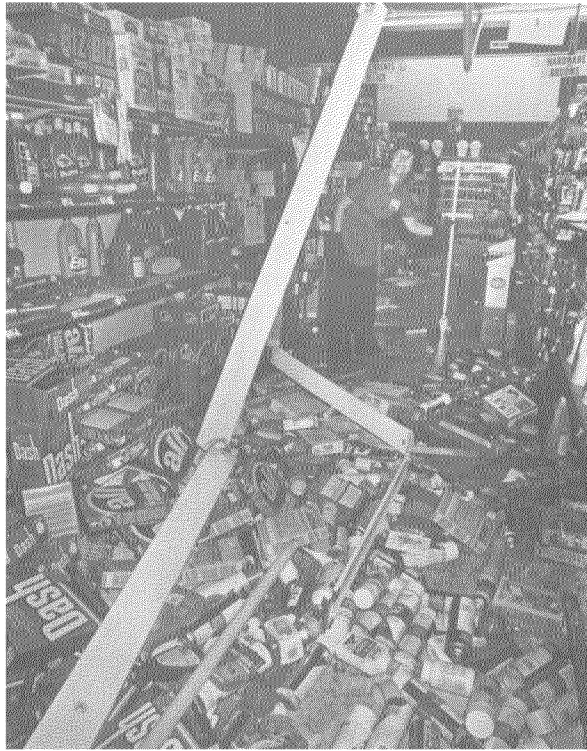
**Fig. 8.1**

Toppled merchandise at Smith's Food King supermarket in Goleta. (Santa Barbara News-Press photo. Reproduced by permission).

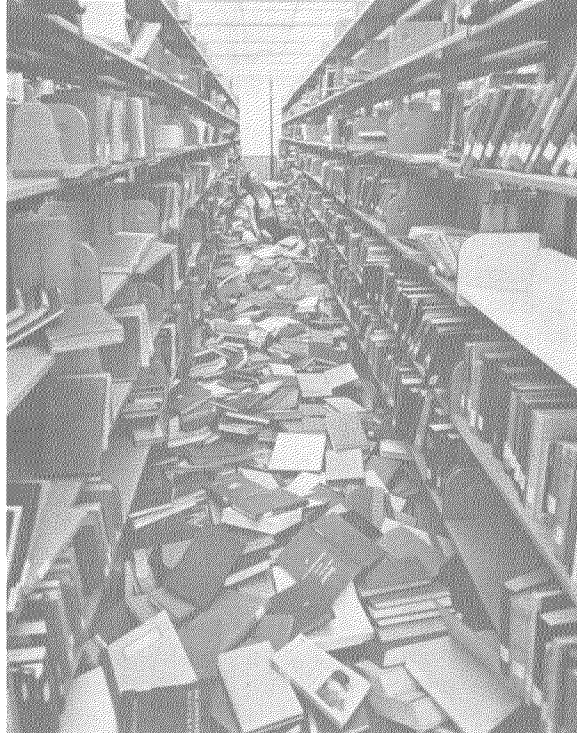
**Fig. 8.2**

Fallen books in the 1.2 million volume collection of the UCSB Library. (Santa Barbara News-Press photo. Reproduced by permission).
