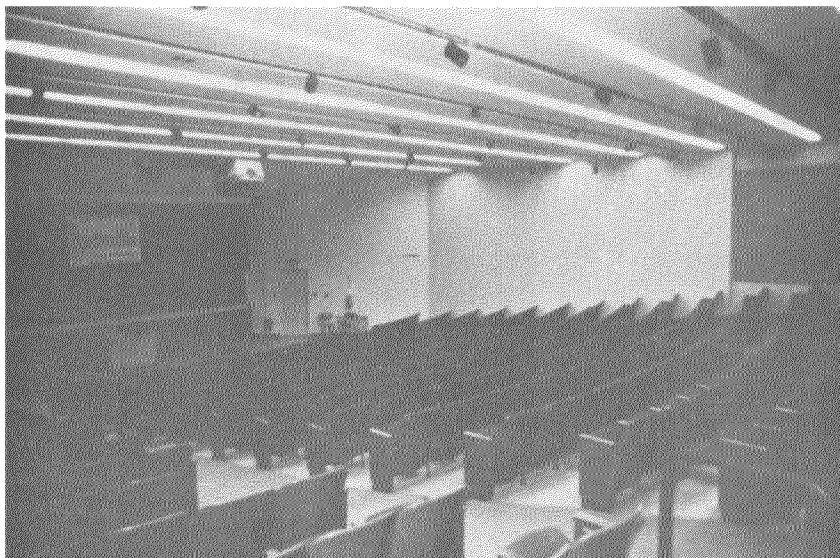
Fig. 8.3 Lecture hall of UCSB Chemistry Building where sheet metal panels fell from the ceiling.

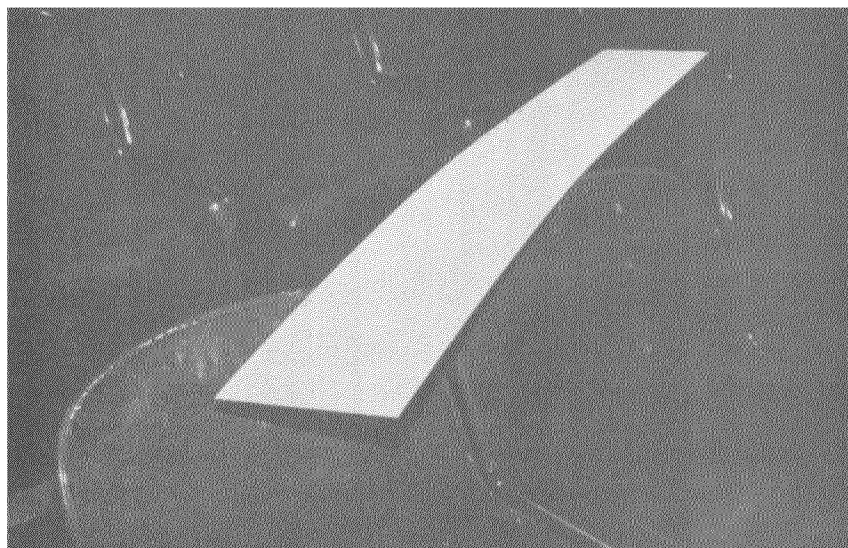
Fig. 8.4 Close up of fallen sheet metal panel, UCSB Chemistry Building (Fig. 8.3).
