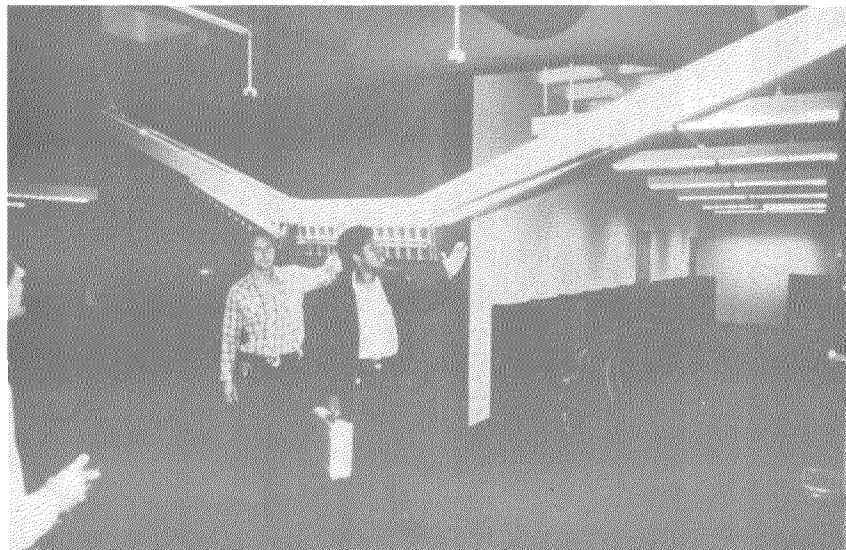
Fig. 8.5 Dislodged fluorescent lighting fixture in UCSB Library.

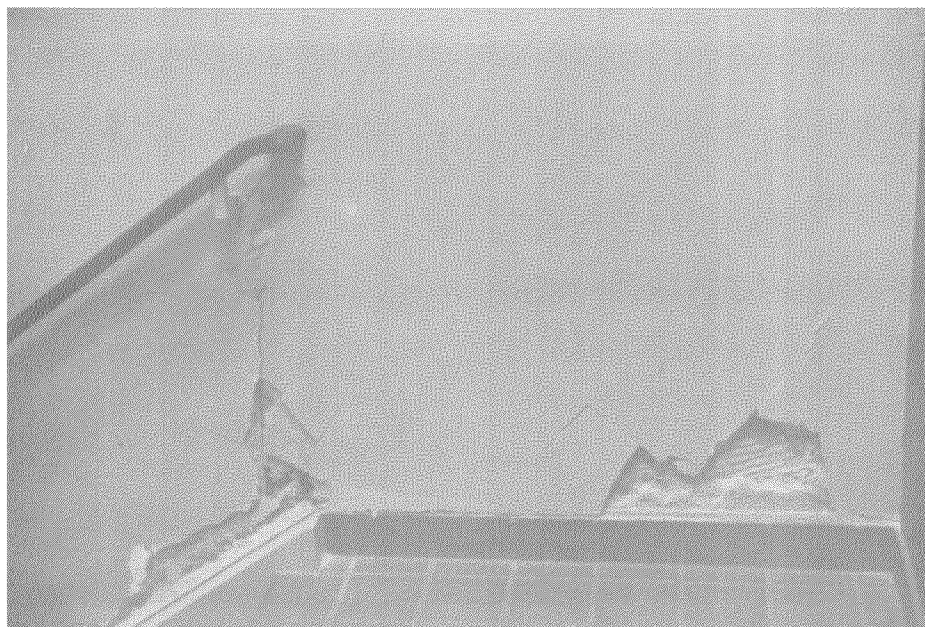
Fig. 8.7 Cracks in plaster wall of Santa Barbara County Administration Building.
