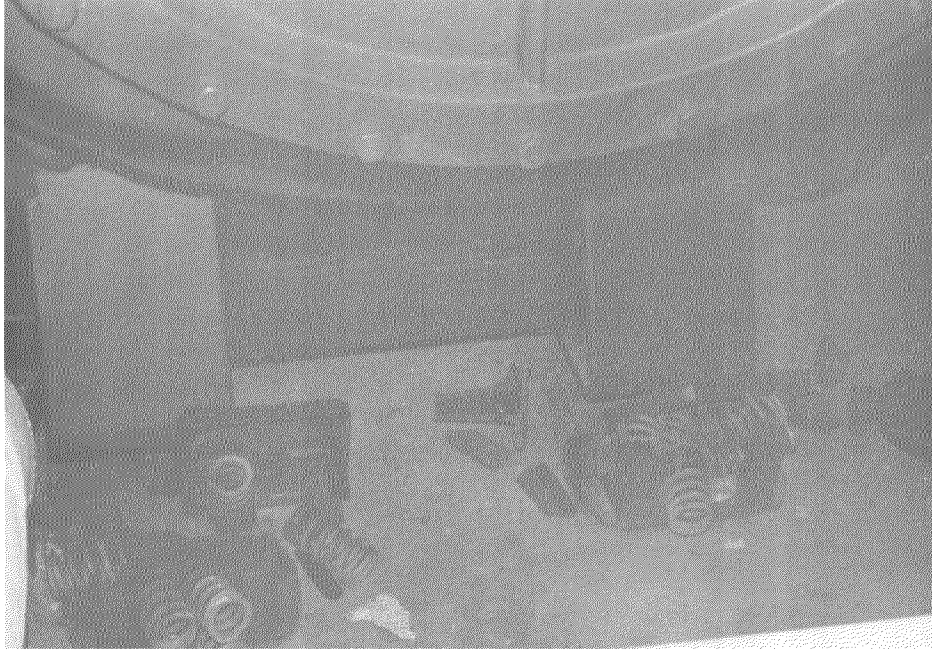
Fig. 8.10 Close up of damaged supports at back of chiller (Fig. 8.8).

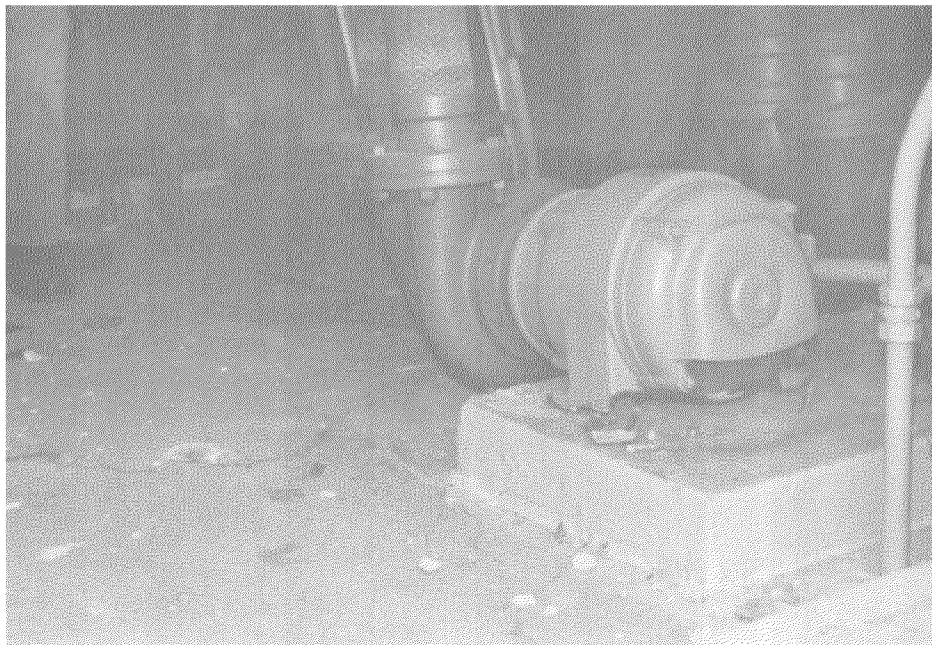
Fig. 8.11 Broken mounting base of hot water pump on top of Library III Building, UCSB.
