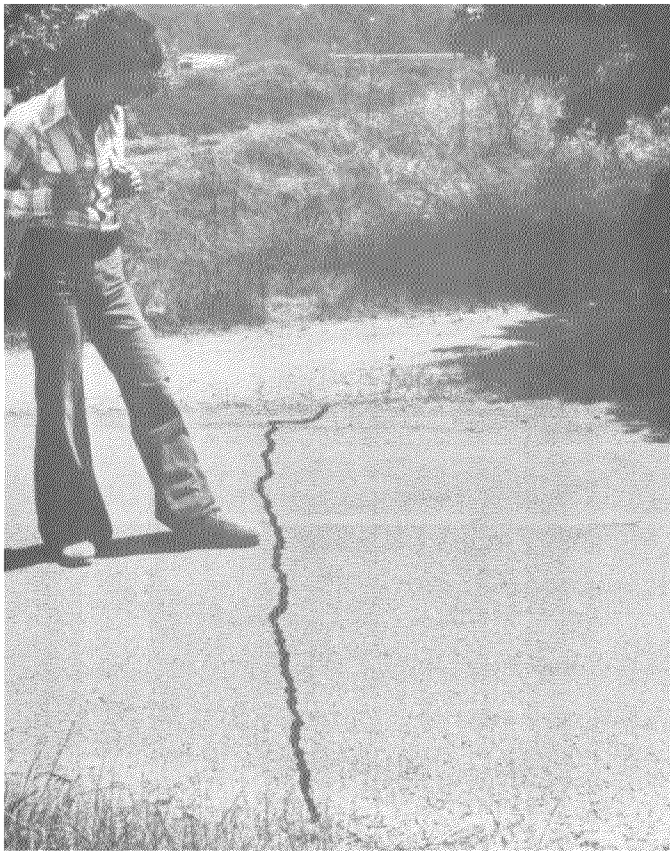
Fig. 9.3 Another extension fracture in the bicycle path shown in Fig. 9.1. This crack also runs in a north-westerly direction.

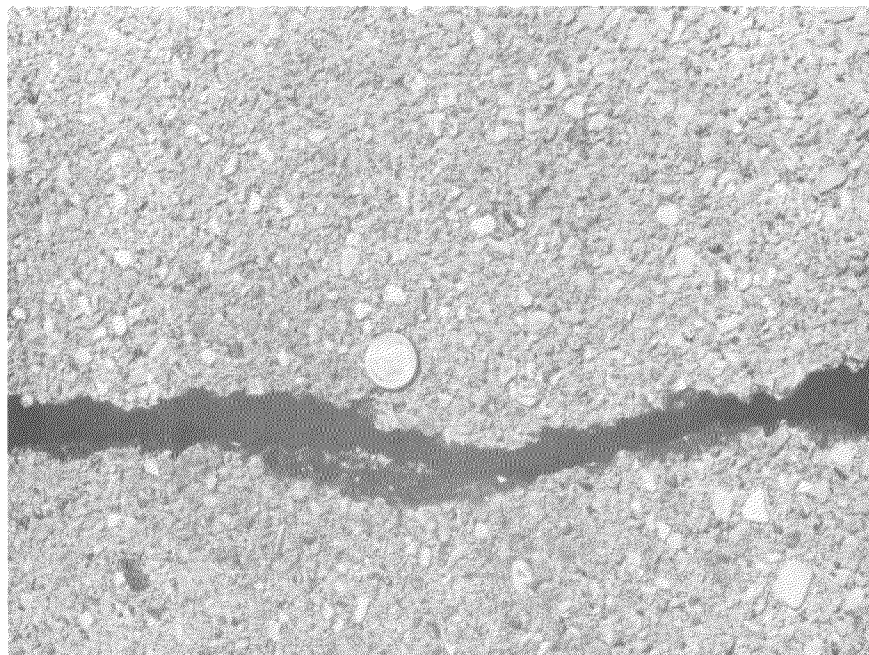
Fig. 9.4 Close up of the extension fracture shown in Fig. 9.3. Scale given by the coin (quarter) in the center of the picture.
