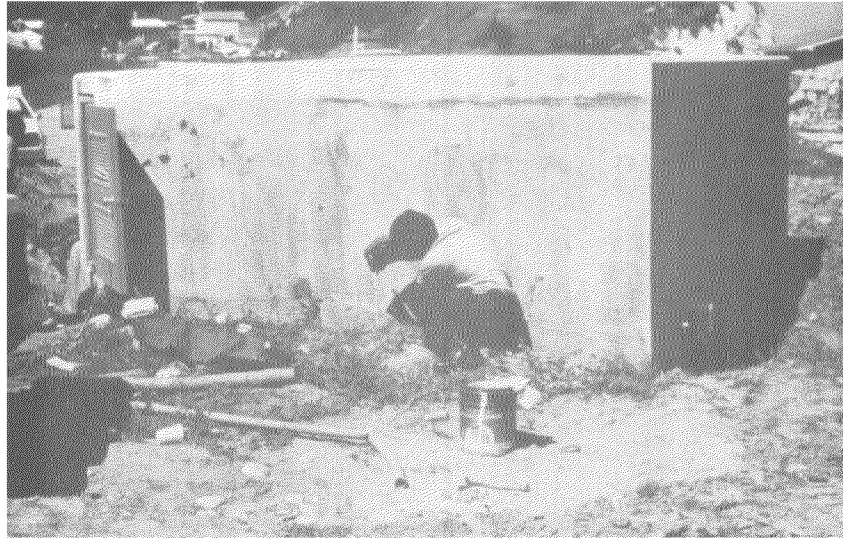
Fig. 9.5 Settlement of soil near pumping facility at sand spit, UCSB. Note previous soil line on concrete.

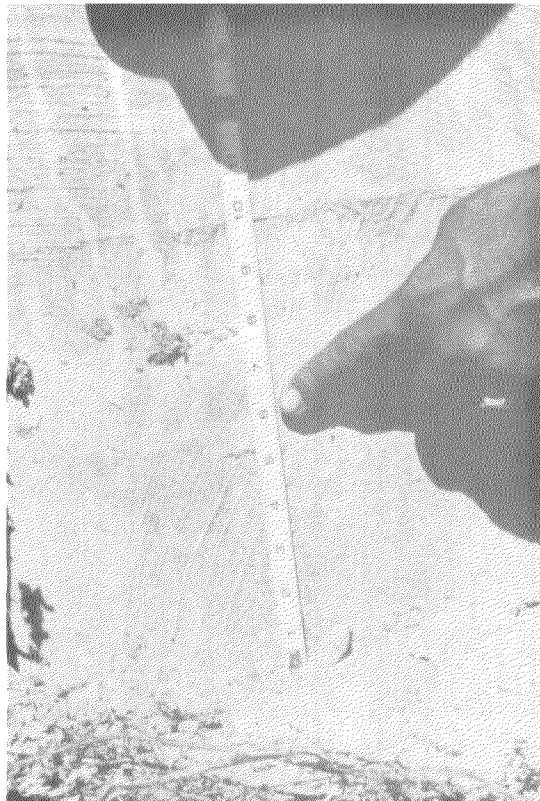
Fig. 9.6 Close up of soil settlement shown in Fig. 9.5.
