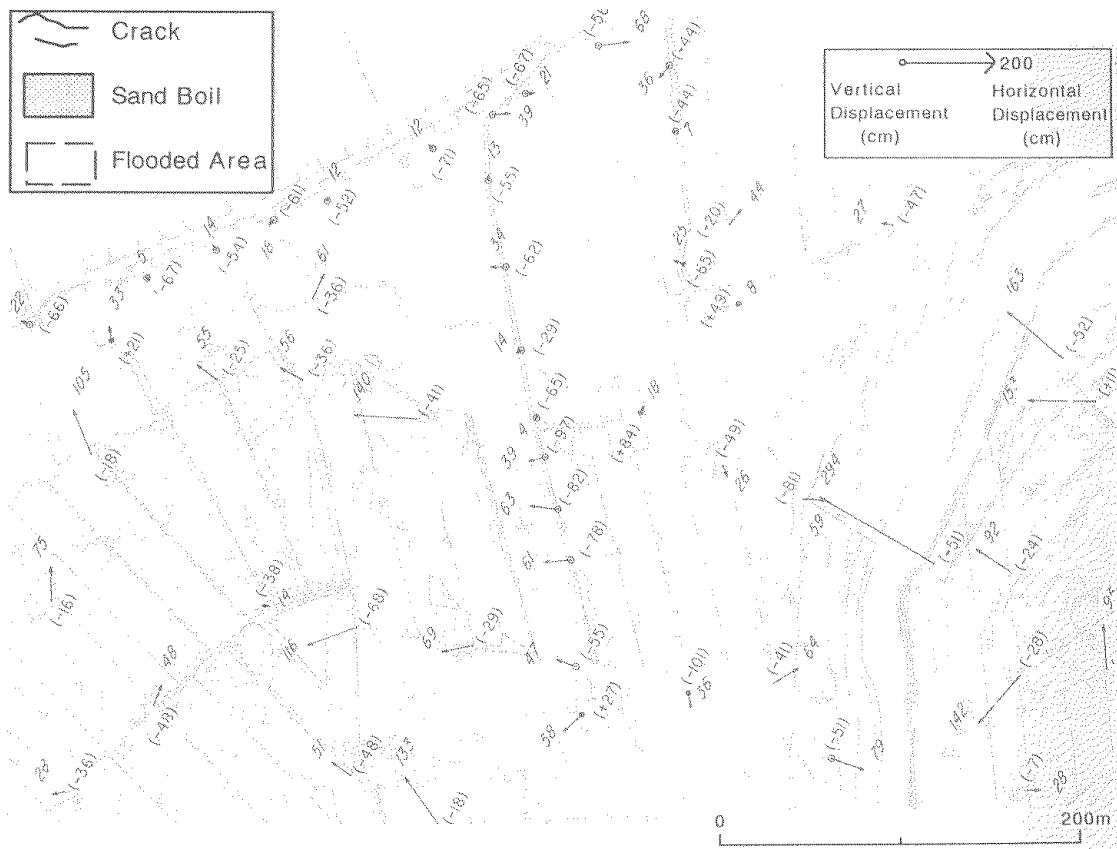
Figure 8 Map Showing Ground Deformations, Cracks and Sand Boils, Area C (About 800 m Downstream of Shinei Bridge, see Fig. 4)

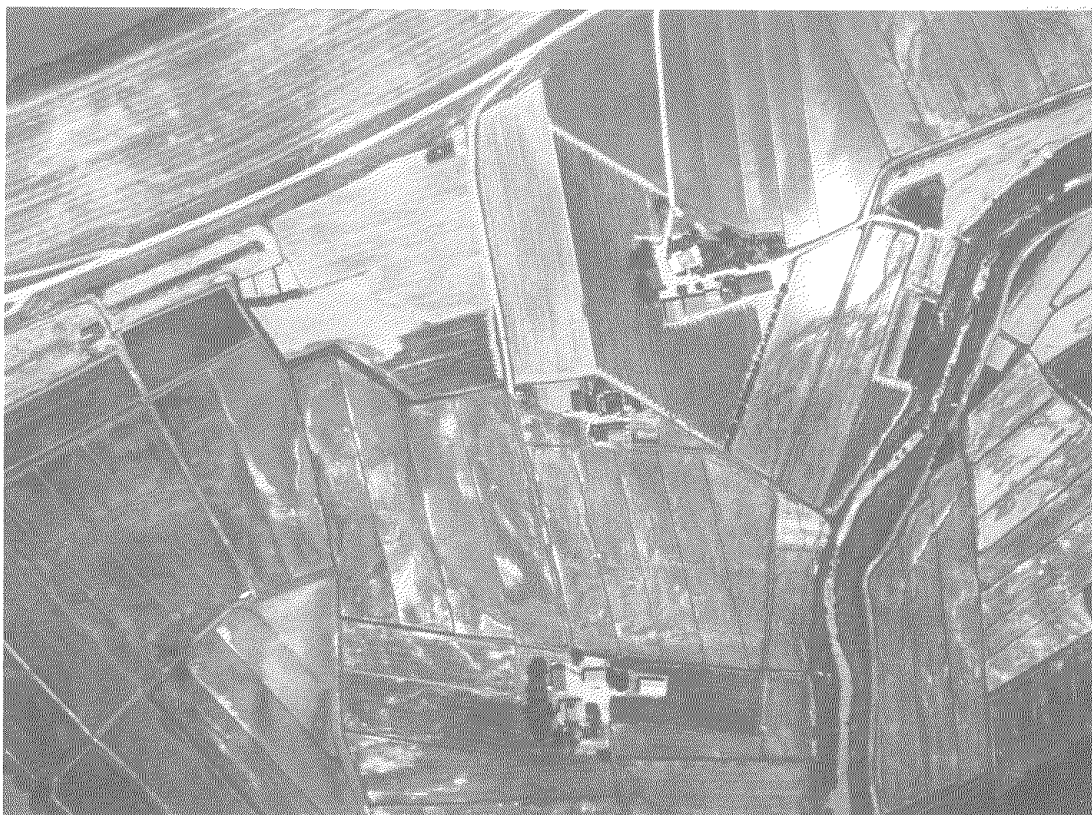
Photo 7 Aerial Photograph of Area C ( Same Scale as in Fig.8 )

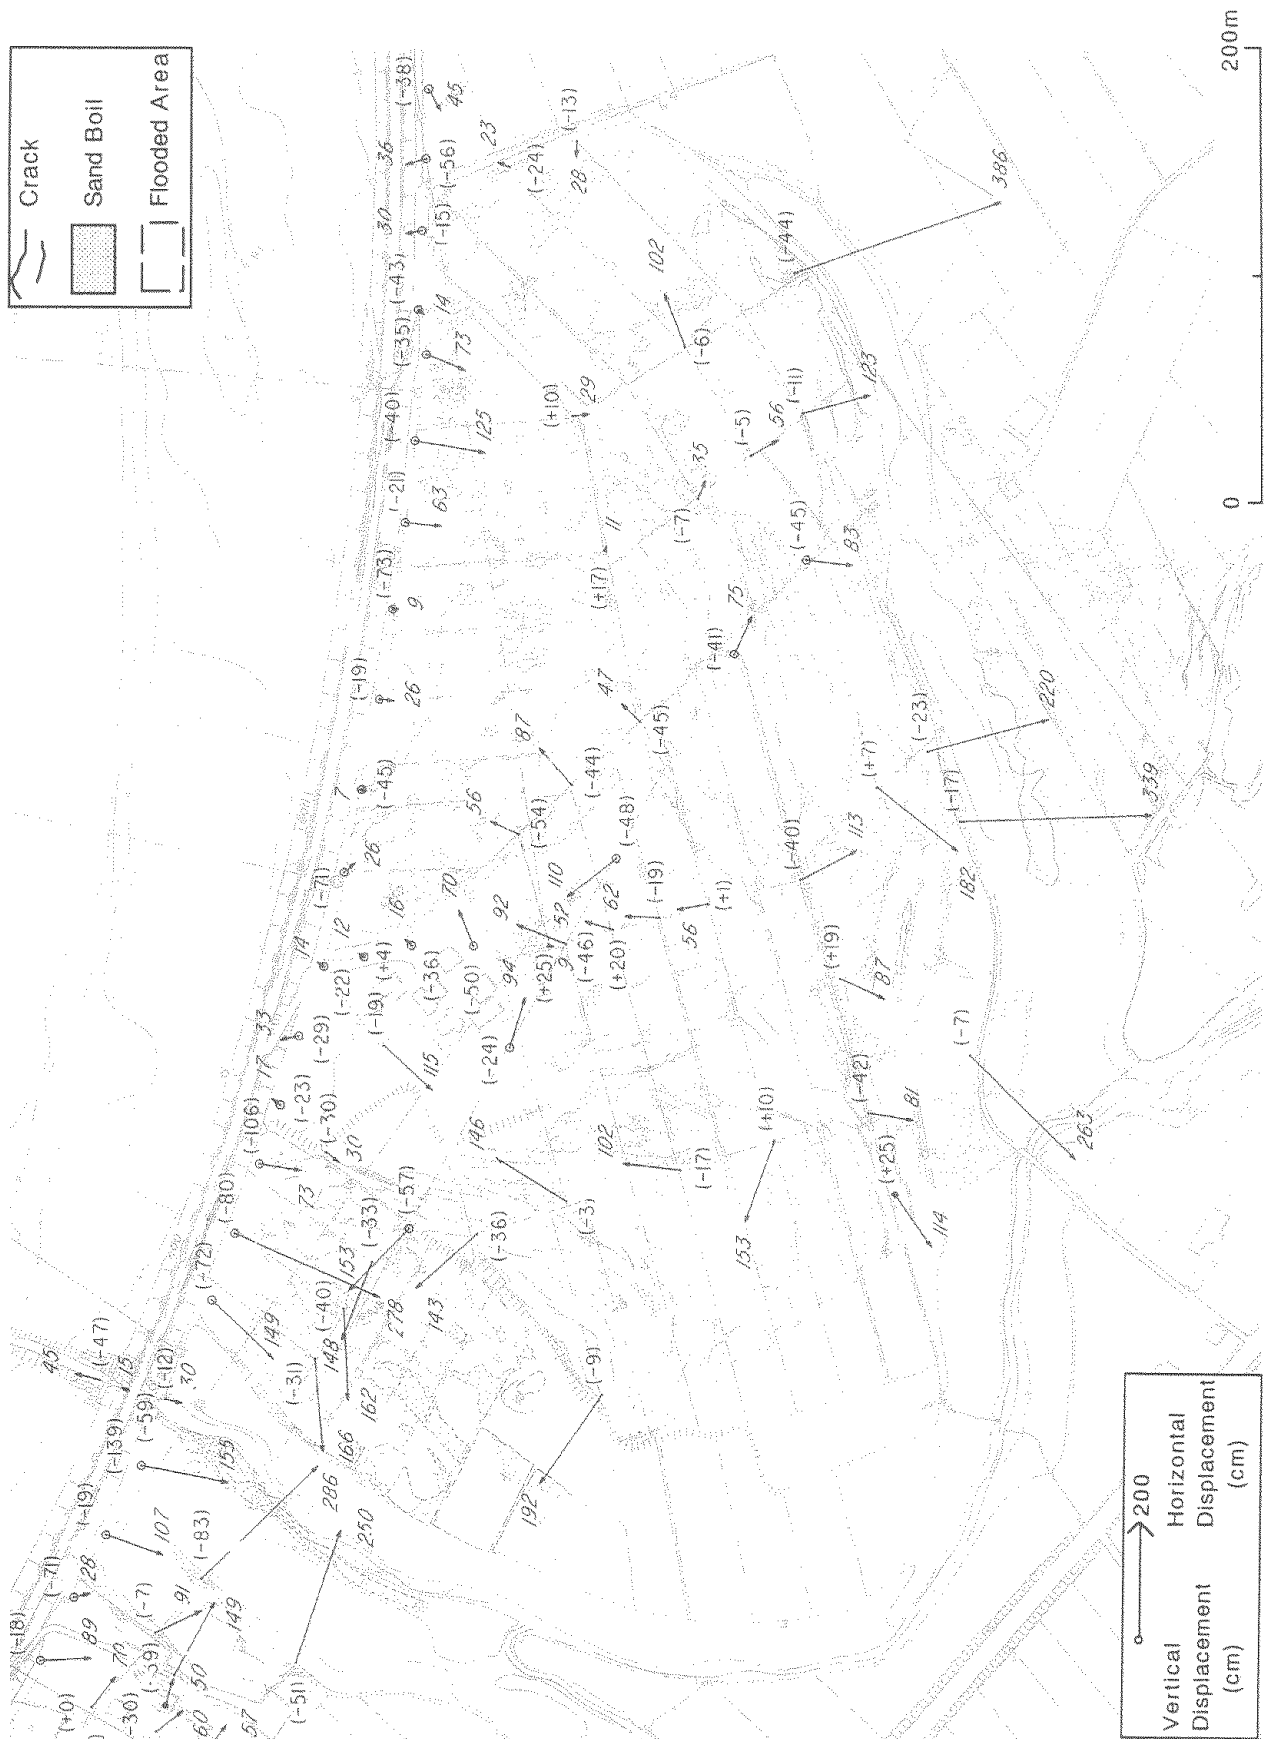
Figure 9 Map Showing Ground Deformations, Cracks and Sand Boils, Aichi Area (Area E, see Fig. 4)
