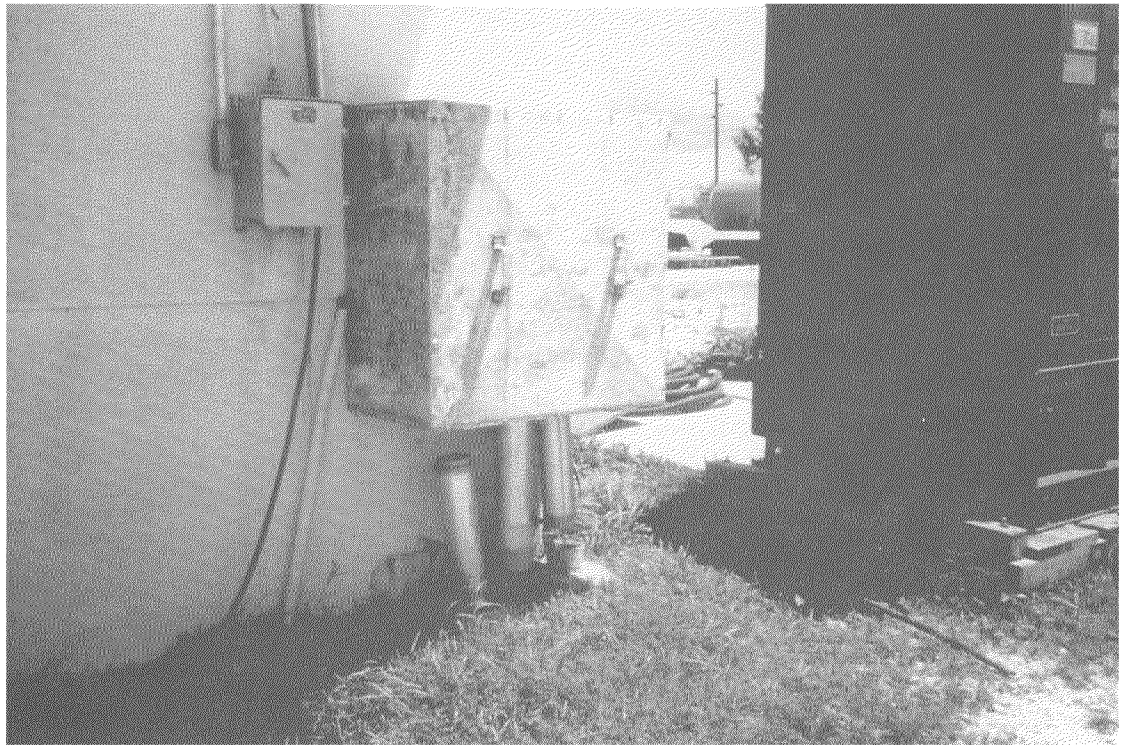
Figure 12: Signs of differential settlement between the pile supported building and the adjacent filled area
