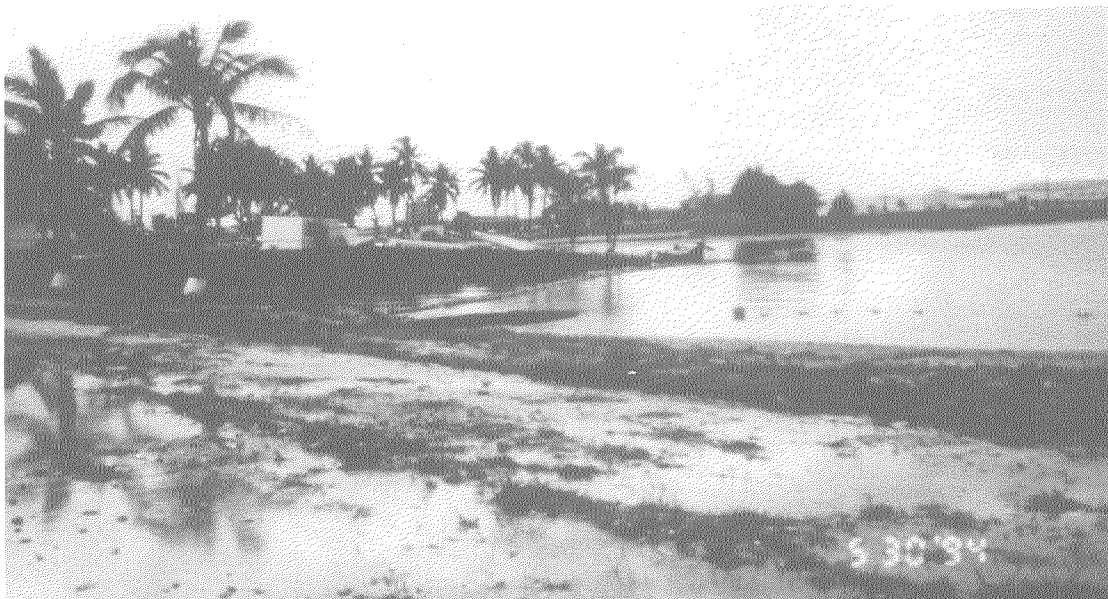
Figure 22: Failure of the sheet pile and lateral spreading near the former Andy's hut

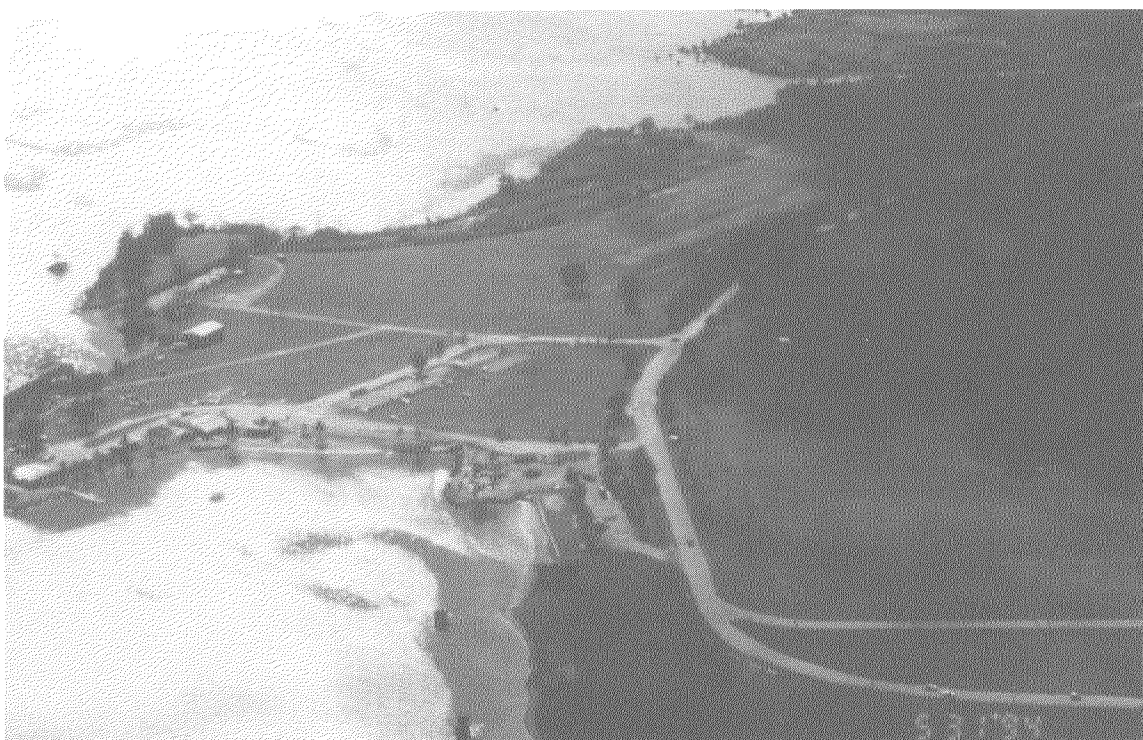
Figure 23: Aerial view of failure of the sheet piles and lateral spreading near the former Andy's hut
