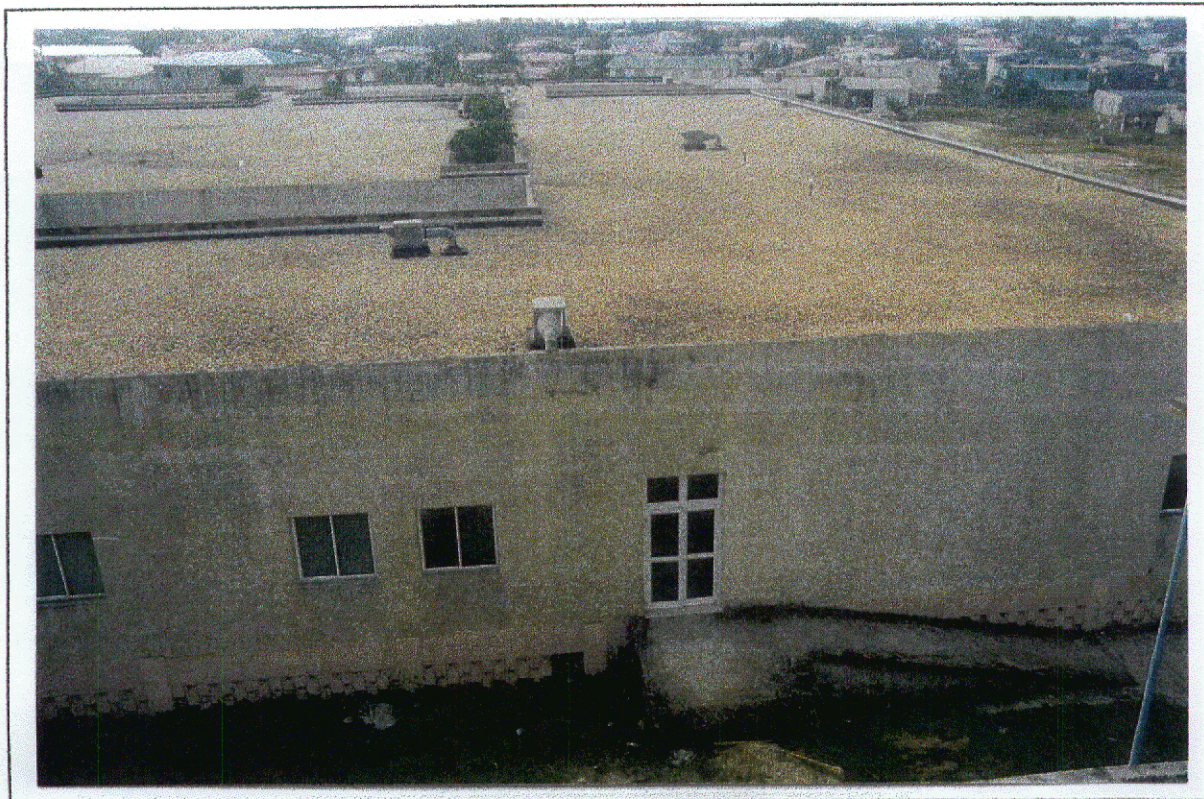
Photo 5 - The roof of the Hospital covered with gravel ballast  
The gravel poses a hazard to windows in high winds  
It is intended to remove the gravel as part of the EU Rehab project

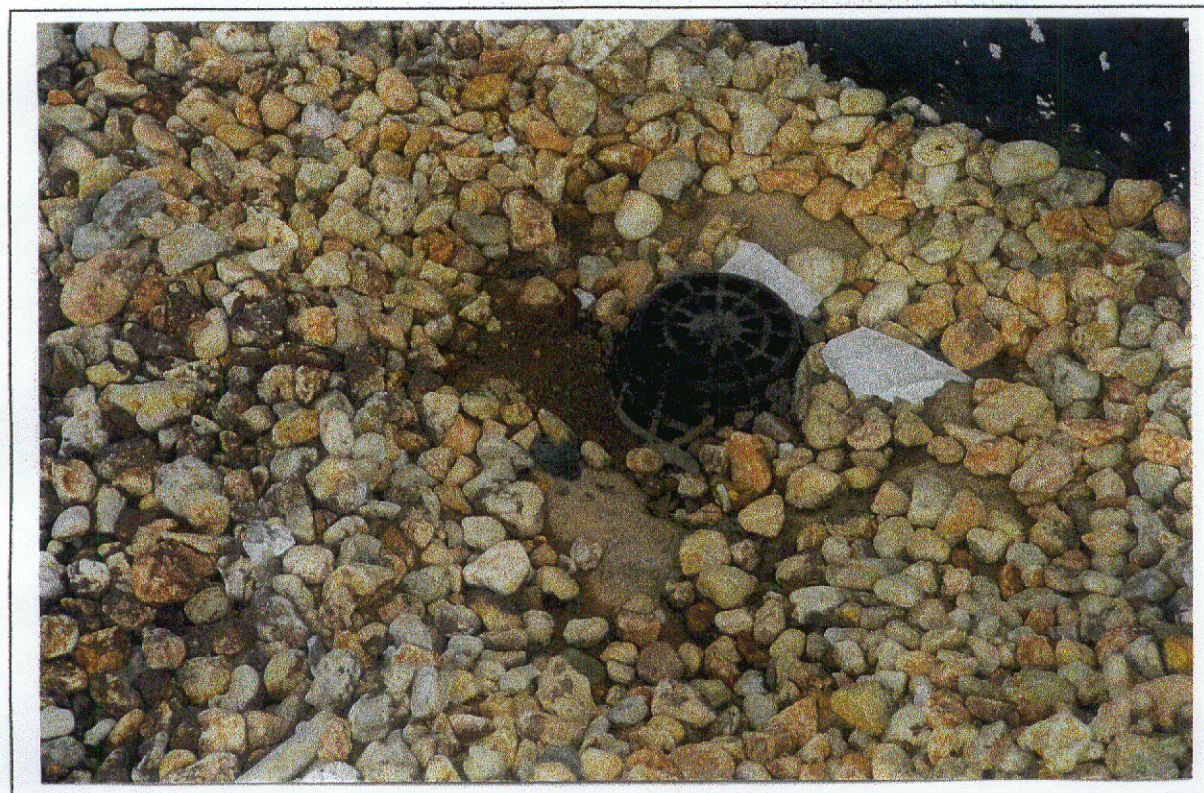
Photo 6 - Drain inlet on the roof of the Hospital  
Some leaks are traced to these locations
